**Cable Strike– Albert Embankment
Tideway Integration Group (TIG)
John Murphy & Sons (JMS)
12th January 2017**

Incident type:	HV Service Strike
	Safeguard Incident No:	6874306
	Incident Date:	12 January 2017 (09:45 hrs)
	Location:	Albert Embankment
	Injured persons:	Although not physically injured, JMS are supporting for any potential psychological trauma effects
	Area or Company:	John Murphy & Sons (JMS) Tideway Integration Group (TIG) Site
	Current Condition:	Cable is being repaired by UK Power Networks (UKPN)
	Incident:	HV Service Strike
	Current Situation:	Initial JMS statement has been provided via the JMS 212 reporting process, Initial Incident Report has been submitted and uploaded on to RIVO Safeguard. Investigation on-going

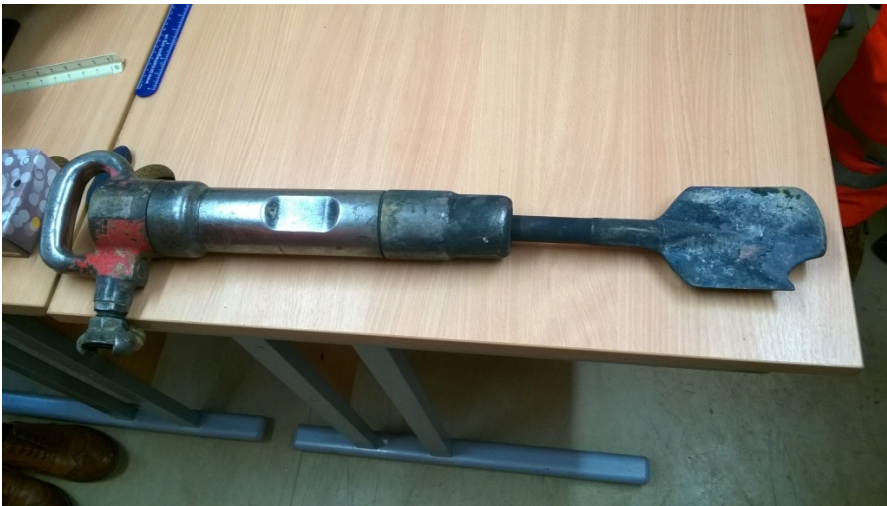
The operative was excavating a trench on the Albert Embankment site as part of a 5 person JMS site team. The operative was excavating using a hand held pneumatic breaker with clay spade attachment (FL22) and insulated hand tools. The excavation was required to expose space below shallow duct work so it could be lowered to accommodate concrete reinforcement work to take place above it as part of asset protection work for future heavy goods access and egress. As the excavation progressed, a known redundant cast iron pipe was exposed beneath the duct work. This had been identified for planned removal to create some of the additional space required. The operative chose to utilise the FL22 breaker to dislodge the cast iron pipe when it slipped from the area and struck an adjacent live HV 11kv electric cable resulting in an explosion and flash over. The operative did not sustain any injury however the clay spade attachment was damaged as was his protective trousers.

(Damage to clay spade)

- Operative slipped whilst using an FL22 hand breaker which made contact with a live HV cable causing an explosion and flashover.

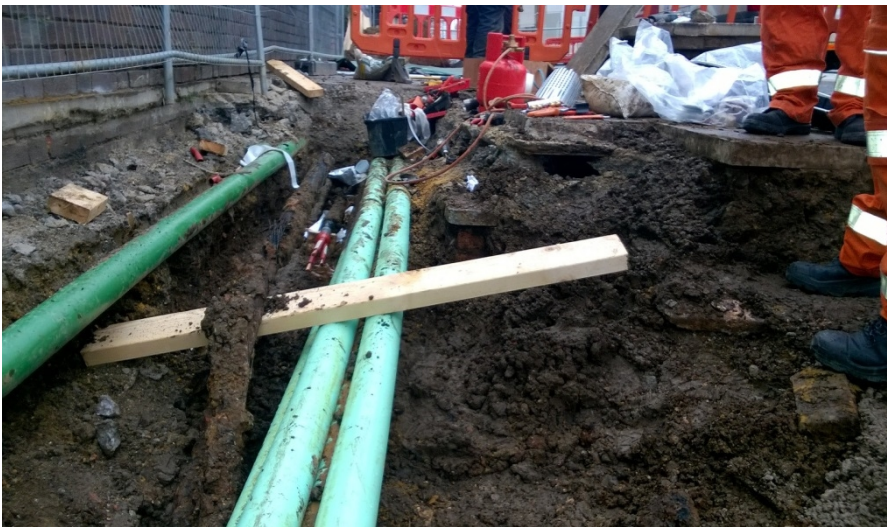
(Showing restricted work space due to chamber right of ducts)

- RAMS did not identify restricted work space at incident location due to an adjacent chamber.
- RAMS were not explicit on the methodology / tools required to break out the cast iron pipe.
- Electric cable was not physically protected from damage.
- Site supervision observed the work activity but did not challenge the unsafe act.
- The operative being distracted by previous day's events to his colleague and friend.
