SAFETY ALERT

| <p>Alert Issued by: FGSL HSSEQ Department</p> | <p>Safety Alert Reference No: FGSL-02-16</p> |

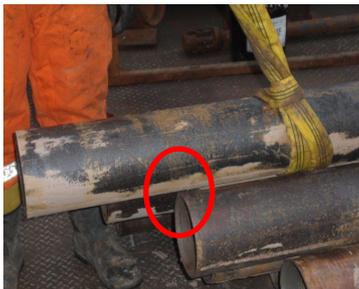
<p>Endless sling –“Choked & Pinch Point</p> </div> <div style="text-align: center;">

| <p>Recommendations and Corrective Actions:</p> | <ul style="list-style-type: none"> ➤ Review and update the drilling operations risk assessment and procedures to capture tubular lifting operations, including non routine activities. ➤ Following changes or encountering abnormal conditions within an operational activity, a "Time Out" should be taken and the situation assessed to identify and communicate any new risks (Principles of S.L.A.M – Stop, Look, Assess & Manage) ➤ All drill pipe and casing are to be stowed at all times within stillages and racks whilst on the drill deck. Prior to applying an endless sling the casing must be clean and free from contamination (e.g. drilling mud, clay, grease, oil etc) ➤ When the use of an endless sling is required to lift a length of drill casing, it <u>must</u> to be applied in a "Double Choke" configuration. ➤ The development of a Technical Briefing Note to clearly outline the methodology of lifting casing / tubular with a lifting sling. ➤ Safety stand-down to deliver site based operational training and technical guidance on the methodology to be used when lifting casing with an endless sling (soft strop). |

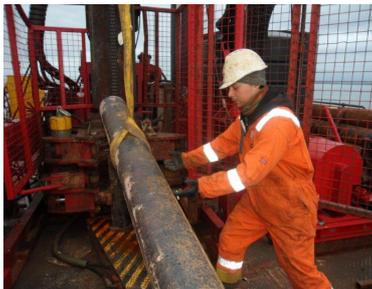
<p>Simulated actions of IP</p> </div> <div style="text-align: center;">

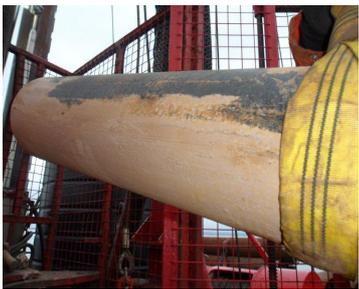
<p>Clay material on underside of 7” casing</p> </div> </div> | | | | | | | | | | | | |

| <p>Findings:</p> | <ul style="list-style-type: none"> ➤ The casing had not been sufficiently cleaned and borehole material (clay) removed after being tripped out from the borehole. ➤ The sling had been placed around the casing whilst it was laid on top of other lengths of casing which were pyramid stacked on deck. This resulted in the sling becoming pinched and not "choking" around the casing fully as the weight was taken by the heavy lift winch. ➤ The combination of the increasing lift angle, contaminated slippery casing and the sling not being properly choked caused the casing to fall from the strop. ➤ The instinctive action of the IP to attempt to grab hold of the falling length of casing is a significant factor that resulted in a personal injury being sustained. ➤ The task risk assessment and method statement failed to identify the potential risks and controls for tubular lifting operations, especially in the use of endless slings to "choke" lengths of casing. |
