Alert No. SA00082018 Serious injury from rotating winch

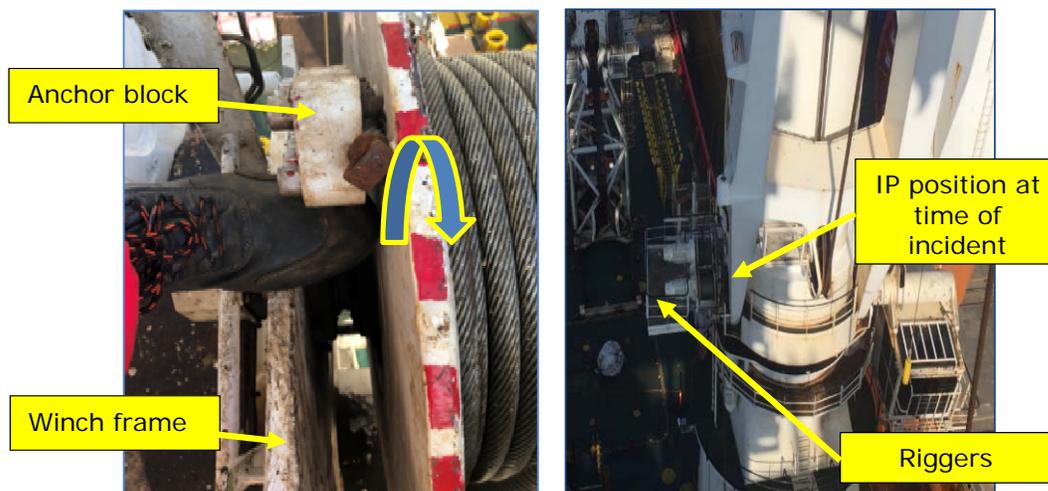
When the IP decided to leave this location he placed his left foot on the winch frame to help step over a protrusion. This resulted in his foot being placed directly into a line of fire position, extending beyond the handrail. The anchor block, fitted to the outside of the still rotating winch drum, struck the extended boot which resulted in all five toes being amputated.

- The Task Risk Assessment (TRA) was inadequate for the work and did not recognise hazards associated with rotating equipment during the spooling operation.
- The Toolbox Talks (TBT) did not discuss positioning for the personnel involved in the task and did not emphasise the rotating block as a hazard.
- The rotating anchor block was unguarded as it was thought to be safe and barriered by the handrail.
- Safer options were available to the work team but not taken.
- There was no time pressure to complete the task.

- Conduct a hazard hunt on winches to identify potential line of fire hazards.
- Assess the effectiveness of the existing safety controls and barriers and implement any required improvements. Vessels are required to send findings to their Vessel Superintendent.
- Reinforce the importance of specific risk assessments, effective TBT preparation and delivery for every activity.
- Whenever possible the TRA should be reviewed at the working area to ensure that all hazards have been identified prior to work starting.
- STOP THE JOB if you see anyone in a position where you could be injured. Repeat this every day in every TBT.
