Reportable Injury – Lower Thames Crossing Ground Investigation Drilling Operations

Incident Overview

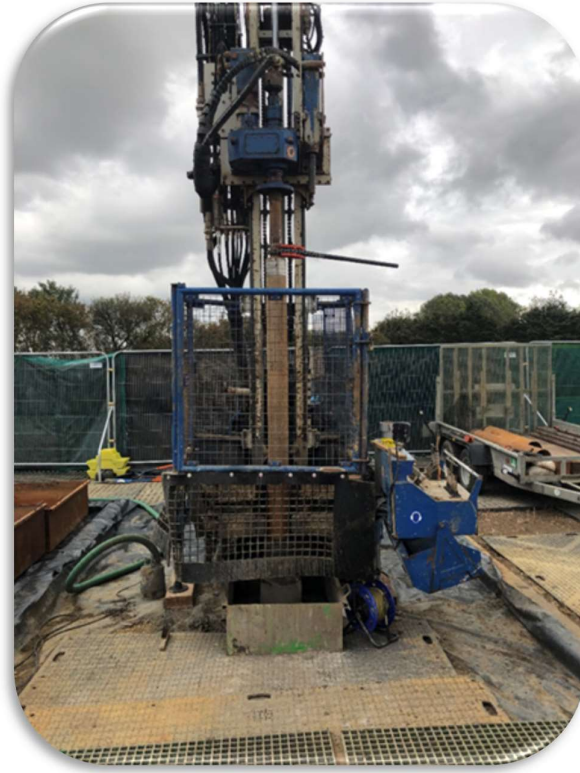
Around 16:30 hrs the drilling crew were finding it difficult to break the last casing from the rotary head with the twin clamps slipping on the casing resulting in polishing. The Lead Driller (fully qualified but newly appointed to the role) suggested that a chain wrench be used to give extra mechanical purchase to the casing, the unplanned / unapproved method being to wrap the chain around the casing, lock the chain off to the wrench handle and wedge the handle against the rig mast above the safety cage in order to provide maximum torque and free up the casings.

As the rig engaged rotation, the torque of the rotation broke the chain away from the wrench handle almost immediately, whipping it around the casing and ejecting it towards the Support Operative striking him on the safety glasses. The impact of the 1kg 650mm long chain caused the Support Operative to stumble backwards and resulted in a facial fracture, whiplash and superficial cuts and grazes.

- Installation of casing using full torque first gear (instead of second gear) resulting in tighter locking together of casings.
- Failure to maintain clamps with wire brush to remove swarf resulting in slippage.
- Applying an unapproved / unsafe practise.

- Failure to stop works when a challenge was made to an unsafe working method.
- Failure to escalate challenge to supervisor when challenge was disregarded and concern remained.
- Failure to follow change management process, obtaining approval and updating RAMS prior to implementing alternative working method.
- Failure to contact fitters to service clamps - clamps should always be able to break casing and where they can't it is a clamp malfunction.
