SAFETY ALERT

2018/UK/SA/001
14 December 2018

Dumper Throttle Pedal Incident

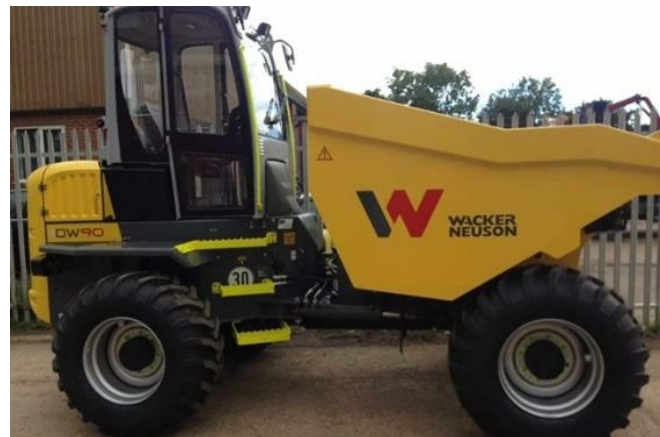
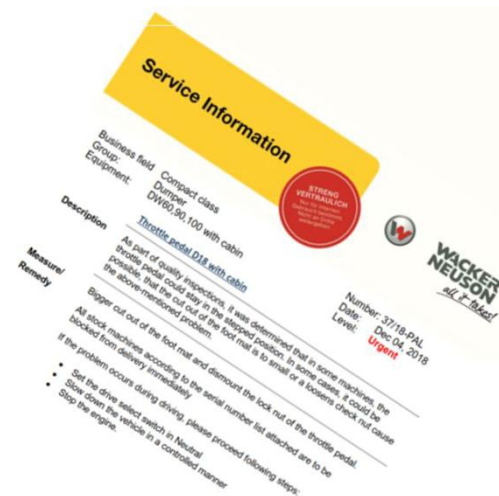
In the early hours of the morning of 20/11/2018 a hired 6 ton Wacker Neuson DW60 Cabbed Dumper was being driven by an agency operative who collided with a Pelican Traffic management Column whilst travelling on the public highway.

The operative reported the incident to his supervisor claiming that the accelerator pedal had stuck down which resulted in him mounting the footpath and colliding with the column before coming to a stop.

The manufacturer has issued a service bulletin to all owners to carry out modifications to the throttle pedal and rubber floor matting as described in the bulletin.

- Plant & Fleet Services are working with our supply chain to only supply modified machines in the first instance.
- If you currently have this type of dumper on your site (DW60, 90 and 100 cab dumpers) and are concerned that the modification has not been carried out, please contact Richard Mason via e-mail (richard.mason3@balfourbeatty.com) who will verify if the modifications have been carried out and if not will arrange for them to be done.
- Projects to ensure that competencies are appropriate for the operation of plant with a particular focus when is a driving license required for work on the public highway.
