## Shared Learning

Near miss (Falling Swivel) Investigation lessons learnt

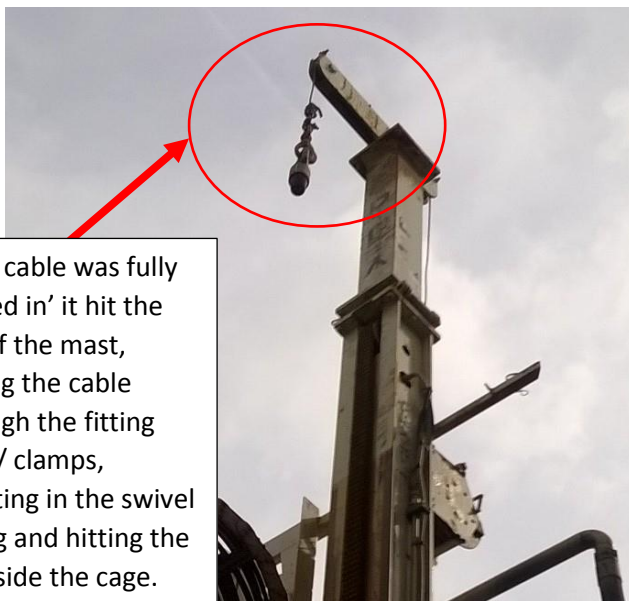
The driller was stood at the rig control panel adjusting the torque on the drill head, whilst undertaking a core run, and accidentally caught the wireline winch lever and activated it in to the 'reel in' location. The wireline winch with swivel attached, was then unknowingly reeled to the top of the mast where it came in to contact with the top of the mast and resulted in the wireline cable pulling through the fitting eyes / clamps and the swivel freefalling to the ground, hitting the back of the rig.

Once cable was fully 'reeled in' it hit the top of the mast, pulling the cable through the fitting eyes / clamps, resulting in the swivel falling and hitting the rig inside the cage.

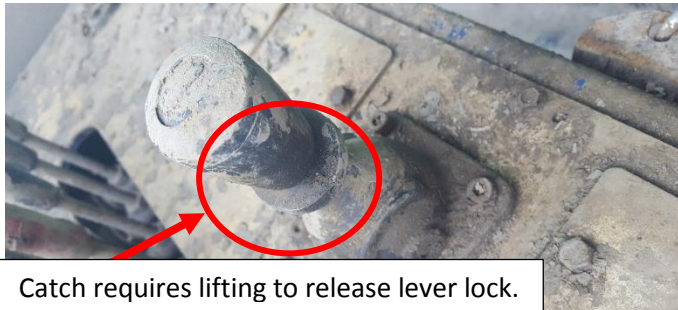
Catch requires lifting to release lever lock.

The winch lever should have been in locked off position. This can be done by putting the control lever in the neutral position fully, which locks it off. A catch has to be then lifted in order for the lever to be used again. The lock stops it being accidentally knocked in either direction (see picture).

1. Swivel should not have been positioned so high up the mast – usually it is lower and the movement of the winch would have been noticed.
2. Lever should have been locked off. The lever clicks & locks off when in the neutral position, but it appears on this occasion the lever had not been fully clicked to neutral, & locked.
3. Extra vigilance when operating controls, and ensure controls are locked off where appropriate, and that PPE does not pose an issue getting caught on controls.

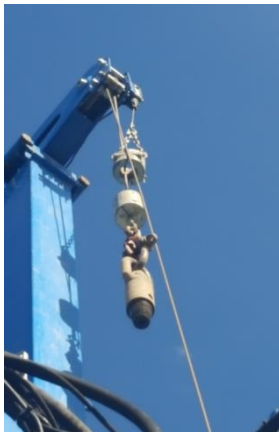
Other rig makes (Soil Mech) do have a 'Chandelier' type safety feature fitted (see picture) which stops the swivel / winch from fully reeling in. If the winch were to be fully reeled in, then the swivel / hook adapter would strike this safety device, and stall the engine. This feature appears to be manufacture specific however, and not dependant on age etc. It would involve considerable cost and design to retrofit the safety device onto other rigs which do not have it factory fitted.
