## High Potential Near Miss

On Wednesday 19th September 2018 at approximately 16:00, at the Scotch Corner/A66 interchange, a Mallatite 10m Post Top Lighting Column (8m above ground exposure) sheared at approximately 1.25m above ground level and came to rest across the carriageway at the Scotch Corner/A66 interchange.

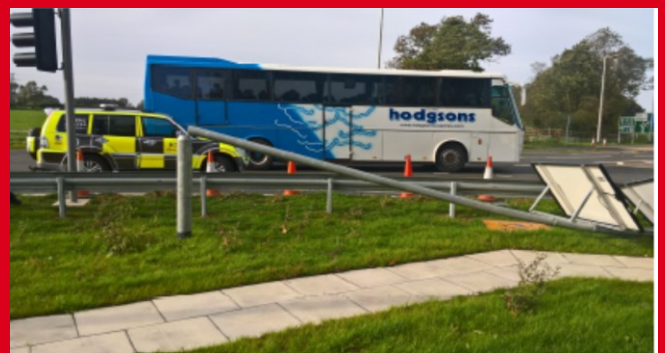
The lighting column also had 3 off 1.7m x 1m x 40mm solar panels fitted to its upper extremities, which on investigation proved to exceed the wind loading capabilities for this particular type of column.

Due to adverse weather conditions on the day the wind loading applied to the failed column caused it to shear above the upper welded swage line where the lower section (168.3mm diameter x 3.6mm thickness) 1.25m above ground meets the upper section and reduces to 114.3mm diameter and is only 3mm thick.

The original manufacturer specification was not complied with, due to miscommunications between various parties involved and the investigation highlighted other communication issues related to client/design approval.

- Determine if the CCTV out station design (mast/cabinet and solar panel post) is an approved departure that has been incorporated into the design
- Review the suitability of the Autonomous CCTV Outstation System
- Conduct a HAZOP to determine current and future risk potential of the fuel cells
- Review staffing and communicate roles and responsibilities to those remaining on the project
- Identify effective and efficient means of communication with all parties for other HE/JV projects
- Ensure materials utilised in the works yet to be completed are in accord with approved MAR's
