SAFETY ALERT

Riddor Reportable Accident

Fractured Metatarsal

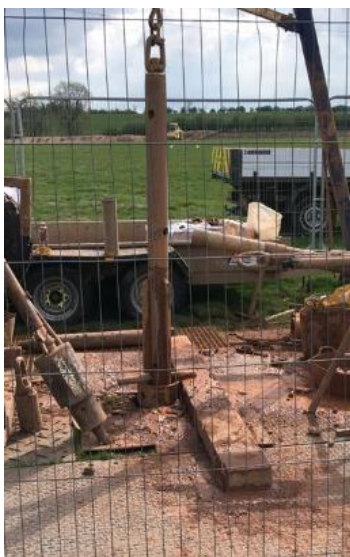
The Driller (Second Man) was guiding the shell into the upright position following emptying during normal CP drilling activity. As the shell was just approaching vertical, the base of the shell slipped off the timber falling approximately 50mm to 75mm impacting the IPs left foot. The tool shoe impacted the foot behind the steel toe cap. The shell was lifted off immediately as the winch continued to raise the shell to the vertical position.

Operative sustained a fracture to the second metatarsal on his left foot.

- Production and operational trials of a tipping tray for use with CP rigs when 'shelling'.
- Further development of best practice guidance for use of CP rigs - detailing exclusion, controlled and safe zones.
- Further development of a standardised SEGL CP rig set-up and work site layouts.
- Effective communication of guidance, rig set-up and work site layouts via SEGL works procedures.
- Metatarsal protection for operatives working in controlled work zones.
