Series of Service Strikes

Background to the incident

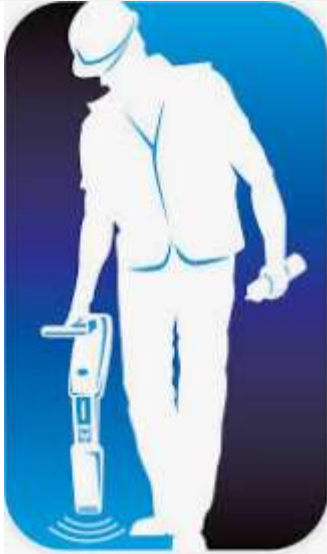
In May of 2020, a 20mm gas pipe and a low-voltage electric cable were struck in Wardington and on the M40 J11 improvement works respectively. In August 2020, another low-voltage electric cable was struck on the M40 J11 improvement works.

Utility drawings can be inaccurate and out of date, and so alone are not to be relied on. Utilities should be installed as per industry standards, which include depths of over 450mm with proximity warning aids including coloured tape to identify utility types and surrounding the service in a bed of pea-shingle - none of these services struck complied.

It has now been mandated that all PAS 128 surveys required for Fusion sites, will now be managed by the Fusion PAS 128 team and follow the same stringent analysis and assurance process.
