# S H E Q A L E R T

## HIGH POTENTIAL NEAR MISS CROWD WINCH MOTOR FAILURE

Date: 23/10/2020

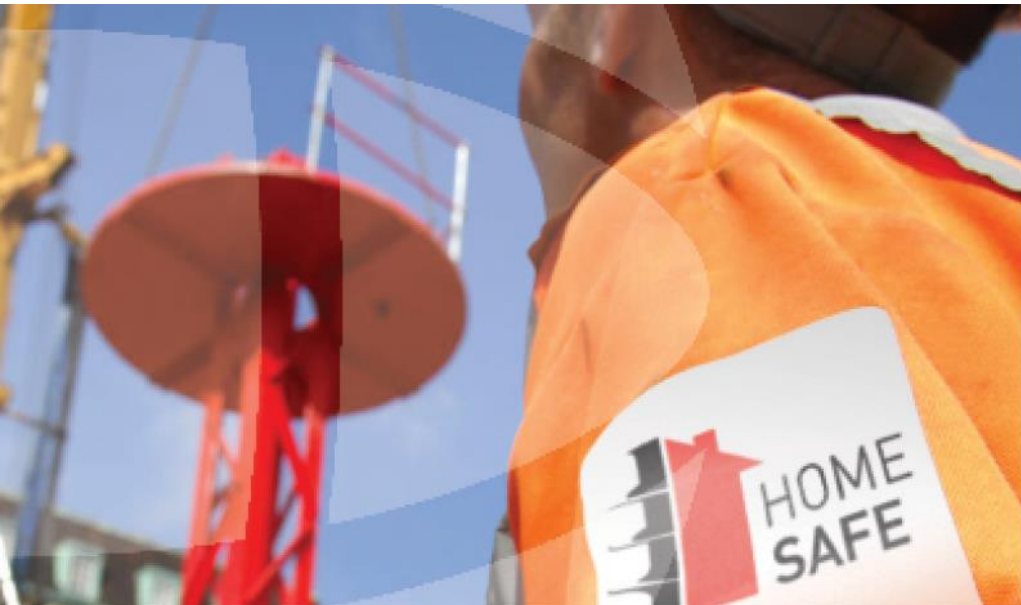
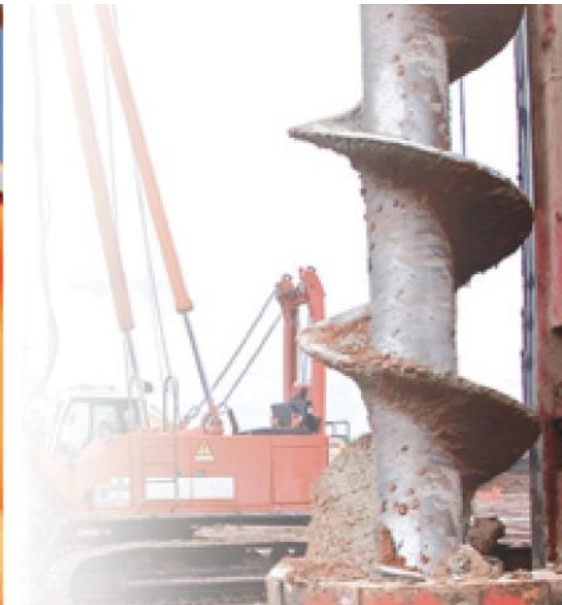
It was reported, the BG39 was in the process of drilling pile position 15 when the rotary suddenly dropped between 4-5m and landed on top of the pile casing. There was nobody at immediate risk at the time of the incident, however the rig attendant was standing nearby just prior to the incident.

- This event has never happened before within BSL or to the knowledge of the rig manufacturer.
- The crowd winch motor on the rig has suffered a catastrophic failure resulting in the rotary to drop in an uncontrolled manner.
- When the crowd winch lever is not in use the brake is engaged and automatically disengaged during operation.
- The failure happened as the operator was operating the crowd lever.
- The motor's casing was cracked, and this would have resulted in a significant loss of pressure on the system including the brake.
- When the casing was inspected various internal parts of the mechanism had been damaged beyond repair.
- The likely cause of the casing cracking was due to a hydraulic blockage resulting in a significant build-up of pressure.

- Safe exclusion zones in line with the FPS guidance should be strictly enforced on all sites. As a reminder, exclusion zones are there to prevent people being struck by moving plant and to protect them potential falling objects whilst working at ground level.
- All staff are to be re-briefed on these requirements.
- The BSL Plant Department have now implemented a servicing schedule for this type of motor that involves a service at a 1,000hrs intervals.
- The rig manufacturer has been contacted to undertake their own independent investigation and to look at changing the manufacturers operating manual to include the 1,000hr service and inspection regime on this type of motor.
