HIGH POTENTIAL NEAR MISS FALLING OBJECT

SR-75 CONCRETE SWIVEL STEADY BAR RETAINING BOLTS

EXECUTIVE SUMMARY

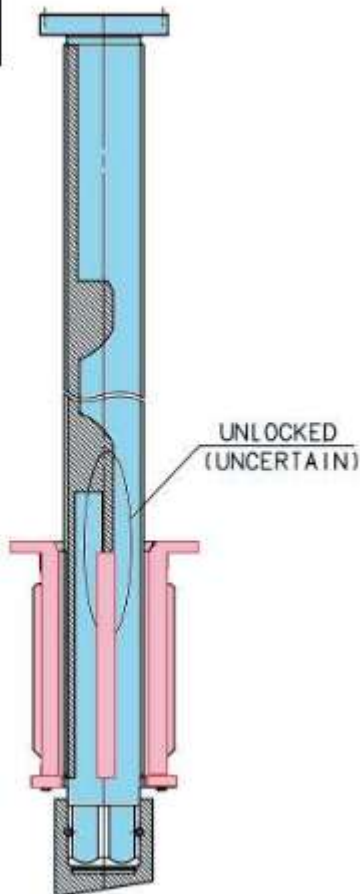
Fig 1. (Unlocked)

Initial investigations and trials indicate that the Kelly Bar was not locked correctly as per (Fig 2.) and was incorrectly locked as per (Fig 1.)

1. Review GSS Procedures (Procedural changes implemented)
2. Implement an internal Training Event for Both Rig Operators and Rig Attendants.
3. Review exclusion zones and management procedures.
4. Provide constraint to bolts to prevent falling as per (Fig 3.) above.
5. Share findings with manufacturer to reduce risks on subsequent models.
(External Locking Indicator lights being fitted on top of the cab plus explore the feasibility of an audible alarm indicating the Kelly Pole is in the Un-locked Position)
6. Share findings with other piling contractors through the Federation of Piling Specialists.
