Incident Report 24.02.2021

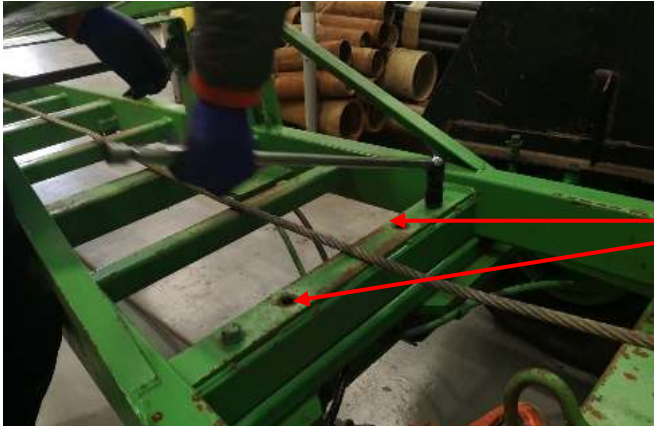
Following an incident where a Dando 3000 cable percussion drill rig became bogged, a fitter was called to site to investigate two sheared bolts between the axle and structural cross member. On investigation it was found that of the two bolts securing the main rig frame to the axle, one bolt had sheared and the other was severely corroded. This resulted in an situation where the drilling frame/trailer unit was not held on to the axle units and could easily have become detached at any point when moved.

Location of bolts fixing rig frame to axle units

The bolts and broken studs were removed, holes drilled out and replaced with M16 10.1 grade threaded bar and M16 nylon lock nuts. The axle was fastened down and checked for any further play. This process has been repeated on all SOCOTEC cable percussion drill rigs. These bolts will be replaced periodically and where only two bolts are present, upgraded to a 4 bolt fixing as shown in the picture below.

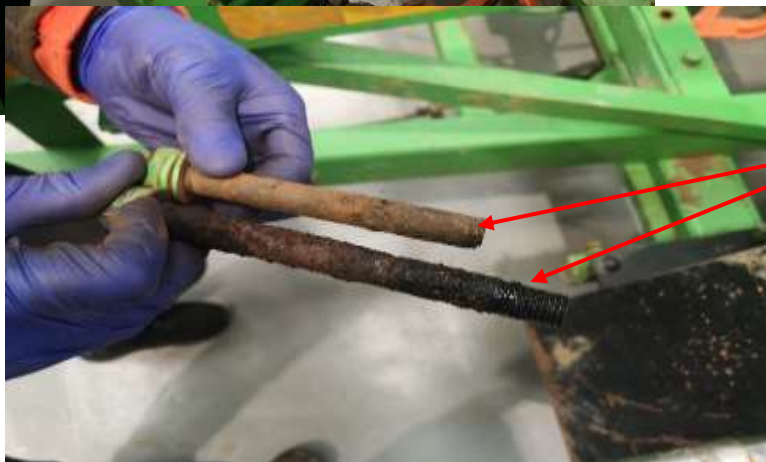
Sheared and heavily corroded bolts

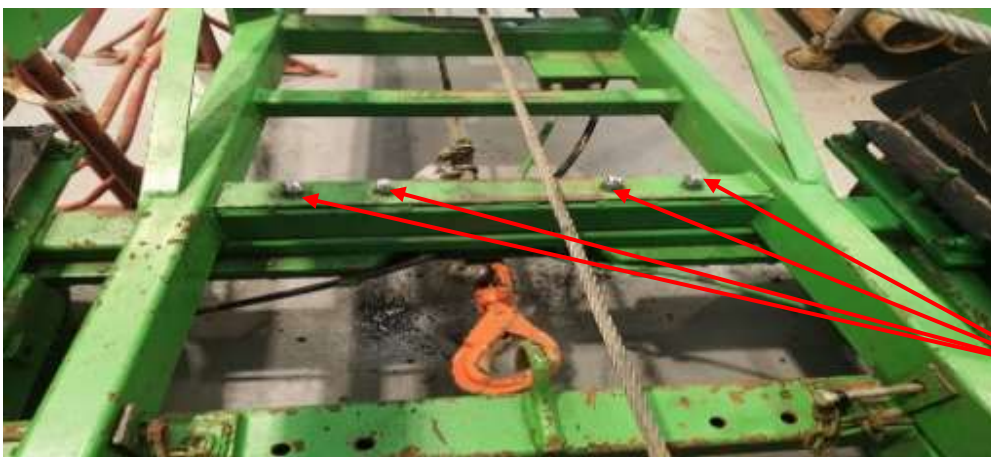
4x new M16 (10.1 grade) threaded bar and nylon lock nuts fitted.
