Safety Alert

High Pressure Gas Main Strike

4 March 2021

Aecom working on Lower Thames Crossing

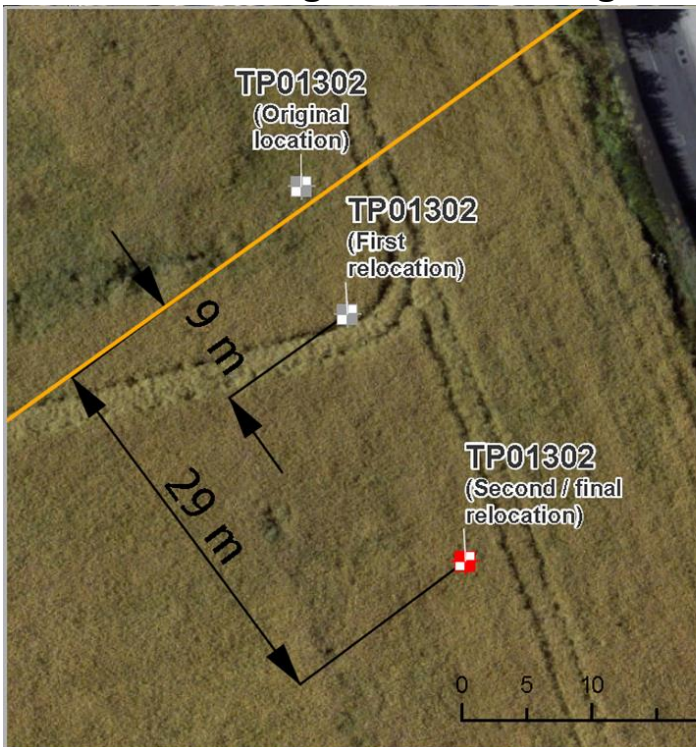
High Pressure Gas Main Strike

Failure to Manage Data led to High Potential Near Miss

At 3m the excavator operator felt unusual resistance as a 50mm scrape of the excavation was being undertaken. On inspection, the high-pressure gas pipe was identified. All works were immediately stopped and the emergency plan followed calling to site the service provider.
