# Safety Alert

## Winch Cable Failure Incident

22 March 2021

## Incident Alert Information

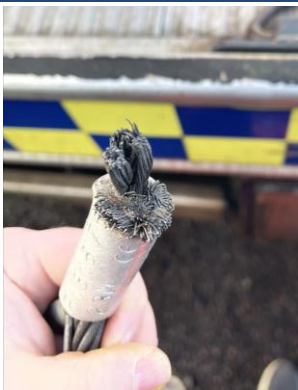
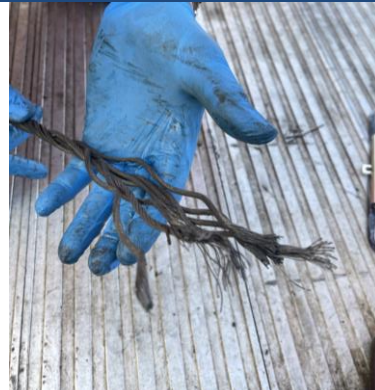
### 2. Photographs

On the 06 January 2021 at 10:51 a winch cable failed during a vehicle recovery operation. During the recovery, the vehicle was being winched onto the back of the recovery vehicle when the winch cable snapped, circa 1" from the ferrule, causing the vehicle to roll backwards off the recovery vehicle, towards the verge. There was no injury sustained, however the broken-down vehicle incurred minor damage.

*'The winch has snapped close to the spliced ferrule termination at the hook end, this is a sure sign of a wire rope overload. Under close observation it was noticed that the 'dead end' of the wire rope again at the ferrule termination was damaged/pressed into the ferrule – this could be a sign the winch wire has been taken into the winch itself underload'.*

With the information available the investigation was unable to identify when this damage may have occurred. The recovery operator had conducted the daily/weekly checks and reported no defects to the winch cable prior to the incident. However, the recovery operator when questioned, states that the winch cable and ferrule did not enter the winch at the time of the incident.

- It was likely that the cause of the wire rope failure is due to the winch cable and ferrule being taken into the winch during a winching operation. However, the investigation could not identify when this occurred.
- Additional assurance checks to be conducted on the recovery contractors.
- Design solution required to prevent the ferrule being taken into the winch.
- Secondary safety strap to be minimum requirement for all Costain recovery contractors.
