Safety Alert

MEWP Hoist Potential Separation

Hoist Body potential separation from vehicle

CTE B-LIFT 20 J

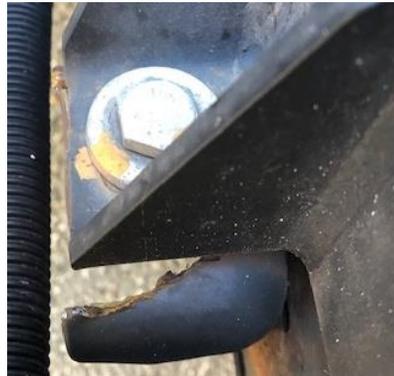
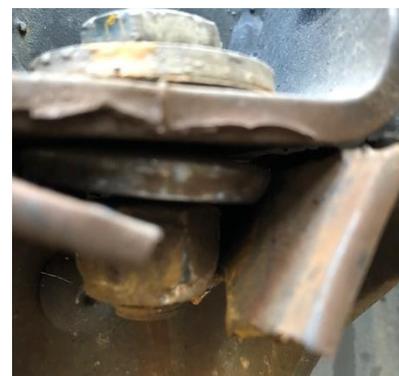
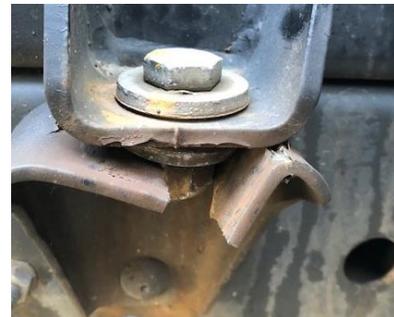
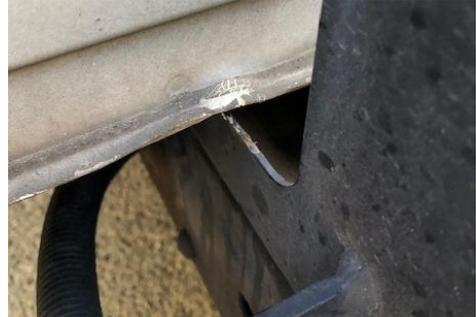
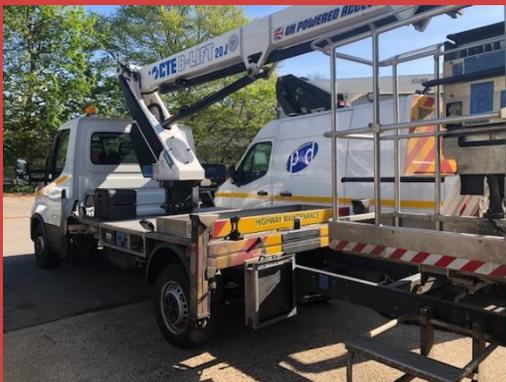
During a routine pre vehicle inspection of a hired MEWP (CTE B-lift 20 J) the operative noticed an irregularity to the positioning on the yellow markings indicating the alignment of the bolts securing the hoist to the body of the vehicle.

Upon further inspection the operative discovered a significant failing associated to the bracket that potentially connects the Hoist to the chassis of the vehicle, also noted was the movement of the hoist bed pressing against the cab

- P&D have contacted the representative of the company who have supplied the MEWP
- Vehicle has been quarantined and removed from service
- Safety alert issued internally and externally

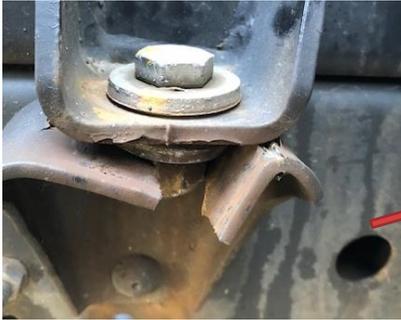
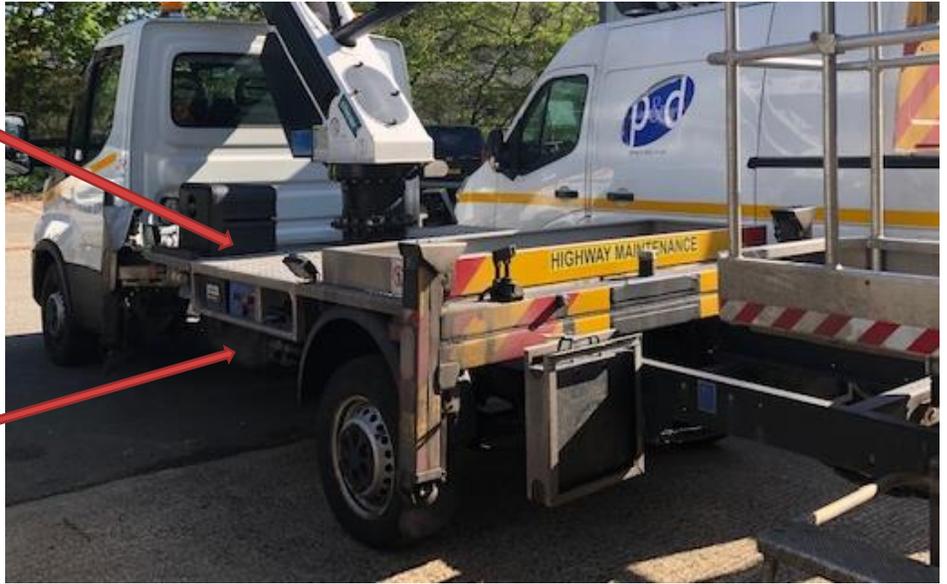
Drivers side and Passenger side

LOCATION OF FAULT

Potential separation of the hoist body from the vehicle chassis resulting in hoist body falling away, this has the potential to cause a major incident putting operatives and the public in danger.
