Industry Safety Share

Piling Contractor Strikes Water Main

Association of Geotechnical & Geoenvironmental Specialists

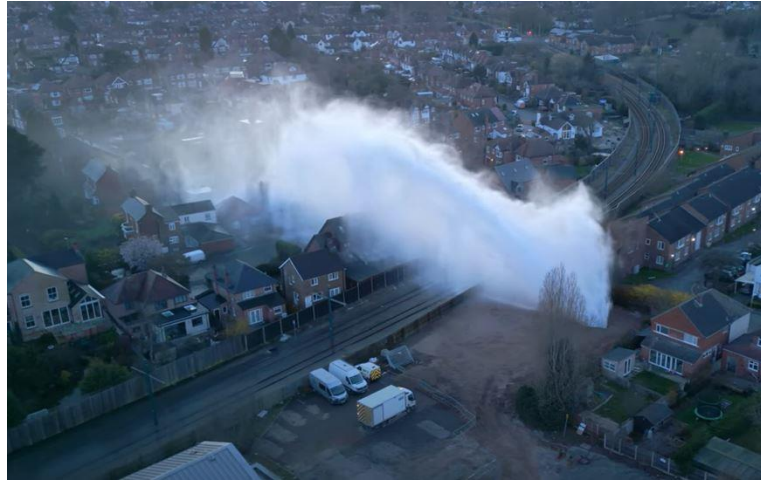
A piling contractor working on the Nottingham College site in Chilwell (AECOM were not involved in this project), struck a water main which runs through the site.

Arriving on the scene a Severn Trent operative records video footage of water, brick and spoil being ejected from the excavation across the nearby houses and streets.

The incident resulted in several houses being evacuated and roads close due to flooding.

As with almost all utility strikes the cause will be as a result of a breakdown in the utility avoidance processes.

- Insufficient or poor communication of utility mapping & record
- Inadequate permit process
- Setting out errors
- Non-conformance or violations of workforce

1. Always check for existing utilities.
2. Confirm existing utility locations through PAS Type B Survey.
3. Ensure the use of a robust permit to dig system.
4. Always fully read the permit to dig and apply controls.
5. Ensure competent supervision for all work tasks.
