BRITISH DRILLING ASSOCIATION SAFETY ALERT

Cable percussion footbrake failure leads to serious injuries

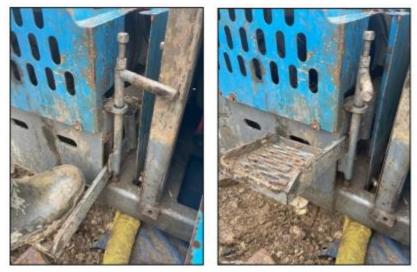
The immediate cause of the incident was a locking latch which became engaged under the foot pedal of the brake assembly, due to a locking nut becoming loose, preventing the application of the brake. As the driller attempted to apply the brake to hold the drill string in the normal manner, he was unable to stop the tooling from dropping with the brake, the driller had to rapidly apply the winch to prevent the tooling from dropping. This stopped the tooling falling, but caused it to swing away from the rig, hitting the assistant driller. The photographs below show the brake pedal in normal operation (left) and the brake pedal engaged with the locking latch under the brake pedal (right)

All the company CP rigs have been recalled and examined. In several cases, the Company have changed the locking latch assembly to ensure the latch cannot be engaged under the brake assembly. Working with industry experts they have developed guidance for adjusting this assembly and have adjusted their rigs accordingly.

The company involved have added this guidance to their preventative maintenance schedule, trained their drillers to check the brake assembly and added the specific requirement to check the brake to our daily check sheets.

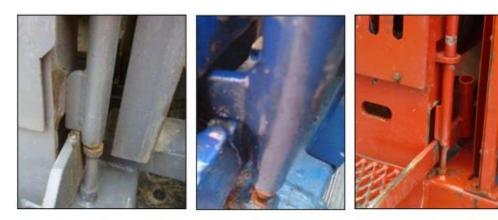
British Drilling Association Limited, Registered Office: 55 Crown Street, Brentwood, Essex CM14 4BD. Registered No: 1341987 WWW.britishdrillingassociation.co.uk The loose nut, the shape/size of the 'blade' on the handbrake assembly and a lack of awareness of the potential problem, all contributed to the incident. The Company have spoken with other drilling contractors and operators, none have reported a similar incident. The Company have also looked at a range of examples of this assembly from other contractors and there is considerable variation in size and shape. It is their opinion, that this is an issue known about by the industry, who in some instances have modified the assembly to overcome this potential issue by placing a curve or chamfer on the top of the assembly, or by extending the length of the locking latch to prevent it becoming engaged under the brake pedal. The following photographs shows some examples of the same assembly, on different equipment.

Brake lock with curved top

Small lock with square top

Larger lock with square top
