Lessons learnt

Date of incident	13/03/2023	Incident type	HiPO
Incident ref number	INC15082e	Contractor	EKFB
Sublot	NCA	Location	Wendover Green Tunnel

Excavator slipped down stockpile and overturned

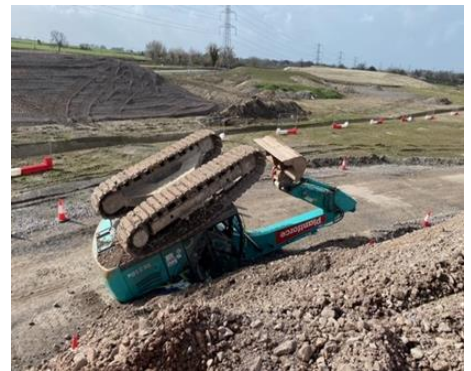
A 21Tonne excavator, working to seal up and regularise a 3.23m stockpile of 6F5 imported stone, reversed close to the edge, slipped down the side of the stockpile, and landed on its roof.

Overturned excavator in final resting position at foot of stockpile.

- Assumptions were made as to the skills and knowledge of the operator.
- The operator had no clear plan as to how the task would be carried out whilst maintaining the safety bunds.
- As the works progressed the excavator working area became restrictive and the safety bund intended to prevent the excavator tracking too close to the edge of the stockpile was not reinstated.
- Removal of the bunds was in contravention to the safe system of work laid out in the Task Briefing for this activity and the guidance contained within the EKFB Plant Operators Essential Guide.
- the drive wheels of the excavator were at the rear which made control of the machine counter intuitive.

- Ensure that the briefing incorporates a two way conversation, so the task briefing is fully understood before works commence.
- Adhere to the SSoW for the works and follow the guidelines laid out in the EKFB Plant Operation Essential Guide.
- Ensure there is sufficient working area for the plant undertaking the works.
- Always have bunds in place whilst working on stockpiles.
- Be aware of the orientation of excavator track drive wheels.
