Crushing Incident STW

CONTROL OUR WORK AREAS

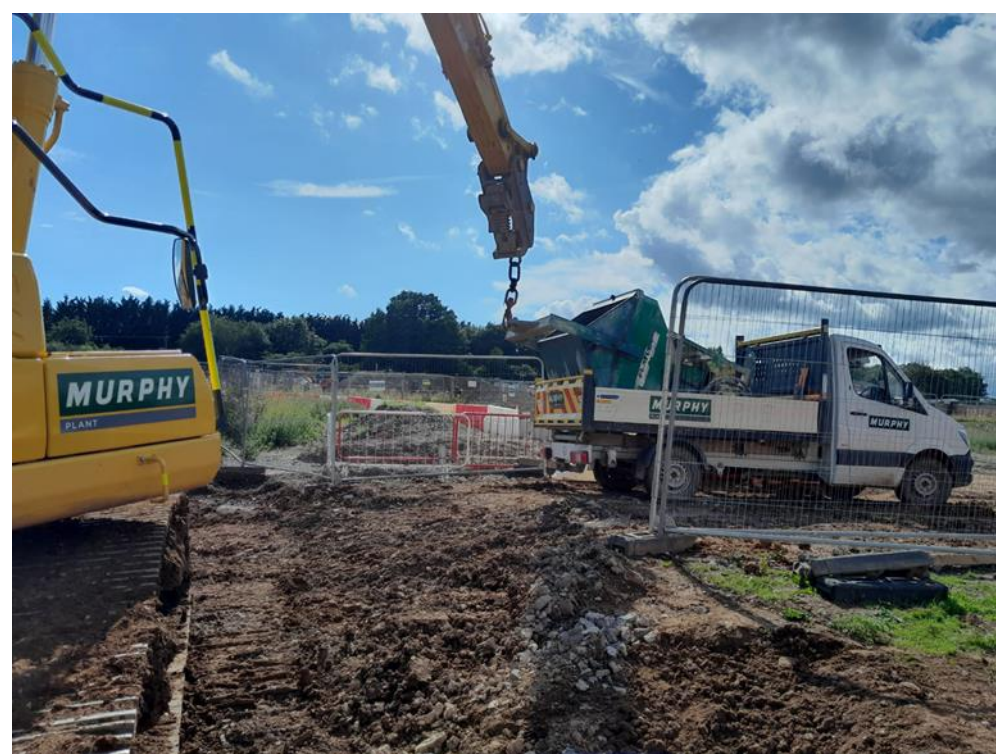
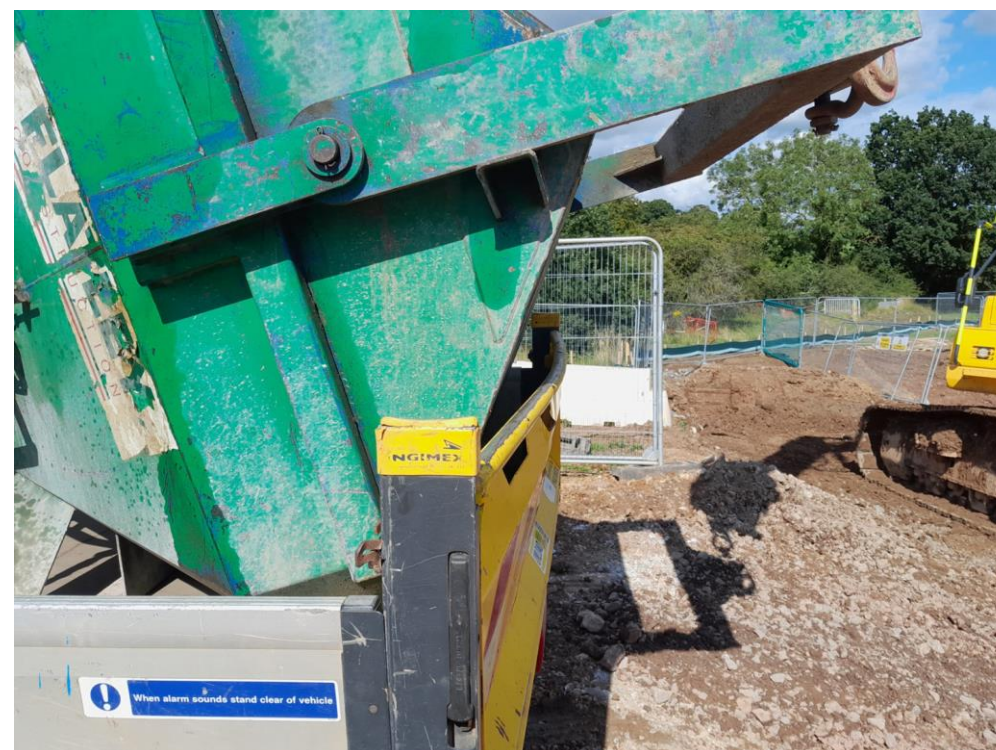
On 2nd August 2023. At approximately 15:50. A JMS team lifted a concrete pouring skip with an excavator onto the back of a 3.5t pickup. The JMS slinger/signaller was unable to release to drop chain hook at ground level so proceeded to climb on to the back of the pickup to release the hook.

The driver of the pickup heard what he thought was a beep from the excavator that he believed was a signal to move. The driver proceeded to drive forward, causing the concrete pouring skip to move to the back of the pickup trapping the slinger/signaller's right leg between the pouring skip and the tail board of the pickup. The concrete pouring skip had not been secured and was attached to the drop chain at this point.

The slinger/signaller was assisted down to ground level where they immediately showed discomfort on their right leg. The slinger/signaller was taken to hospital as a precaution where it was confirmed that the slinger/signaller had a fracture to their right knee cap.

- A podium step could have been used to access the hook from ground level.
- The driver should have exited the vehicle during the loading process to ensure loading had been completed and load is secure for travel.

1. Review suitability of vehicles carrying large goods to ensure they are not causing additional risks when loading/unloading and travelling
2. Rebrief Site Personnel to understand roles and responsibilities regarding lifting, loading/unloading and traveling with loads.
3. Review documentation to ensure all loading/unloading activities is covered and briefed to all relevant parties
