## RIDDOR SPECIFIED INJURY: FRACTURED RIB FROM UNCONTROLLED LOWERING OF ENGINE HOOD

### The incident

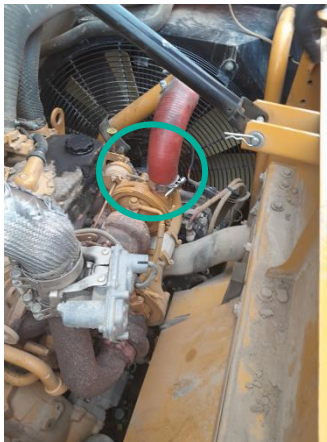
Location of turbo hose being reattached

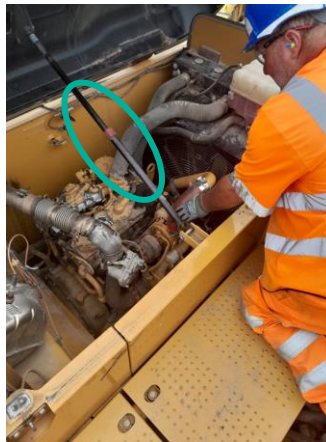
Position of Mechanical Foreman during task and gas strut highlighted

- The gas strut included an automatic locking mechanism however, the gas strut was found to have no pressure within the cylinder rendering the locking mechanism and strut defective
- There was no catastrophic failure which indicates a gradual loss of pressure over time and although the timeframe hasn't been determined the investigation concluded this would have likely been over weeks or days, rather than hours
- The gradual loss and/or total loss of pressure hadn't been identified during daily or periodical inspections however, the requirement for a check wasn't specifically requested as part of the PPM process and solely relied on operator / fitter knowledge of the gas strut mechanism.

- Include a requirement for gas strut inspections and a functionality check as part of the daily and periodical maintenance programmes
- Where gas struts are installed to support a load, hood or cover ensure a functionality check is undertaken prior to working underneath the arrangement.

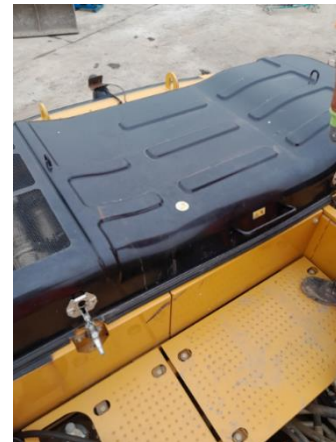
Engine hood in closed position
