SHE BRIEF

Vehicle Wheel Losses

Key initial learnings to be shared more widely

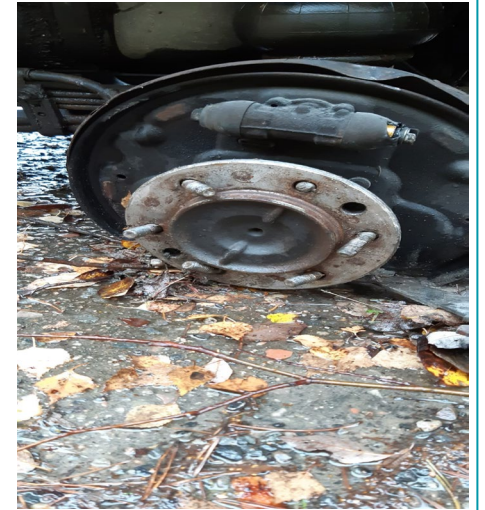
Loss of wheel from 2018 Toyota Hi Lux, resulting in damage to 3rd party vehicle travelling in opposite direction.

We have experienced the loss of wheel studs with corresponding wheel loss, specifically related to steel wheels on older vehicles (+5yrs), with the most recent occurrences taking place following a puncture and subsequent fitting of the spare wheel.

The wheels on these are under-slung, which appears to be causing corrosion. Specifically imperfections in the wheel lug mating surface, causing the wheel nuts not to tighten correctly.

Should you experience a puncture in any vehicle, you should contact the leasing company driver helpline [unless local exceptions are in place and agreed with Fleet, and local risk assessment and work instructions are followed] and request recovery to change or repair the wheel. If the spare wheel is used, then specific attention should be made to the condition of the spare wheel by the fitter before fitment. Condition checks should be applied, no matter if an SSE supplied fleet vehicle or daily rental, and wheel sentry devices re-installed where available.

It is important that the manufacturer's recommended torque settings are adhered to when securing a wheel back onto a vehicle, which is why we recommend any wheel change is completed by a competent professional. On initial tightening, there is a strong possibility of the nuts then seating themselves into position and loosening slightly. It is therefore **strongly** recommended that the wheel fixing should be retightened to the recommended torque after 30 minutes if the vehicle is stationary or within 25 to 50 miles if the vehicle is used, where reasonably practical. This should be completed at an approved provider and regular observation via the daily checks and wheel sentry system for looseness will still be necessary.

If, on inspection of the wheels, you see anything which raises concerns, DO NOT DRIVE the vehicle and call SSE Driver line and request recovery to a tyre repair supplier.
