C23 Alert

Incident Date: 23 January 2025

#138

Partial overturn of rig

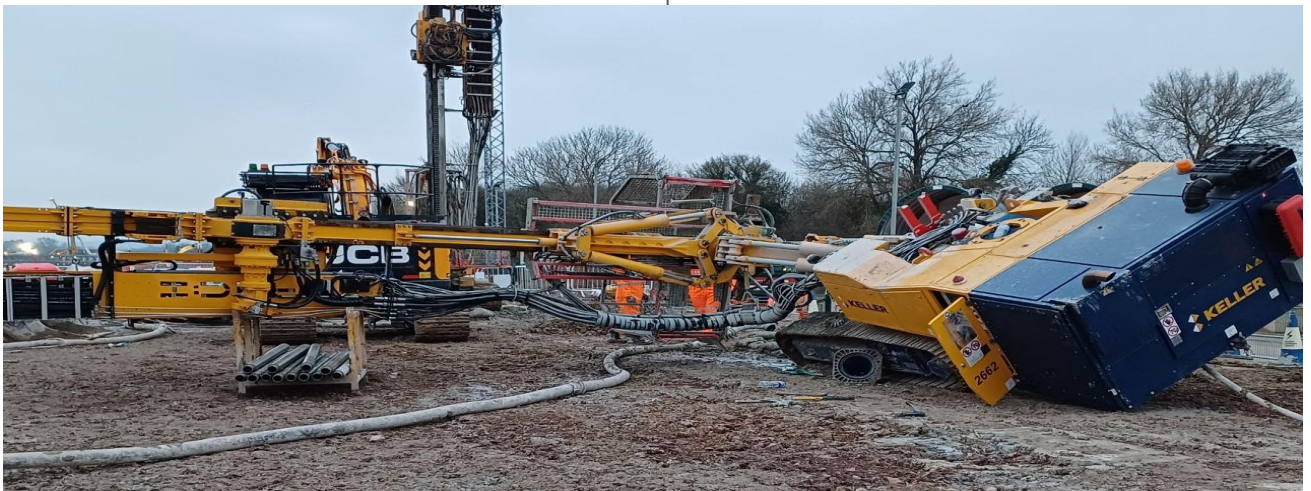
During the routine daily maintenance of a BKJV drilling rig, the mast was being manoeuvred to facilitate the oiling of the chain when it became unstable. The offside track was lifted off the ground and the mast came to rest on top of a metal stillage located within the vicinity.

- the working platform was not a contributory factor in the destabilisation of the drill rig.
- The rig operator using the control for the rig moved the mast of the machine in a manner that destabilised the rig.
- The metal stillage prevented the rig from fully overturning.

- Works were stopped immediately, and the area was made safe.
- An exclusion zone was set up and the area was secured with a double ring of barriers.
- Plans have commenced relating to a recovery operation.

- Ensure that you operate the rig as per the manufacturer's instructions.
- Ensure that there is an exclusion zone in place while maintenance is taking place.
- Ensure that you have sight of both sides of the machine when manoeuvring the mast.
