## Incident Lessons Learned Electrified Equipment

Project Name	Project Number	SCO ref
River Garry Retaining walls	GT00110	
Location (address, ELR)	Time and Date of Event	Type of Event
	29/08/2024 @ 00:02	Electrical incident-Rail sparking on contact with tools

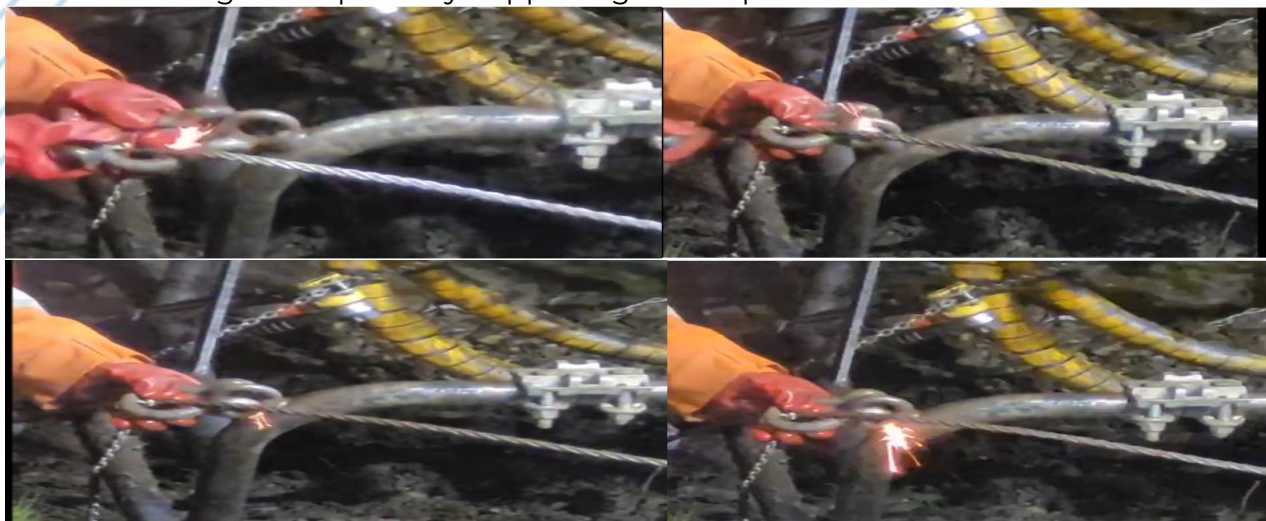
While setting up work to install ground anchors for a drilled retaining wall, operatives noticed sparking or electrical arcing while attempting to attach hoist equipment to an RRV using steel rope and shackle equipment.

- No one was injured, but operatives felt a mild “shock” when attempting to attach tirfor wire ropes to a shackle on the RRV.
- The same thing was reportedly happening on the previous shift.

- Signals and Telecoms teams attended the site to investigate and concluded the issue was not caused by Network Rail S&T assets and no clear cause could be identified. Some evidence pointed towards nearby High-Voltage (275 to 400kva) overhead lines running parallel to the track for over 10 miles, which could be potentially inducing a voltage onto NR infrastructure. Which may have been exacerbated by the prevailing weather conditions in the area.
- An M&E Contractor was employed to produce a temporary bonding design to allow the project to proceed.
- The M&E temporary bond design introduce breaks in the rail line and fencing to allow for earth rods to be connected on either side of the works.
- Once the designed solution had been installed the project re-commenced without further issues being reported

- Some local checks were carried out and a process of elimination showed that the problem was likely not coming from the plant in use.
- Batteries were disconnected from drilling rigs and associated nearby plant to rule out any effect they may have had.
- All site works were stopped by the Site manager with all equipment and personnel returning to the compound and off track.
- Senior management contacted to notify of the incident.
- All project works were suspended until cause was established.

- Does the design allow for potential energization of rail, fencing and associated infrastructure?
- Can Test before Touch be carried out during the pre-construction phase?
- Can the energy provider assist the project should the testing show any induced voltage, such as balancing their lines?
- Are there existing earth/bond points, and if not can a temporary bonding solution be designed and installed?
- Have weather conditions been taken into account? (Long periods of inclement weather can impact induction/arcing.)
