# Safety Alert

## Installation Monitoring

23 October 2025

**Location:** M5 Northbound, North of Junction 12 at Marker Post 91/9 (Gloucester Services)

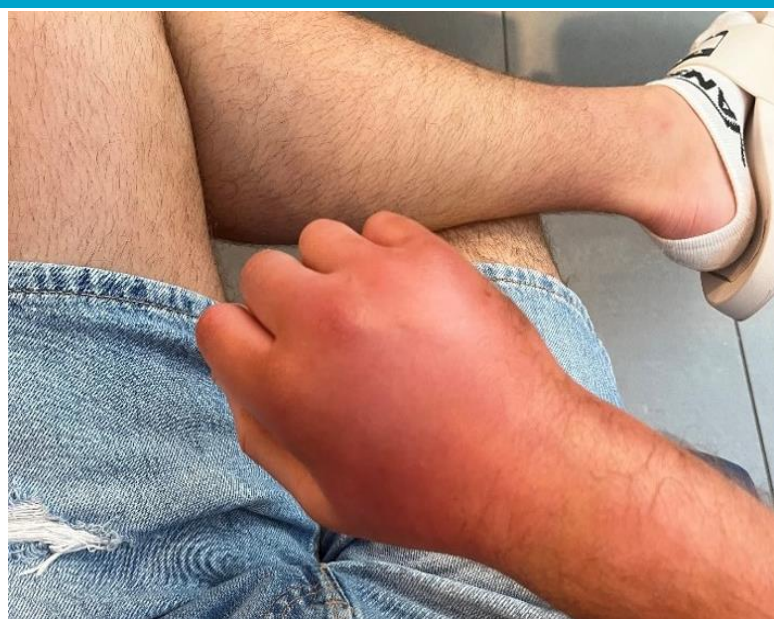
- Removing the access cover (one bolt was missing).
- Reaching into the chamber to remove the protective bung.
- Conducting the monitoring and replacing the bung and cover.
- Due to the missing bolt, the water seal was compromised, allowing surface water ingress.
- The engineer's hand was submerged in the water during the task.

- The missing bolt compromised the water seal. Cause of bolt loss is unknown but may be due to traffic vibration.

- Equip monitoring kits with spare bolts.
- Investigate use of anti-vibration washers or thread-lock bolts to prevent loosening.

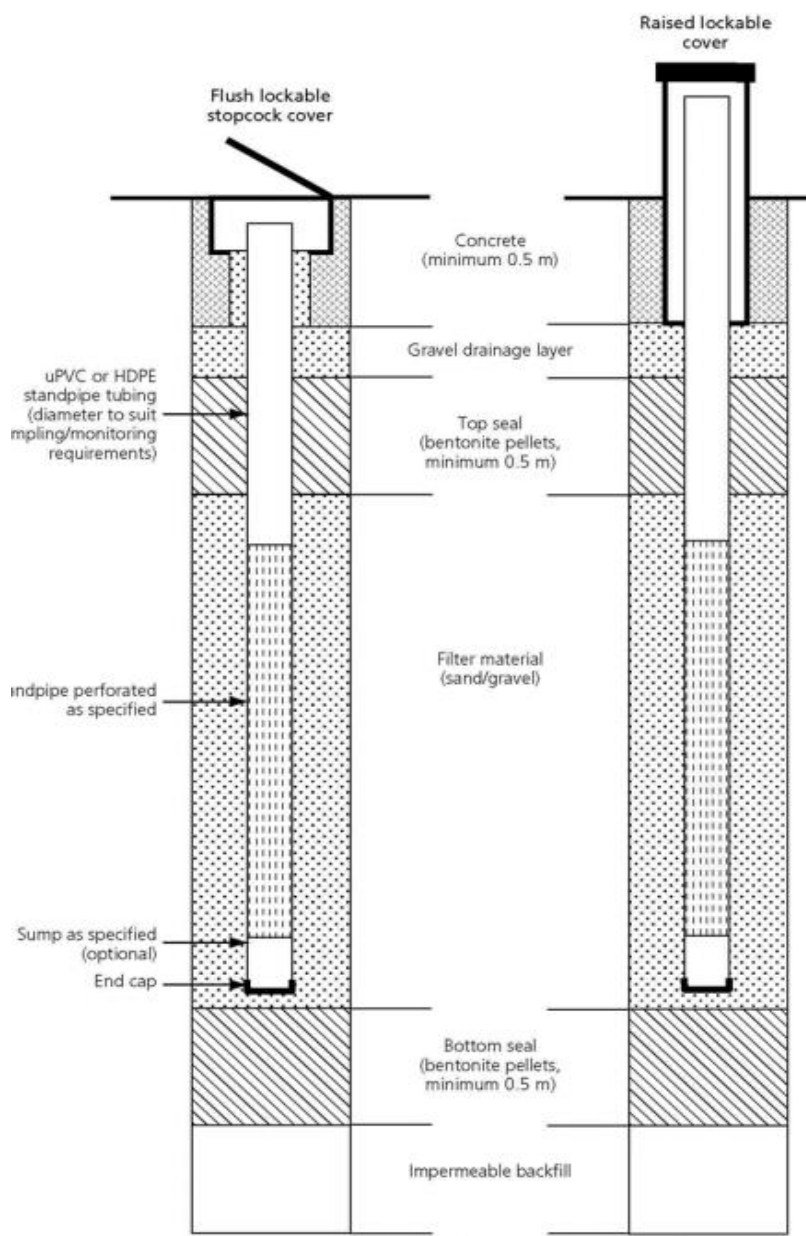
*Figure 11.1. Schematic drawing of observation well installations, UK Specification for Ground Investigation, 3<sup>rd</sup> edition.*

- The installation met ICE Specification for Ground Investigation (3rd Edition).
- (see diagram on page3).
- However, the absence of a drainage feature means any breach in the seal results in water accumulation.

**Recommendation:** Consider design revisions to include drainage solutions in future installations
