# C23 Alert

20 November 2025

C2G – Preston Bissett

#188

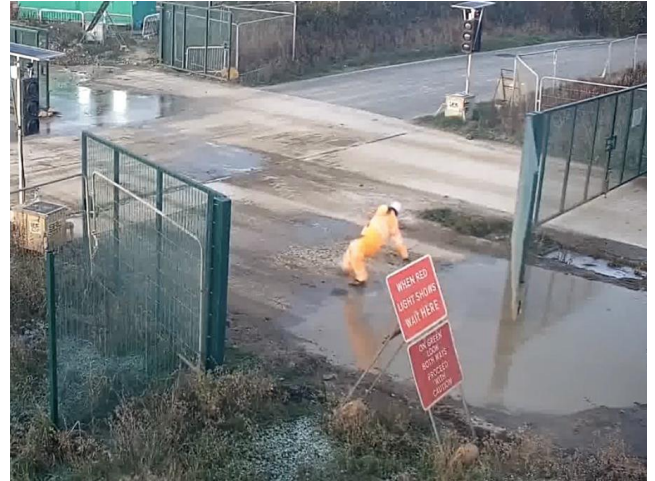
**A traffic marshal slipped on a crossing slab when opening the gates for the haul road at the start of the shift.**

**Injured Person (IP) taken to A&E and confirmed a closed hairline fracture to their right wrist.**

- The IP was opening the gates at the start of the shift.
- There were no supervisor checks of the work area before sending IP out to work.
- There was heavy rain the night before and freezing temperatures overnight.
- The area was not gritted the night before.

- A tractor spreader attachment is now available to spread grit over haul road crossings.
- The crossing points are now gritted prior to freezing temperatures.

- Review winterisation plans and arrangements for managing inclement weather.
- Regularly review weather conditions.
- Ensure all work areas are checked by a supervisor before starting work.
- Address any areas where there is pooling water to minimise icy conditions
- If your work area is not safe, stop and speak to your supervisor.
