BDA Audit Cable Percussion Drilling Rig

conducted for
Drillers Inc'

Audit number

000023

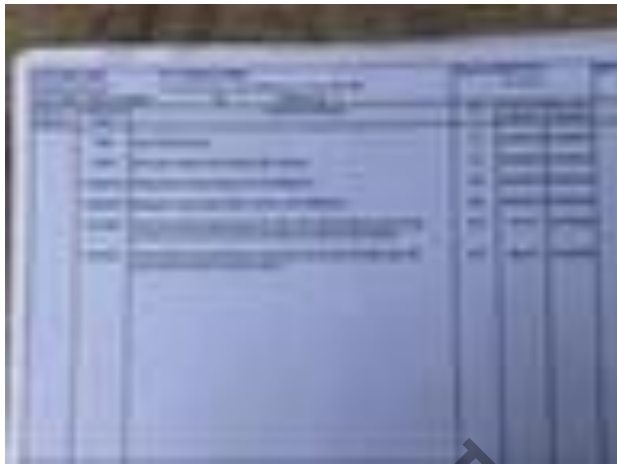
Appendix 2	Appendix 3	Appendix 4 Appendix 5
Give details of the manual handling training of the auditee	None – Driller does have a back problem	
Identify any substances on site which require a COSHH Assessment		
Welfare facilities are available	No	None provided by the client
Failure to meet current standards results in a major nonconformance of this audit		
Are any licenses and or permits required for this drilling activity IE Coal authority, Environmental agency?	N/A	
Is a permit to dig required if yes please photograph the permit	No	
How are you avoiding damage to services	RE uses the CAT Driller digs pits

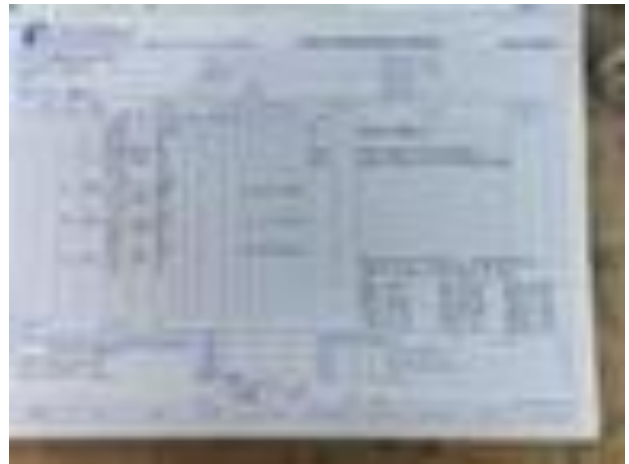
Appendix 6

Is an underground service avoidance and location procedure in place	Yes	The clients rep had all the information to hand
Who has cleared/ located the underground services	RE cleared the services	
Is there a certified CAT and Genny on site	Yes	Date on photo
Date of calibration		
Have hazardous gases been identified as a risk on this site	No	
PPE		
PPE Being worn, Mandatory items include Safety Footwear, Safety Helmet, Gloves, and Eye Protection.	Safety Helmet, Safety Boots, Eye Protection, Overalls, Gloves	
Other PPE available	Safety Wellington, Ear Protection, Gloves	
Is PPE Appropriate to this site	Yes	Yes a small site but good
Drilling Operation		
Drilling instruction are available (written) and are being followed accurately	Yes	Very basic
How does the auditee communicate with their colleagues, does he issue clear instructions.		
Borehole log is being completed is clear accurate and legible	Yes

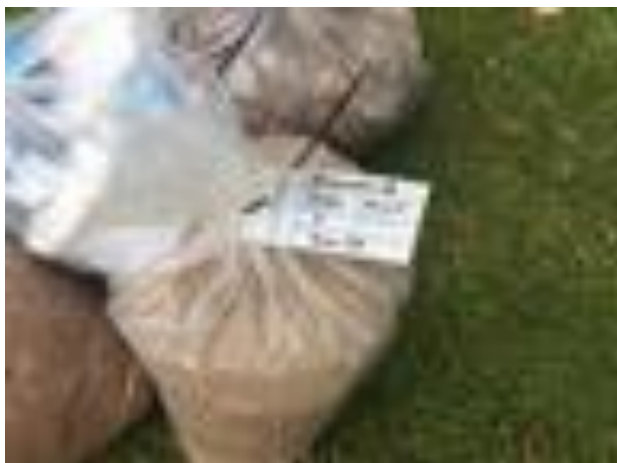
Appendix 7

Type of strata being drilled	Gravel, Sand	
Testing observed and being carried out according to current standards during this visit	SPT	
Does the auditee have a clear in depth knowledge of the equipment being used on this site relevant to the drilling operation?	Yes	Lead Driller is hugely experienced and was able to explain in great detail many different methods of use of his equipment
How was measurement of borehole being achieved?		
Samples are being taken labelled, stored in line with current standards and the drilling instructions	No	Samples are not being double labeled individually , discussed with Lead Driller but he points out that the samples are being labelled to the clients instructions

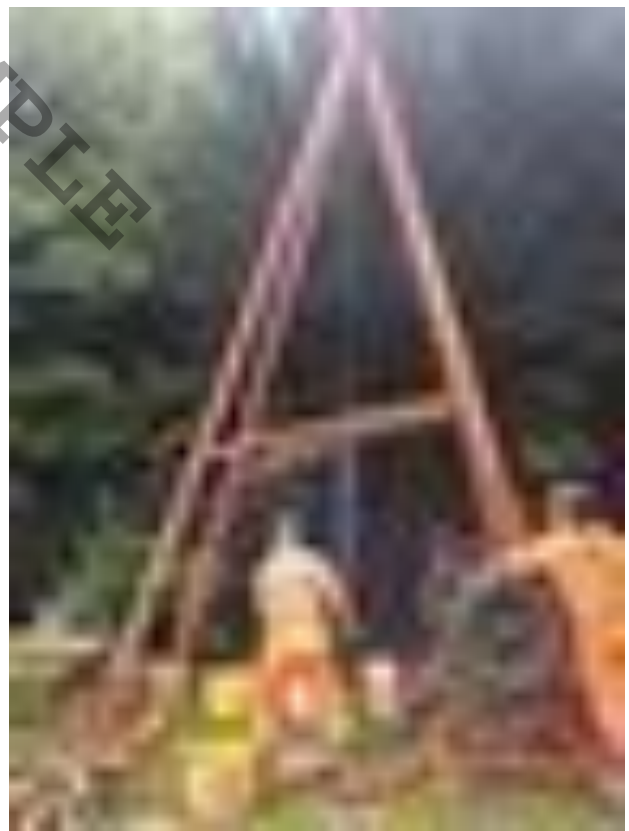
Appendix 8

What are the arrangement for the completion and reinstatement of the work site	Back filled and very well reinstated see photo of the first position next to the red car	
Rig Details		
Type of drilling rig	DANDO 150	
Please photograph the drilling rig

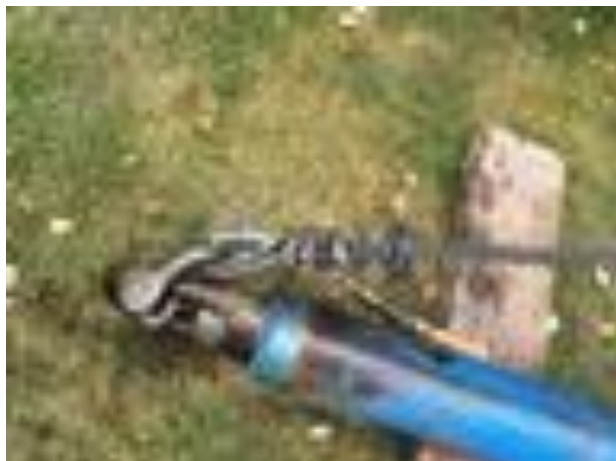
Appendix 10

Rig over run brakes and handbrake operate correctly	Yes	Yes all looked good but not tested other than the handbrake
Tyres and running gear are in good condition and operate correctly	Yes	Tyres good and high load rated
Rig has additional lighting and or reflectors along the length of the rig available	Yes	Reflective tape fitted in many places
Wire Rope		
Size of rope fitted	16mm	
Wire rope is in good condition free from birds nesting and fraying	Yes	Yes and it is well laid at all times
Is the auditee trained to carry out inspection of the wire rope	No	
How is the ongoing inspection carried out	Driller uses his vast experience to ensure that the rope thimble and eyes are changed regularly	
Are u bolts and thimble correctly fitted and in good order. (4 u bolts must be fitted)	Yes	4 u bolts fitting but thimble end will need replacing soon, Driller is monitoring this hourly which is acceptable

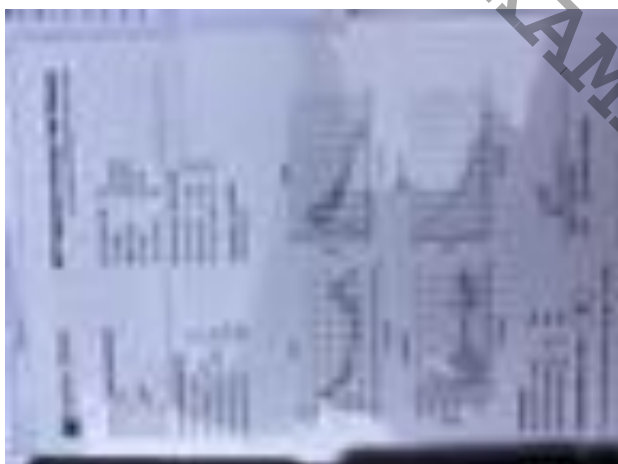
Appendix 11

Certification		
Rig LOLER Certification is both available and current	Yes	Yes all in date
Enter the LOLER Certificate date of examination	14/10/14 05:11 PM	
Photograph of the certification		
The listed equipment has current LOLER Certification available	Lifting Swivel, Snatch Blocks, Other Lifting accessories	
Please give details of addition lifting equipment	need Certs for snatch blocks swivels, safety hooks	
SPT hammer has a valid energy efficiency certificate	Yes	
Date of calibration of SPT Hammer	11/02/15 10:20 AM	
Photograph of the certificate
