## SF310 Near miss investigation report

Contract/Location :	Markinch	Contract no:	5718
Date of incident:	15/04/2015	Time of incident:	1535 hours

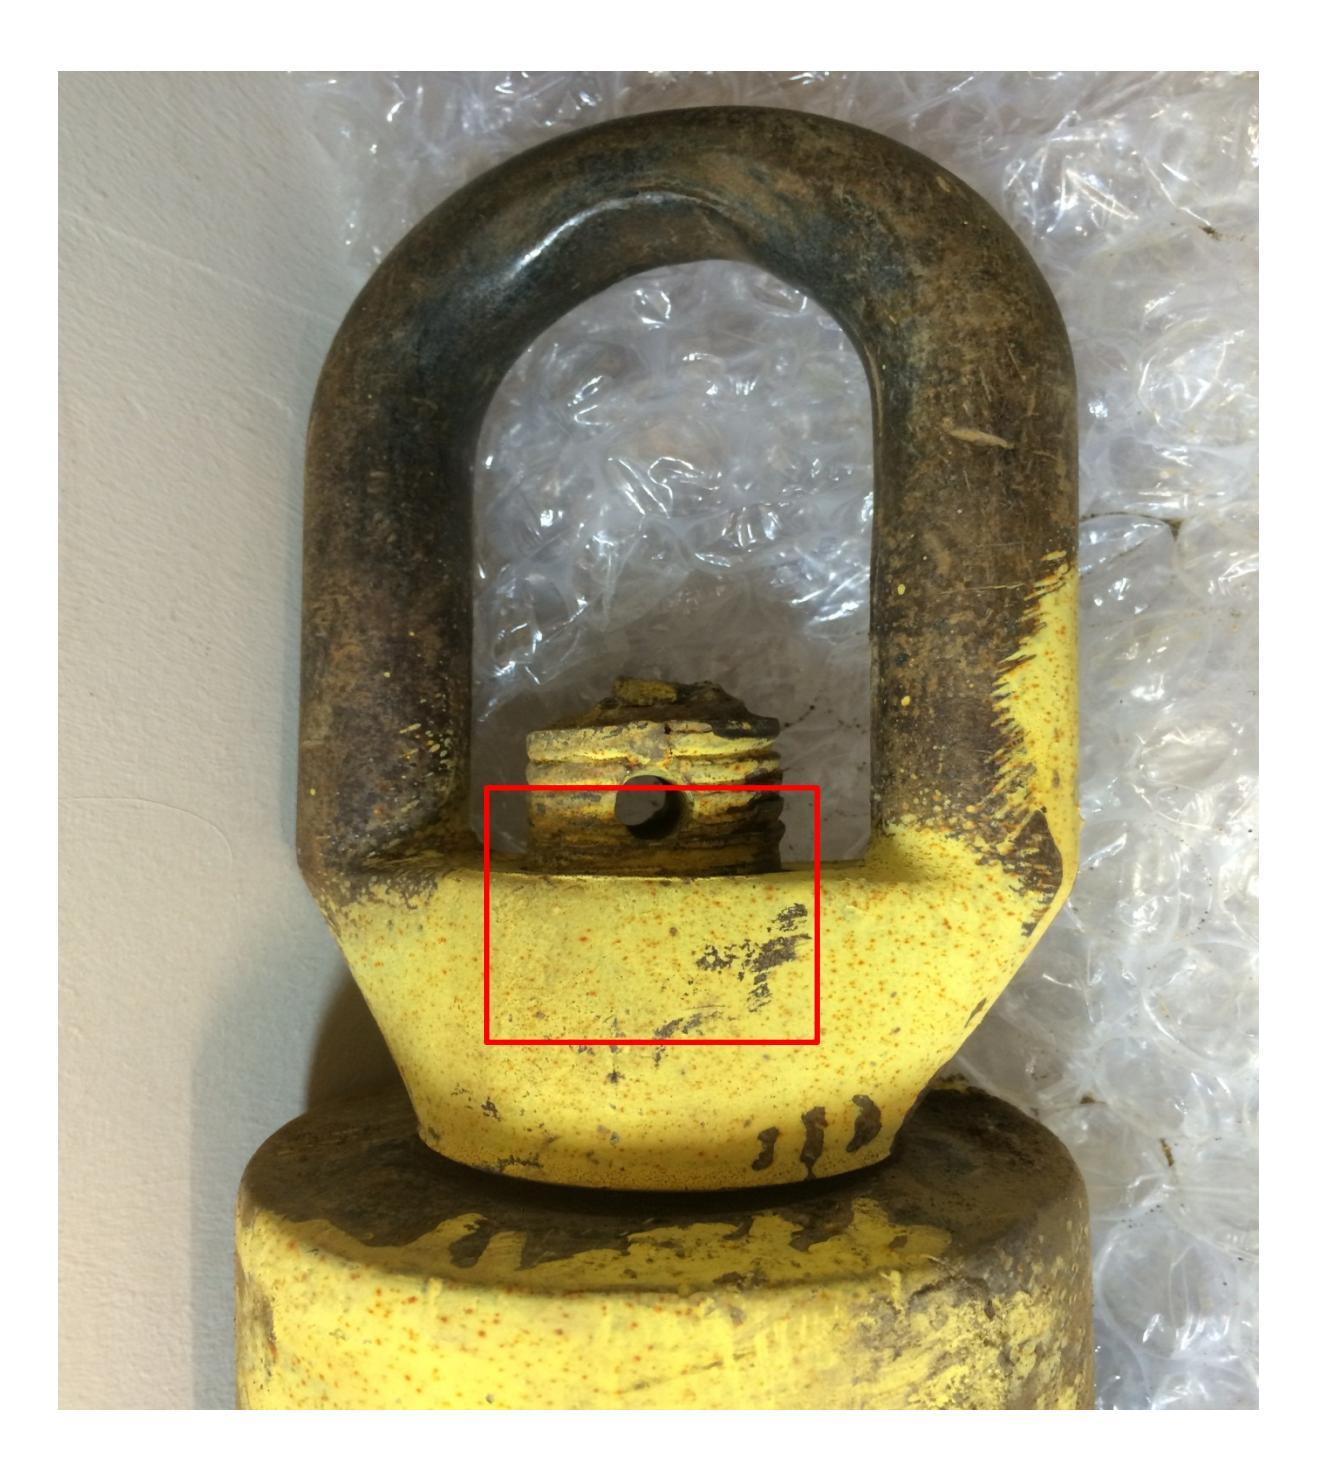
The nut has pulled free from the thread of the top sinker bar. Contained within the nut is a roll pin to prevent movement of the nut. A further measure to prevent movement is the welding the top of the thread and nut together. The nut and roll pin were not recovered post event however it can be clearly observed that the threading of the top sinker bar has failed; potentially caused by continuous movement. Once the top sinker bar and swivel were returned to the BAM Ritchies Yard and new roll pin was inserted it was noted that the opening created for the roll pin was enlarged and as such would no longer fit. This suggests that the roll pin and the weld had failed prior to the disconnection of the swivel.

*Figure 1*; - This image shows the original top weight sinker bar, protruding threaded section and swivel. The highlighted section shows the remaining threaded portion of the extension that should house the nut, roll pin and weld. The yellow paint is a secondary measure to clearly display that this item is not fit for use.

Actions taken to prevent re occurrence: Inspection of all sinker bars in BAM Ritchies Fleet by Works Manager	By who X	By when 06/05/15
Re-briefing of all operatives in duties, responsibilities and procedures of all drilling equipment and plant, with focused attention on sinker bars	x	07/05/15

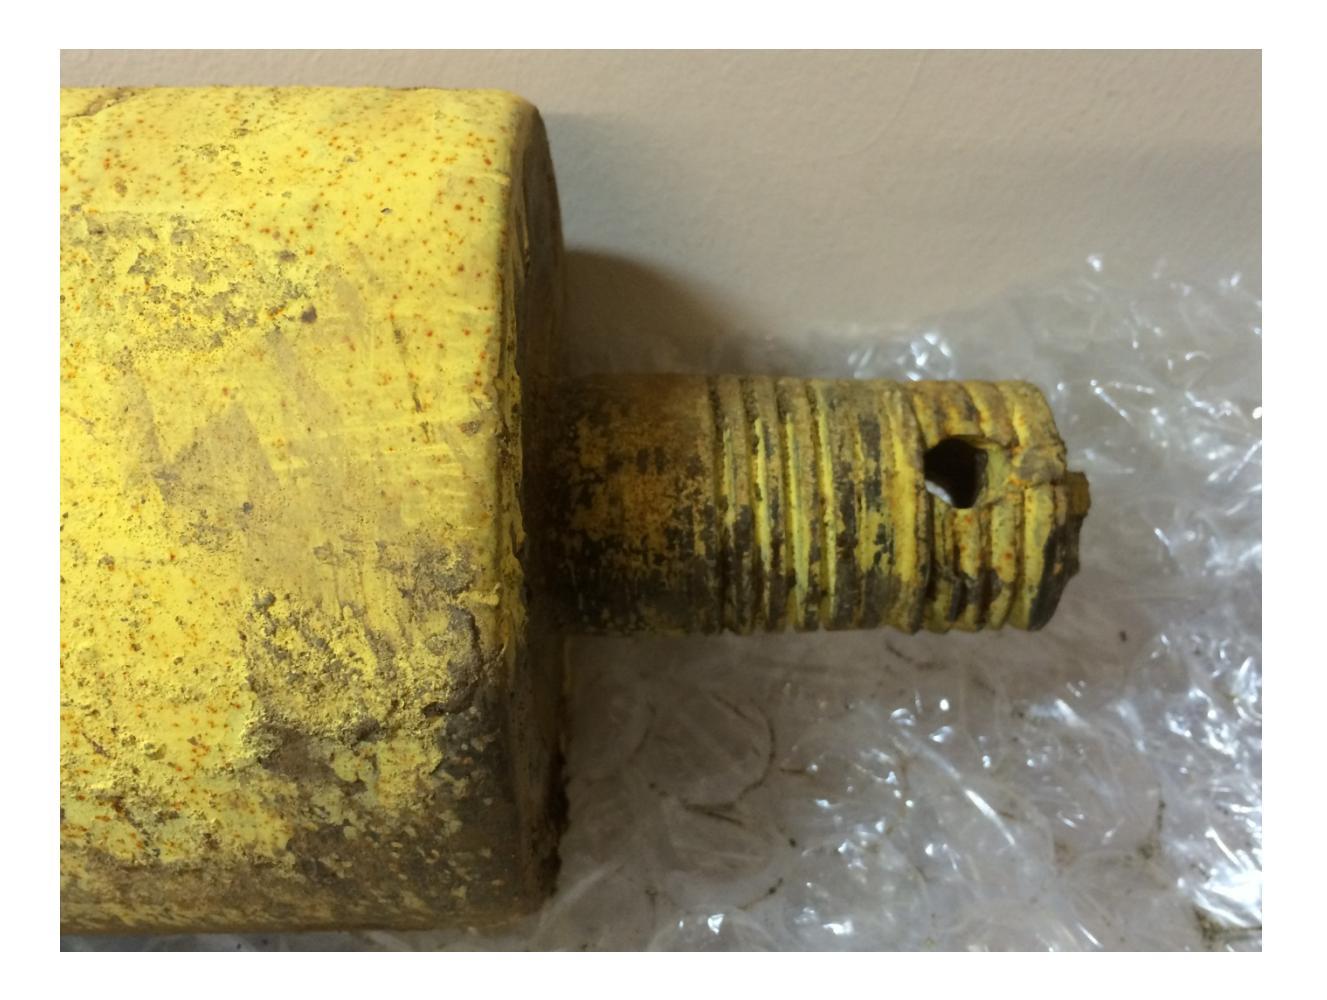
*Figure 2*; - This image shows the original top weight sinker bar, the threaded extension and the opening created for the roll pin.

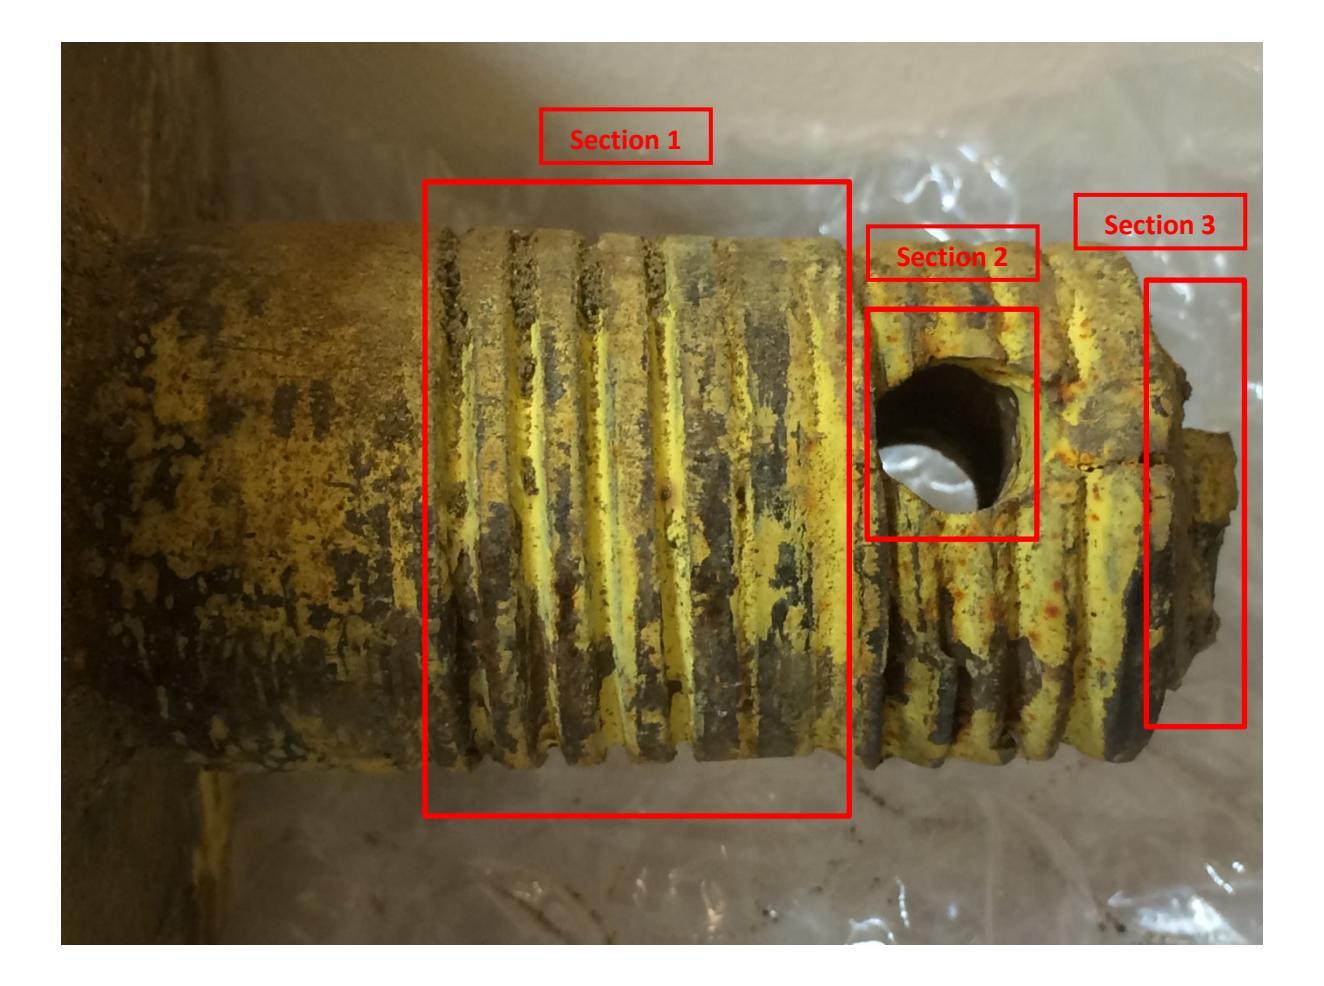
*Figure 3*; - This image shows the threaded extension and the opening created for the roll pin, magnified. Section 1 illustrates the elongation of the opening for the roll pin and Section 2 illustrated the smoothing of the threads, both caused by movement of the nut. The Section 3 illustrates the remaining weld that initially connects the threaded extension to the nut.

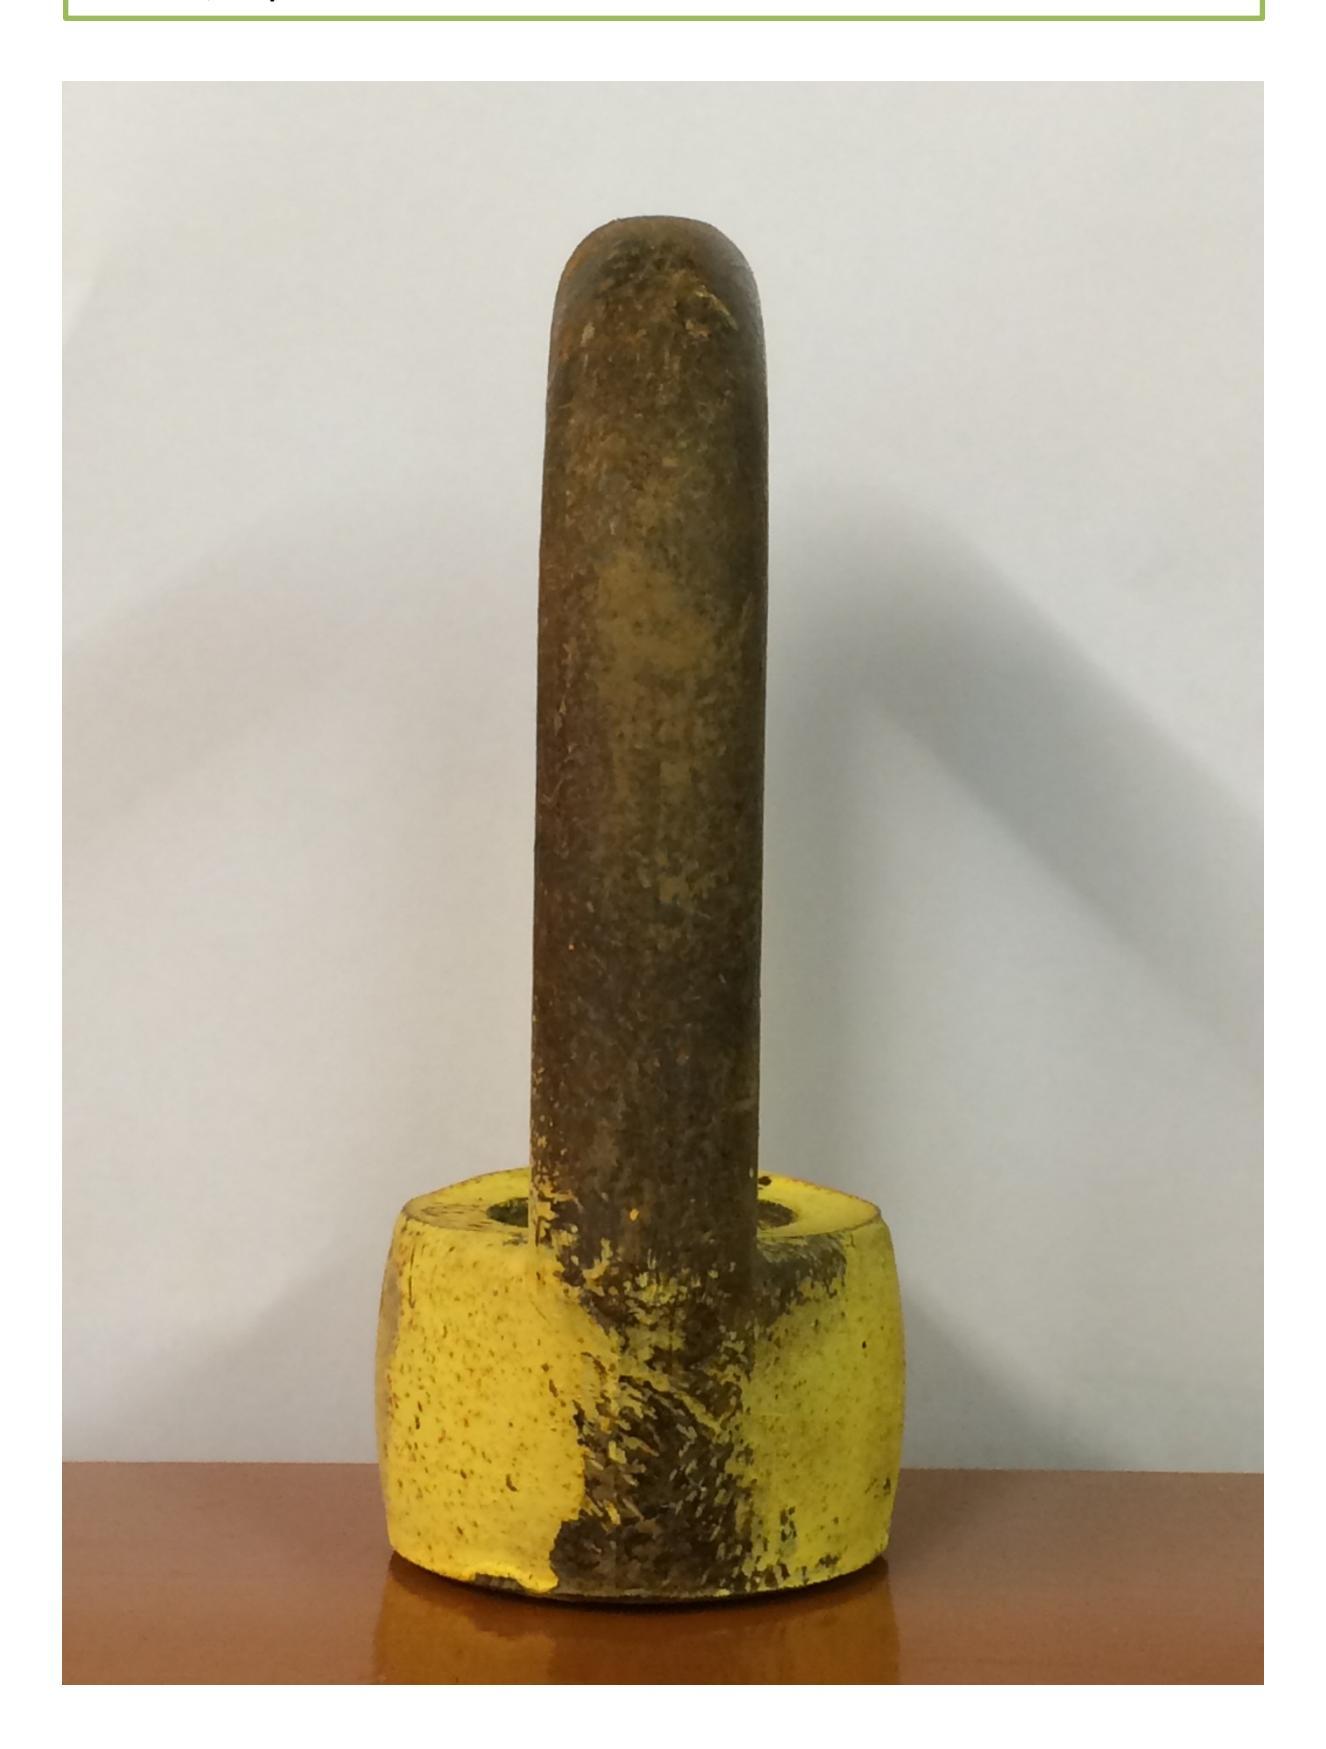
*Figure 4*; - This image shows the side profile of the swivel. It can be seen to lean slightly to the right. This deformation is caused when the tool is not placed on the ground carefully. Continued handling in this fashion results in undue stresses being placed on the nut, threaded extension, roll pin and welds and manifests in this deformation.

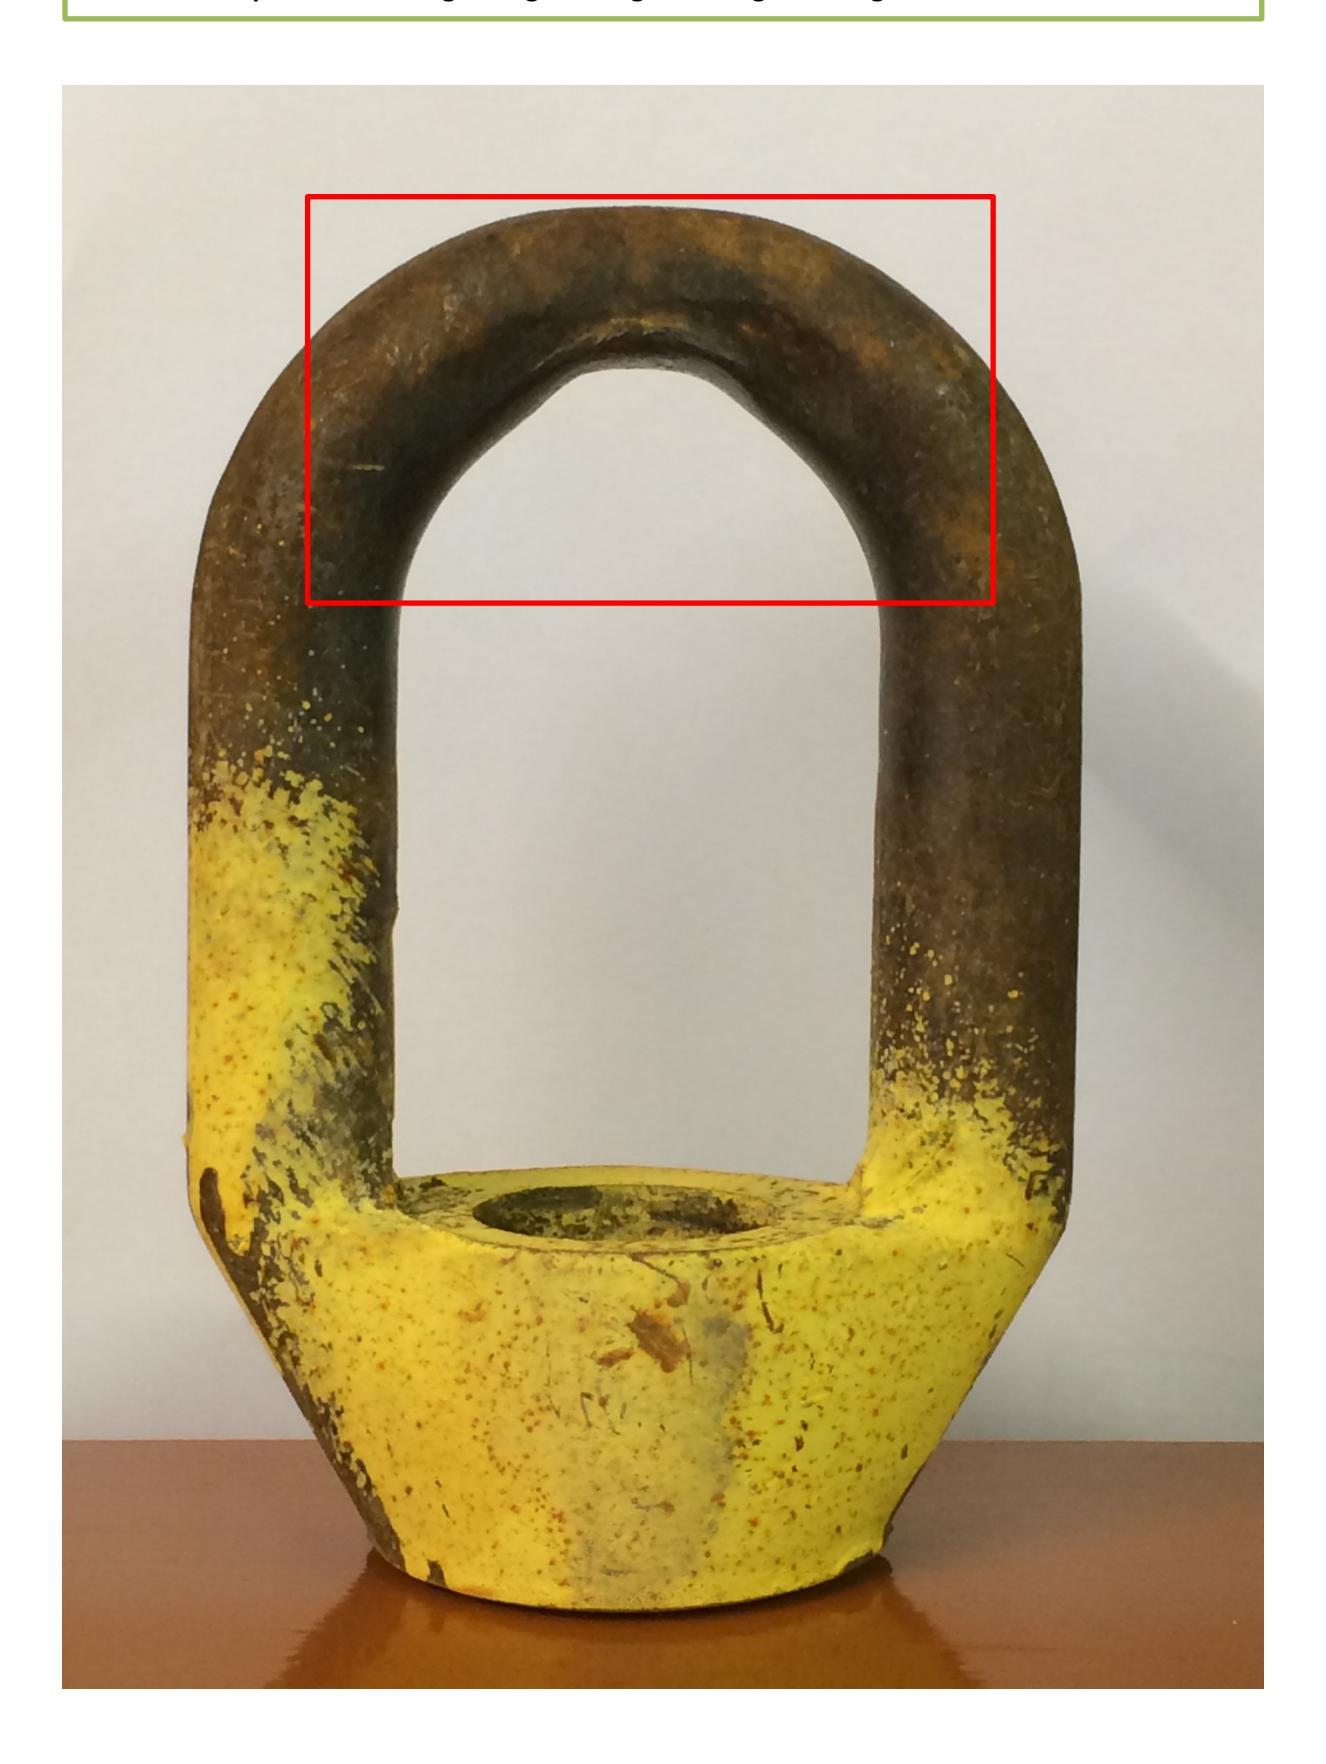
*Figure 5*; - This image shows the swivel. The highlighted area illustrates slight deformation of the swivel at the bow section. This is caused by the fixed eye connection to the 16mm wire rope of the cable percussion rig. This deformation is well within tolerance and would not require to be changed. Again a slight leaning to the right can be observed.

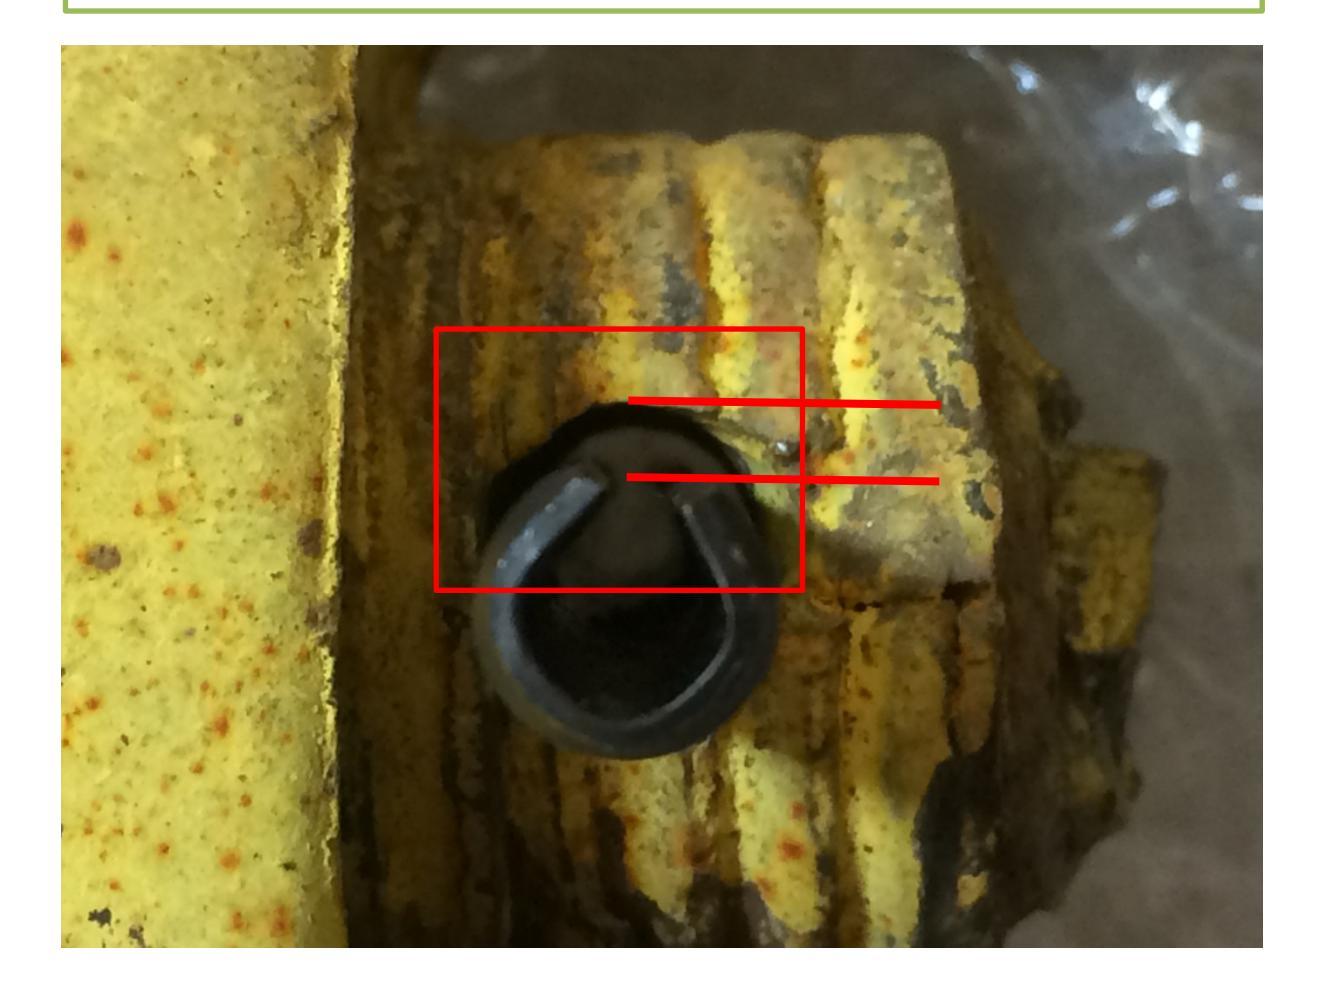
*Figure 6*; - This image illustrates a replacement roll pin placed within the opening on the threaded extension. This insertion would always require to be carried out using force; however it can be observed, due to elongation of the opening, that the roll pin can slid easily into the opening. There is also further evidence of stripping of the threads that would have housed the nut. The two red lines give clear indication of the deformity between the roll pin and the created opening.

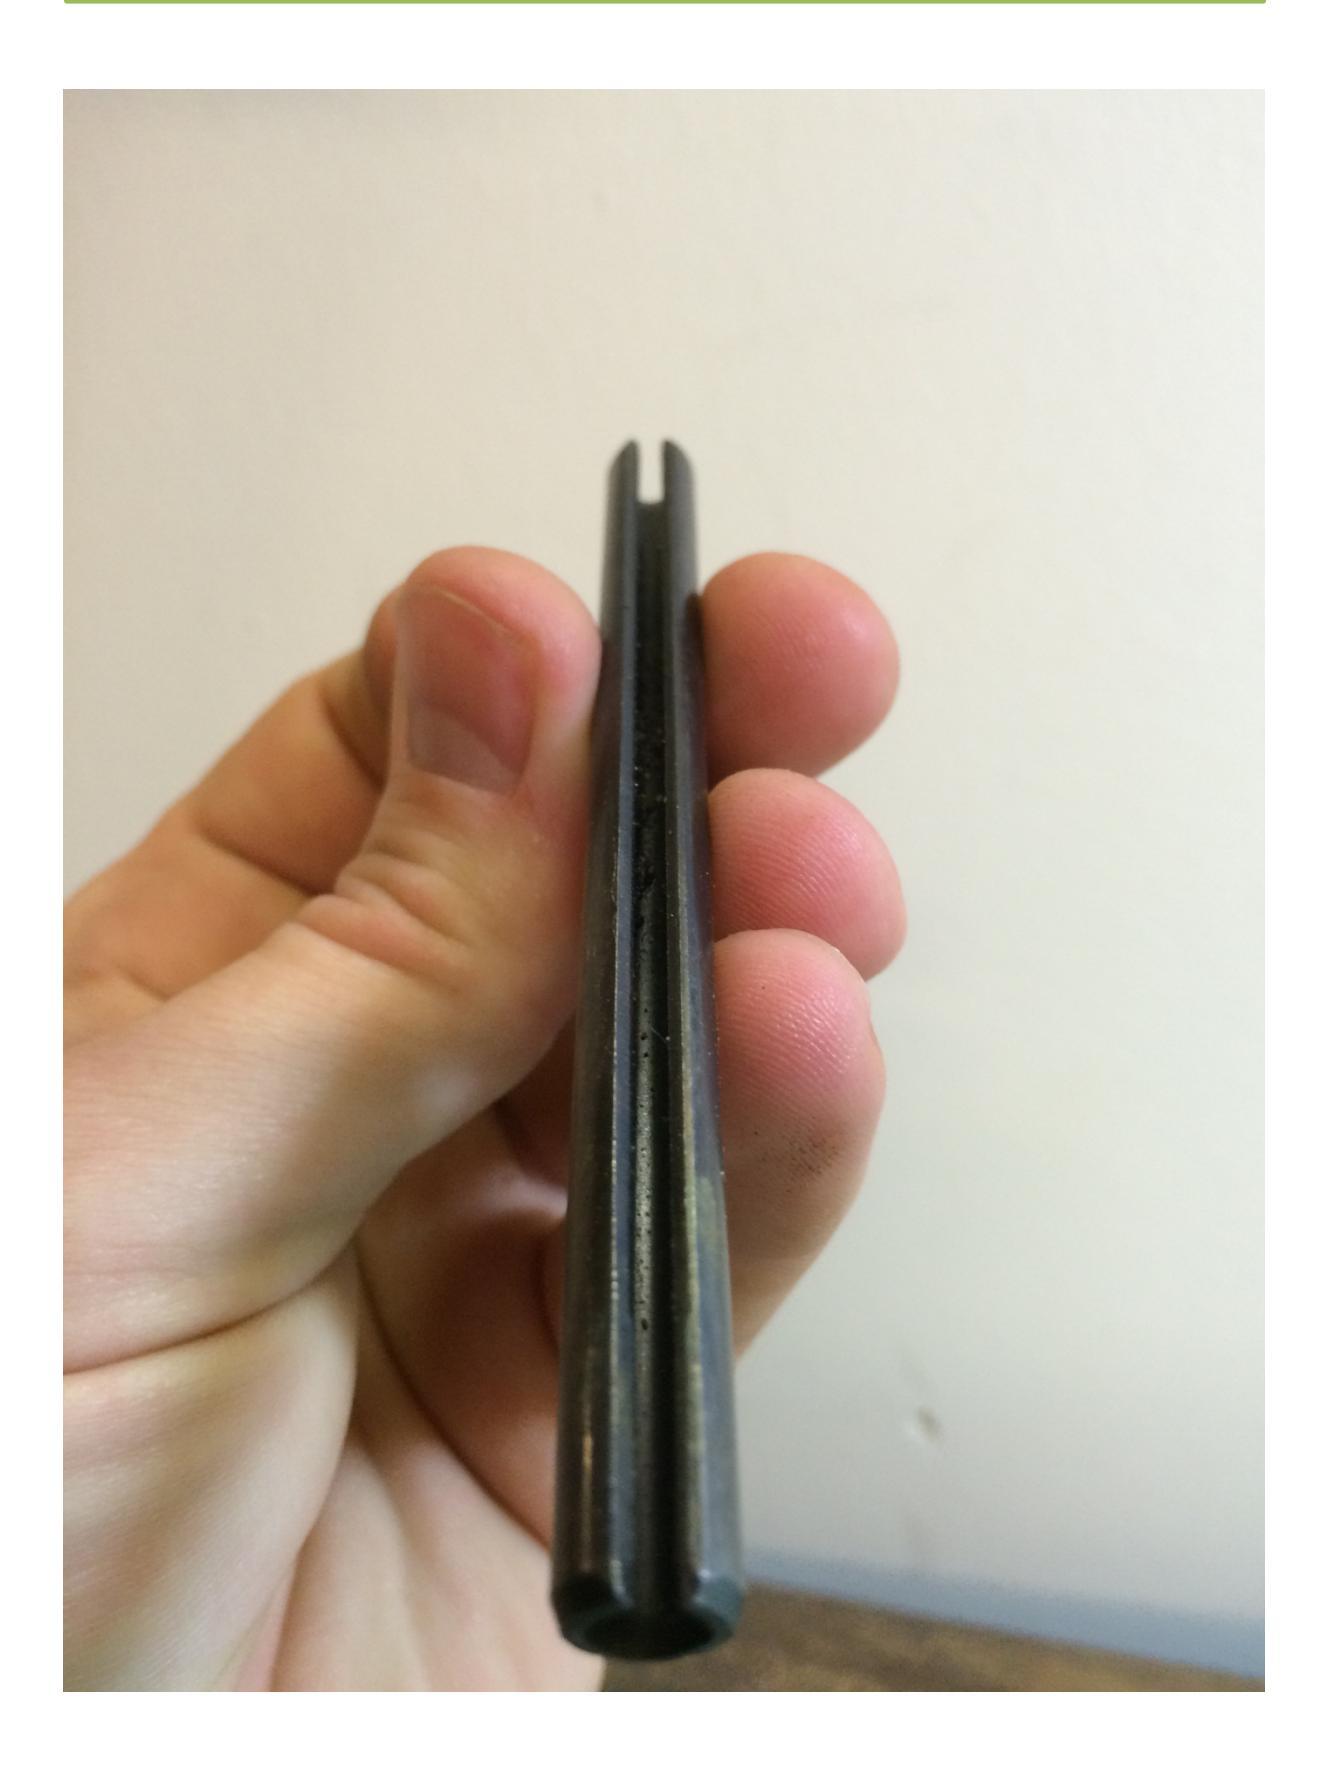
*Figure 7*; - This image illustrates a roll pin. The gap that runs the length is to allow for a tight and secure fit and the roll pin is forced within the created opening.

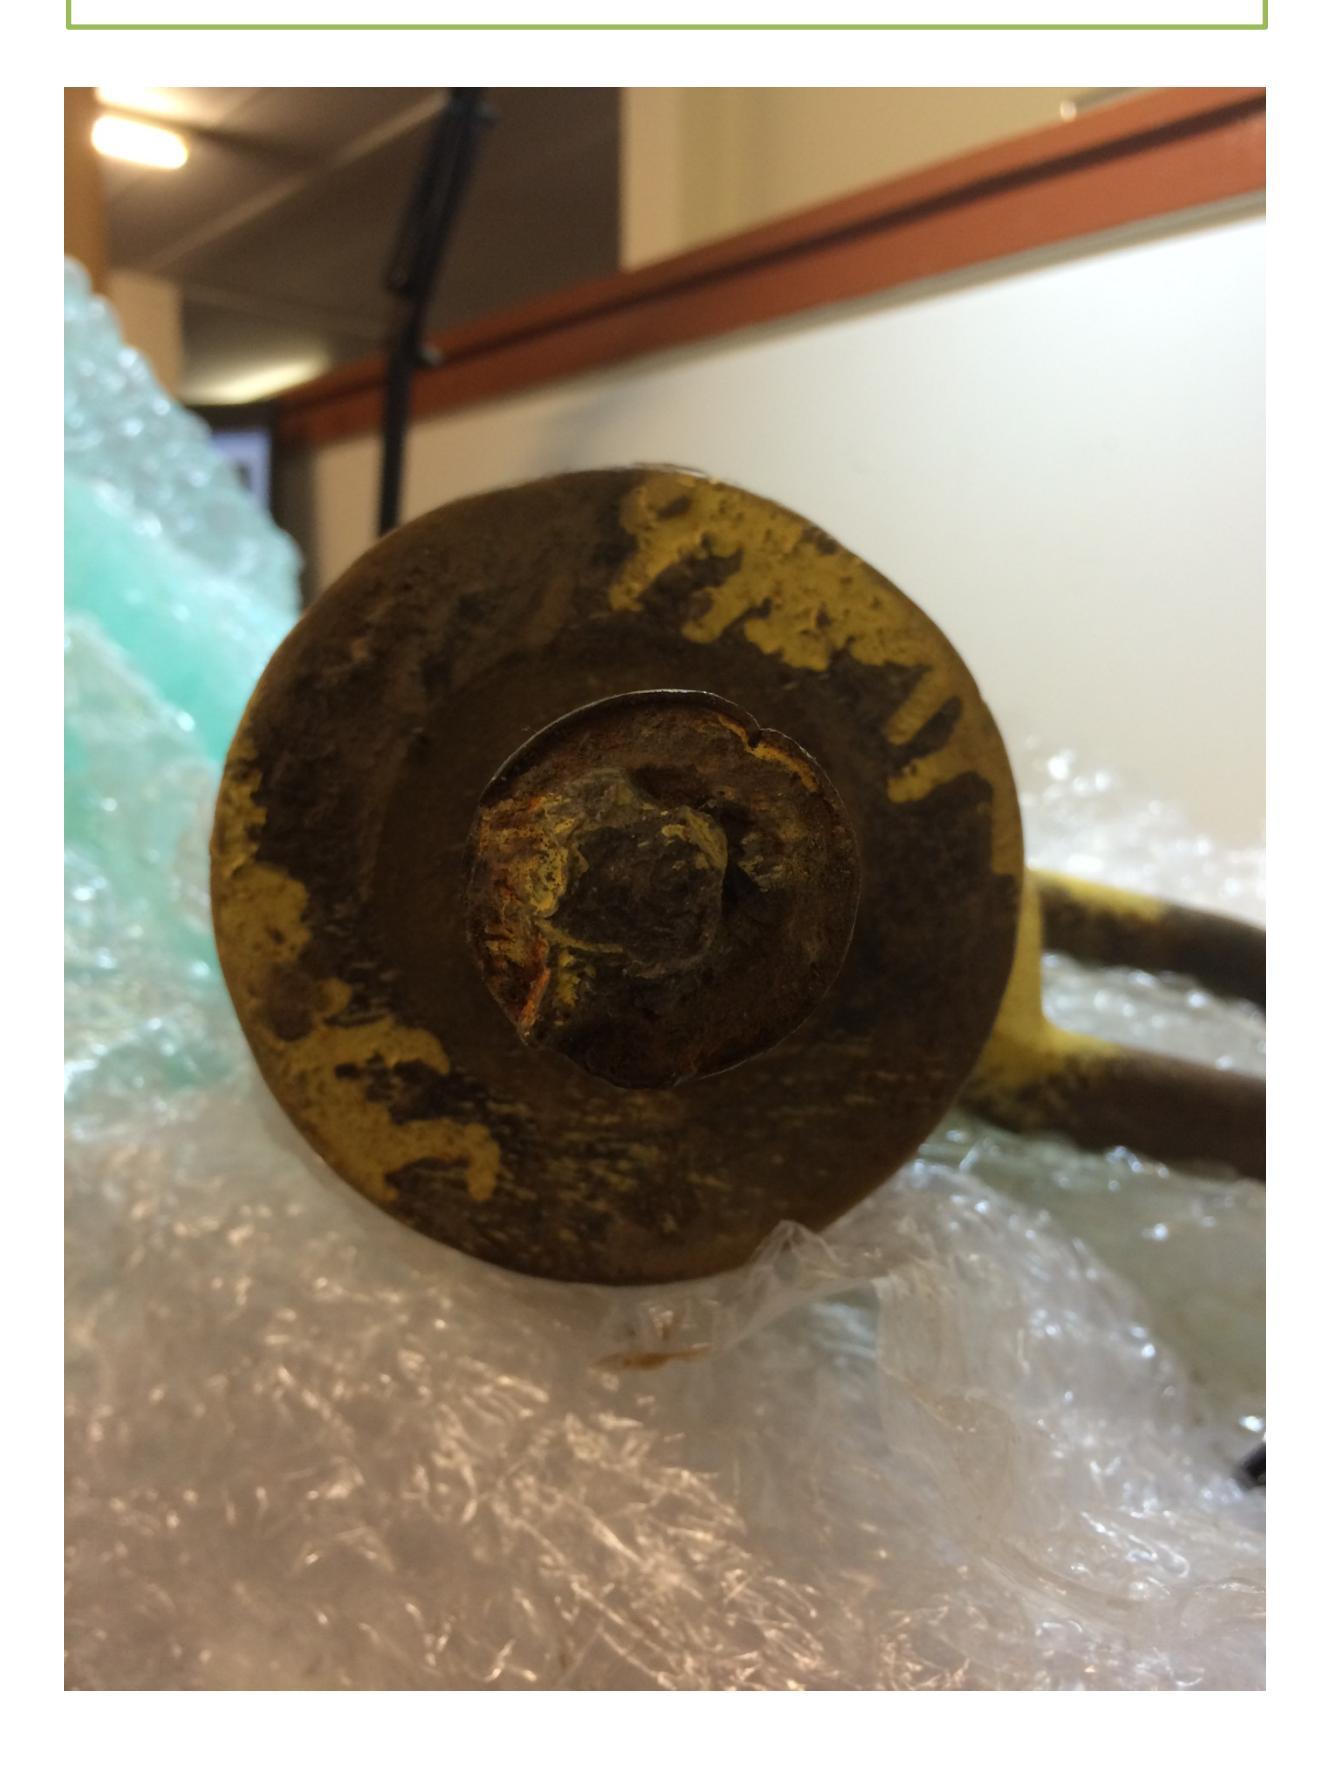
*Figure 8*; - This image shows the remaining weld at the top of the threaded extension.

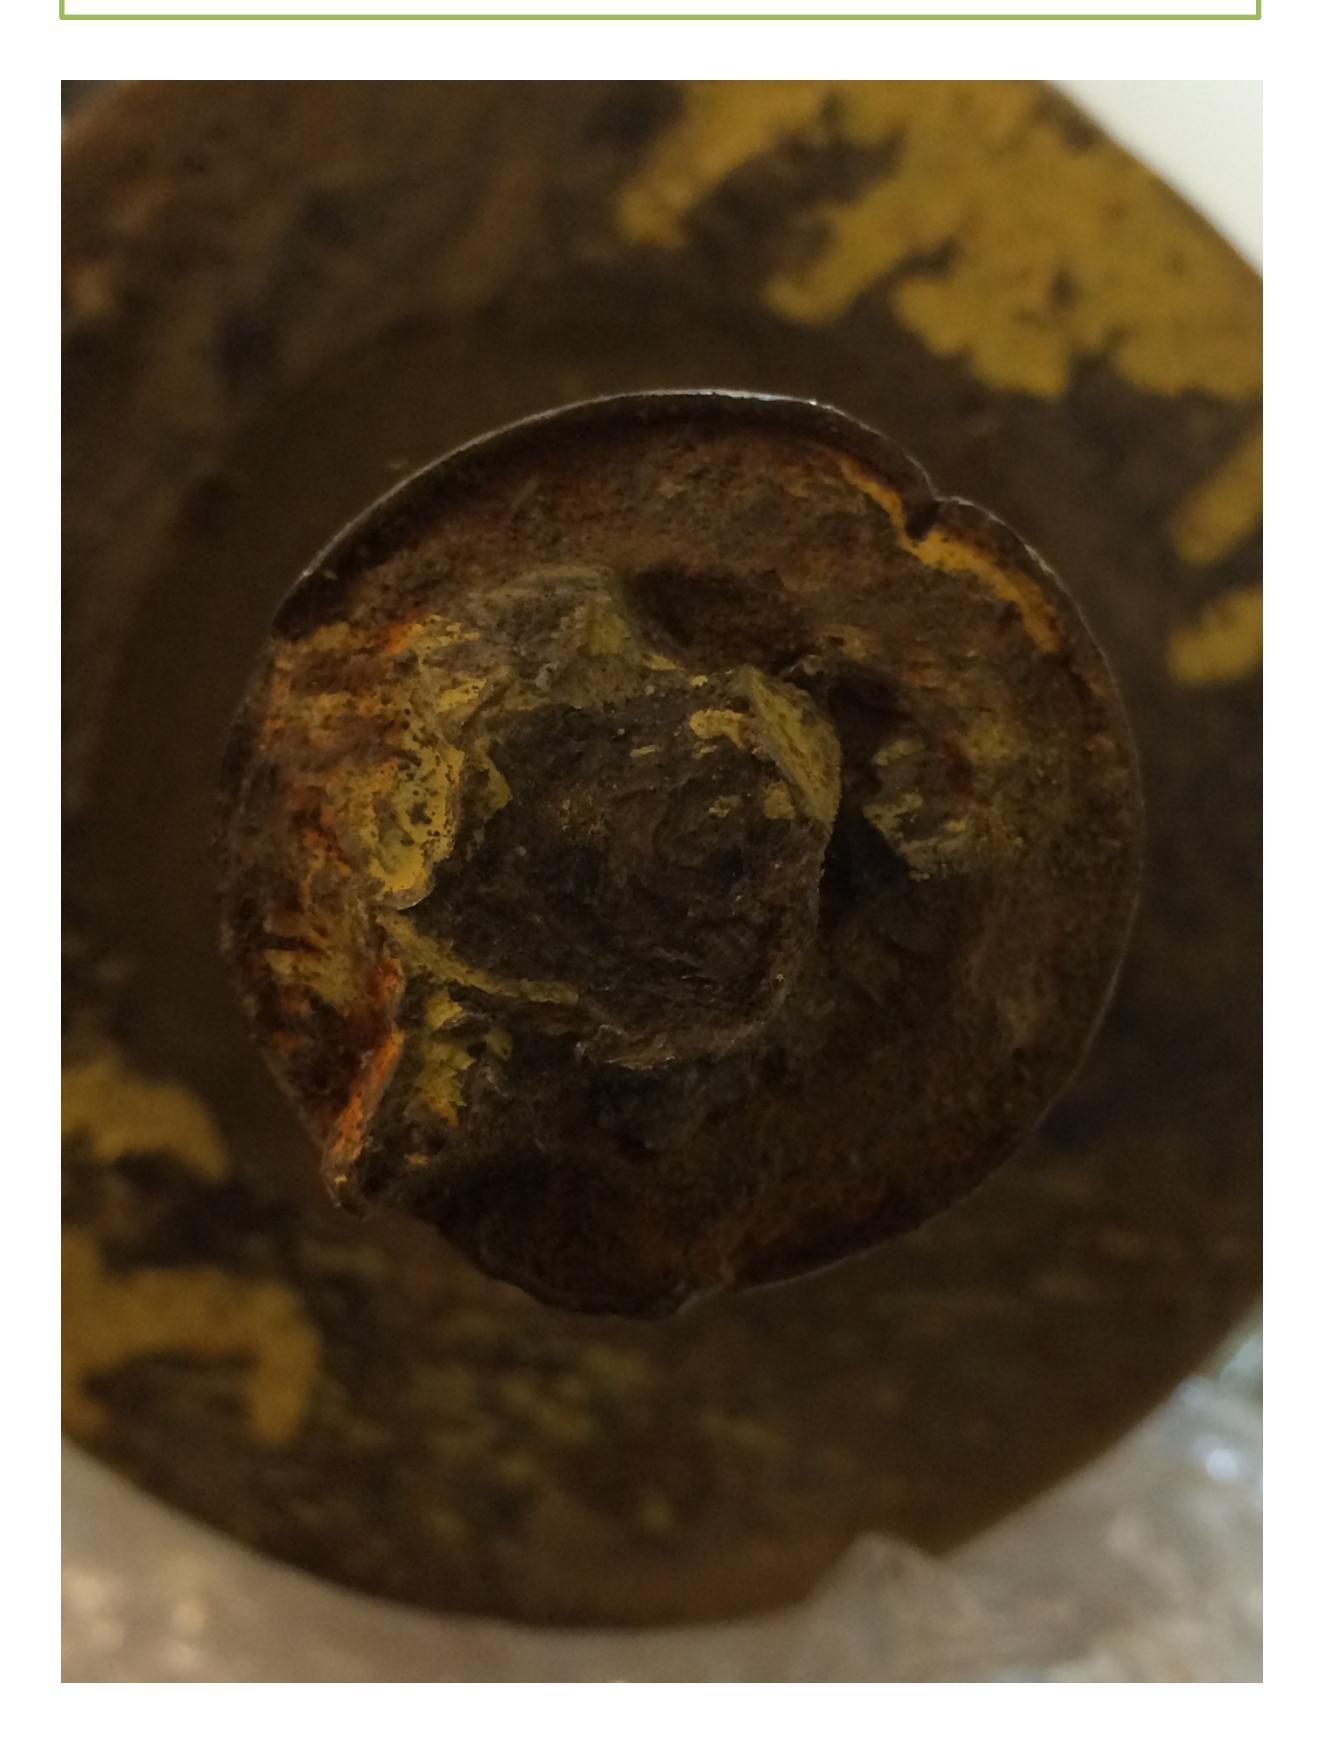
*Figure 9*; - This image shows a closer image of the remaining weld left at the top of the threaded extension.

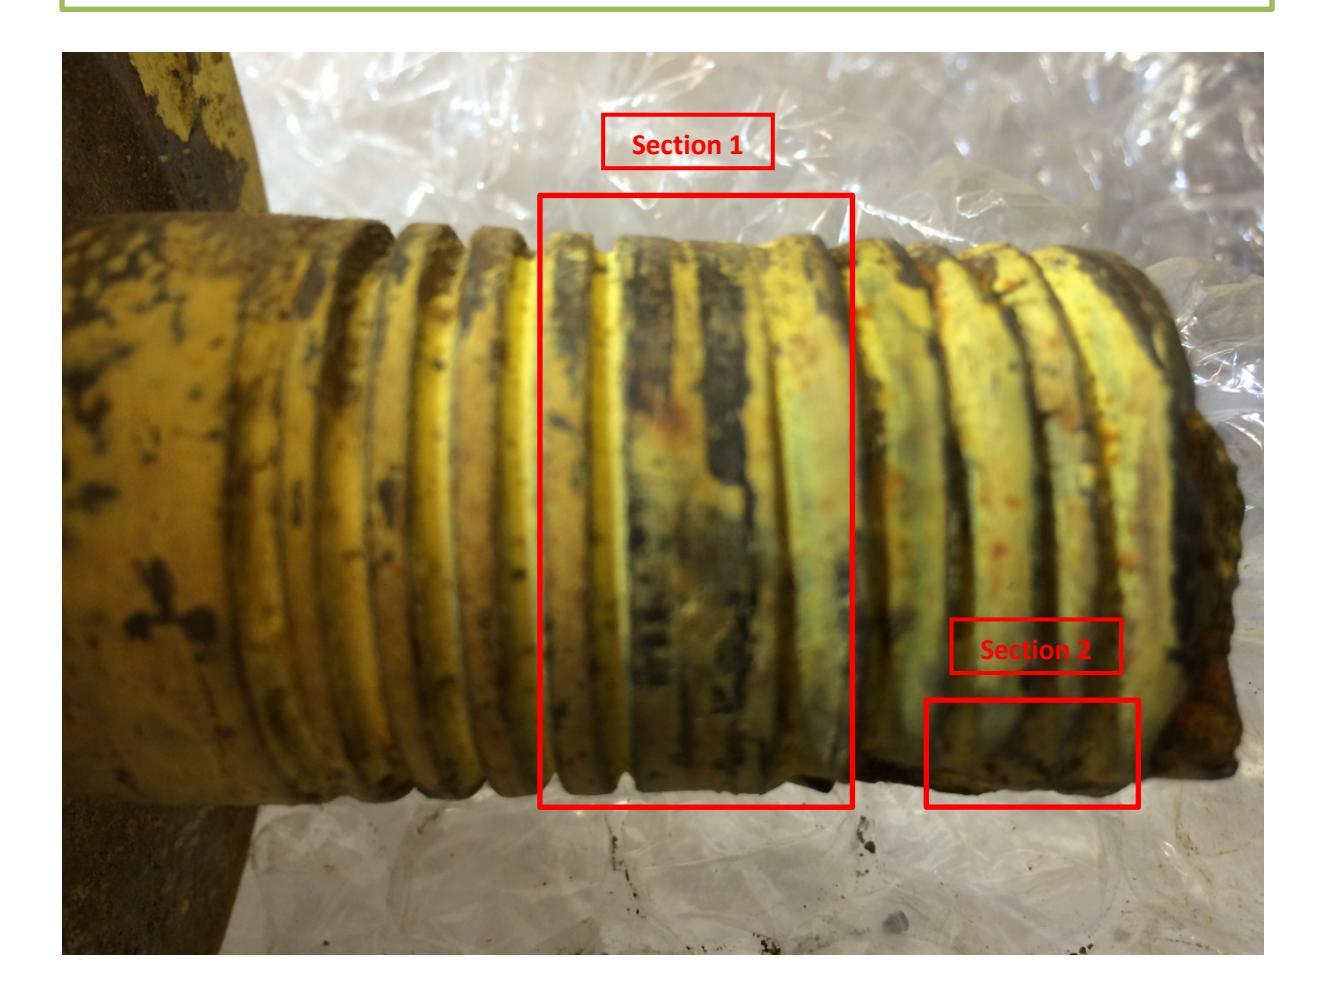
*Figure 10*; - This image shows a closer view of the stripping that has occurred prior to the nut coming free from the threaded extension. Smoothing areas have occurred at the section of the extension where the nut would have met the swivel, as indicated in Section 1. Section 2 illustrates rutting to the threads.

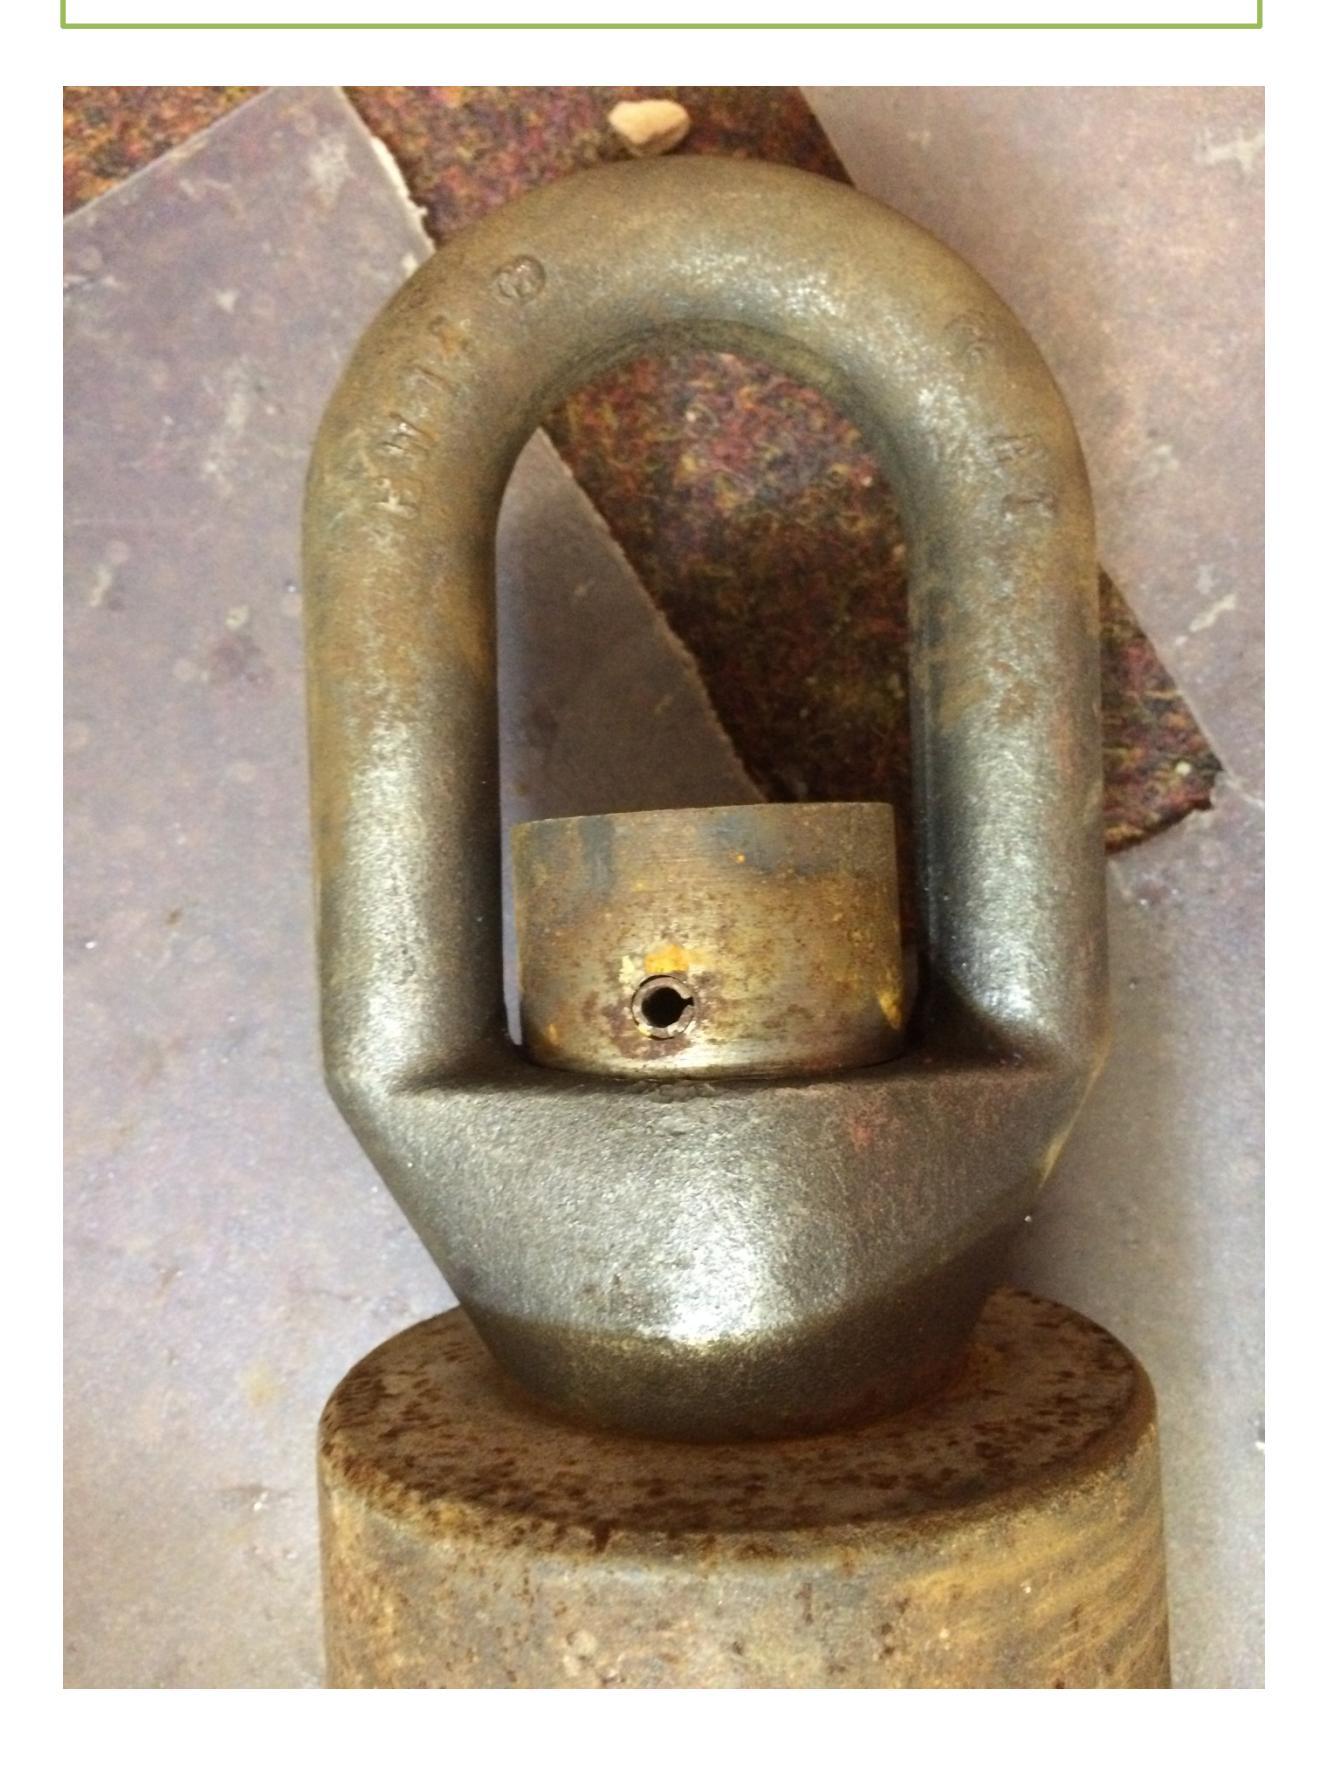
*Figure 11*; - This image shows a new top weight sinker bar, swivel, inserted roll pin and nut. It is clear that there is no threaded extension visible.
