## SF310 Near miss investigation report

Contract/Location :	Markinch	Contract no:	5718
Date of incident:	15/04/2015	Time of incident:	1535 hours

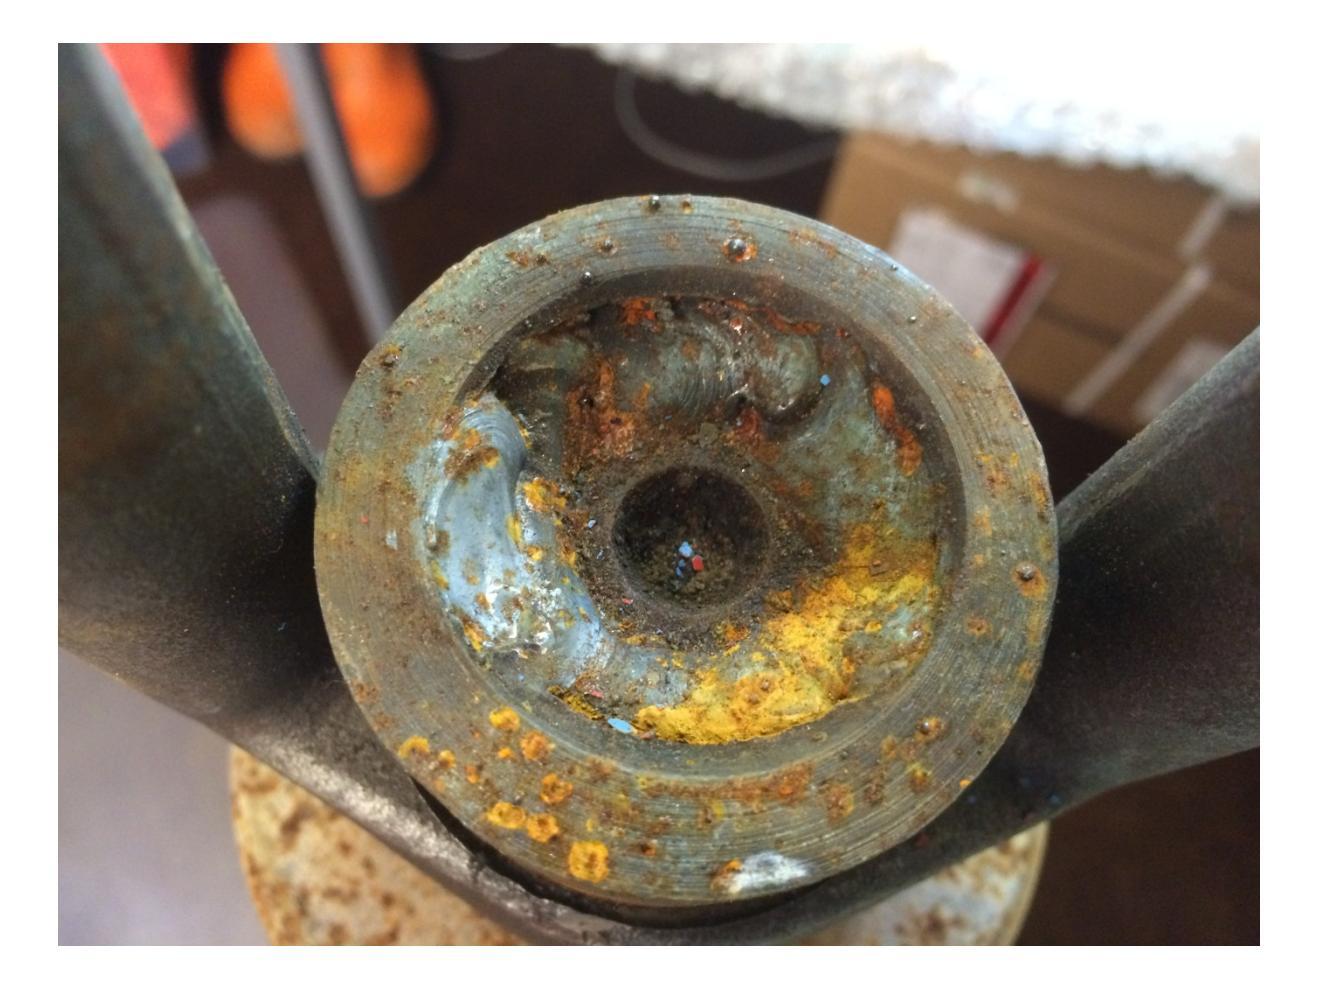
*Figure 11*; - This image shows the weld in place to connect the nut to the threaded extension.
