13 October 2014

No: NRS 338

## Network Rail Safety Bulletin Crush Injury to Slinger / Signaller

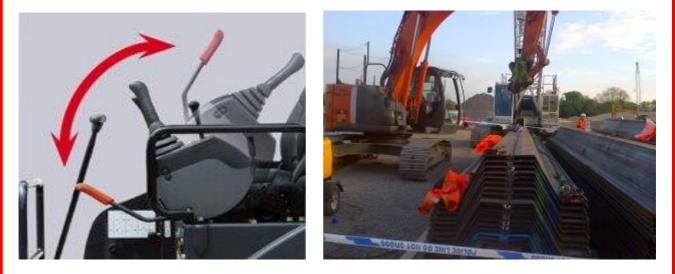
On 2 October 2014 a serious incident occurred on site during a lifting activity. A slinger/signaller was in the process of attaching lifting accessories to the lifting eye of a 22 tonne tracked 360 excavator. Whilst attaching the lifting accessories to the excavator's quick hitch, he came into contact with an unintentional movement of the dipper arm of the machine. The slinger/signaller, positioned between the machine's dipper arm and a stack of sheet piles, sustained serious crush injuries.

- Before work commences, how do you ensure as a machine operator, that the plant you're operating cannot make an unintentional move whilst activities take place with staff within the exclusion zone?
- As a work group, do you always understand and agree the communication protocol that indicates that the load and associated equipment is safe to approach?
- What could be the effect of the slinger/signaller fitting or removing an attachment/lifting accessory to an item of plant before the machine operator confirms the safety lever (dead man's handle) is in the safe position?
- As the machine operator how do you ensure that the dead man's handle is in the safe position when plant is used for lifting operations and accessories are attached or removed?

Remember - Always follow the lifesaving rule "Never enter the agreed exclusion zone, unless directed to by the person in charge"
