Safety Alert

Drilling Rig Safety

16 June 2020

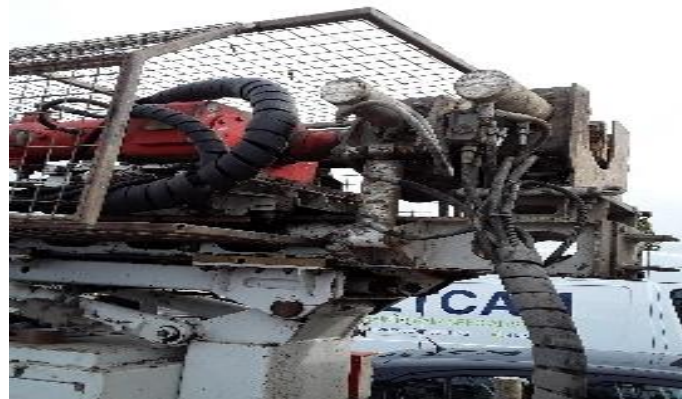
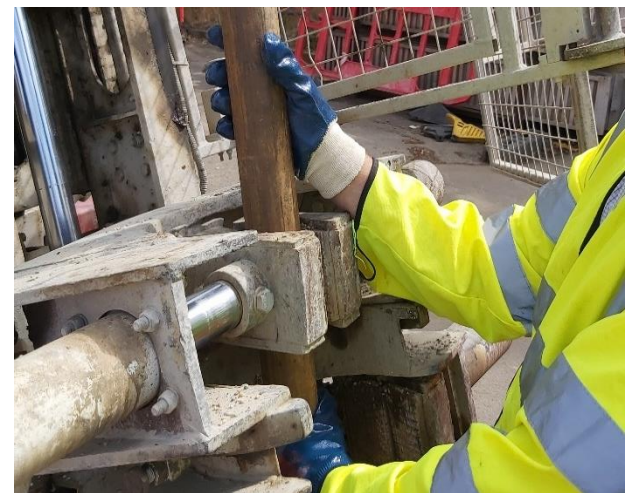
- Geotechnical Engineering were using a Commacchio 305 drilling rig for borehole works.
- The incident occurred when the IP (injured person) was removing the drilling rod from the clamps (*see photo below*)
- The IP took the weight of the rod and the barrel, causing their hand to slip behind the clamp. The IP then instructed the driller to open the clamps which trapped their wrist. The IP sustained two fractures to their wrist and will make a full recovery.

- Review working practices with drilling rig teams
- A new clamp configuration that covers the gap will be retrofitted to all rigs
- The RAMS are being updated to be more pictorial showing a storyboard of the process.
- All operators within the company have been briefed on the incident using the reconstruction videos
