What happened?

During April 2022, a contractor was carrying out a shallow borehole whilst using a multi-purpose rotary drilling machine. The borehole was being completed by a fully competent VQ qualified Lead Driller with over 25 years' experience in rotary drilling. During the progression of this borehole, the Lead Driller was undergoing an Audit from the BDA.

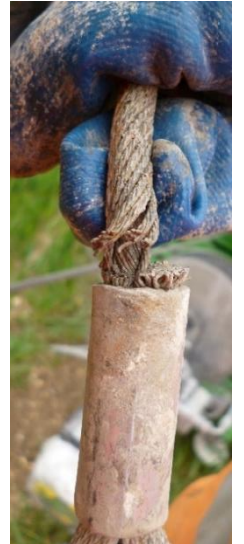
However, there was no requirement on the daily/weekly inspection to expose the rope behind the tensioning weight. When the auditee was asked to expose this section of the wire rope as part of the audit, it became evident that the rope was severely worn / broken - see adjacent image and images on Page 2.

The rope had approximately 50% of its strands entirely broken.

The Lead Driller immediately stopped the drilling machine and reported the findings to the supervisor and the head office. A replacement rope was immediately dispatched, and the machine remained unused until and new fully certified rope was fitted.

A toolbox talk was scheduled for the next morning by the company for all operators of drilling machines to check this area of the ropes before starting work, and the daily/weekly inspection criteria changed to include the specific requirement to inspect behind the tensioning weight.

All wire ropes in use on drilling machines should be inspected across their entire length on a regular basis. This check should be documented within both official Thorough Examinations, and daily/weekly inspections. All inspections should include removal of the tensioning weight from the ferrule area, and should be conducted by a competent operator who has received formal training on how to inspect wire ropes.
