**6<sup>th</sup> January 2023**

**A sub-contractor arrived at site to collect a tractor and towable tanker.**

**NCA – Mulberry Park**

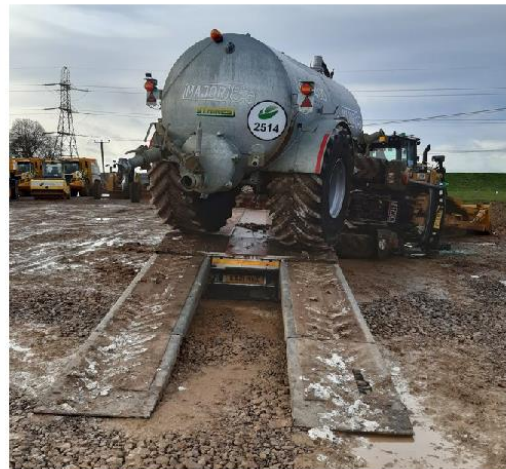
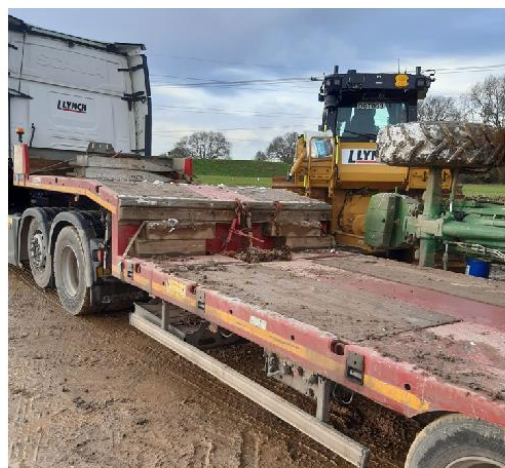
**The tractor and tanker were being loaded and due to their combined length, the front wheels of the tractor needed to be positioned on the raised section at the front of the low loader (the swan neck).**

**Whilst driving up onto the swan neck the tractor deviated from the low loader and toppled to the ground coming to rest on its right hand side.**

- Tractor/trailer was being loaded by the sub-contractor lorry driver
- The tanker was empty awaiting collection
- Ramps (for the access onto the swan neck) were in the stored position at the front of the low loader
- The tanker remained attached to the tractor and remained upright on the low loader trailer bed
- No injuries were sustained

- All planned plant deliveries/collections cancelled pending outcome of investigation
- Recovery plan is being developed
- D&A tested of the driver was negative
- An investigation has commenced

- Plan all plant deliveries and collections from site
- Supervise all plant deliveries and collections from site
- Carry out a PoWRA for the area
- Ensure a restricted area is in place (i.e. barriers/segregation)
- Ensure loading and unloading operations are undertaken by trained and competent personnel in accordance with SSoW
