On the 24<sup>th</sup> October 2022, a rotary drilling rig toppled whilst loading onto a plant trailer. The operator and all other personnel were a safe distance from the rig using remotely operated controls. No injuries occurred as a result of the incident.

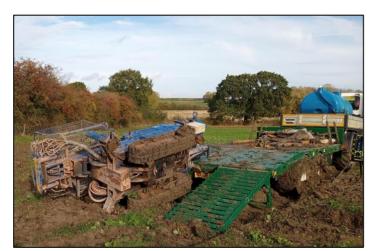
Rig immediately following incident

- An agricultural plant trailer towed by a Unimog was being utilised to move a rotary drilling rig around fields to enable access in soft ground conditions.
- Whilst loading, the rig slid on the ramps causing one of the rig tracks to fall off the inside edge of the ramp.
- This caused the rig to topple to the side.
- The lead driller was standing a safe distance from the rig and using remote controls. No other personnel were in the vicinity of the rig during the loading operation.
- No injuries occurred as a result of the incident.
- Upon righting the rig there was no significant damage to the plant.
- There was insufficient safety margin in the spacing of the ramps to allow for lateral movement of the rig during loading.
- Poor ground conditions resulted in the back of the rig sinking during loading resulting in additional instability.

- The suitability of specific plant trailers for the equipment being loaded must be adequately risk assessed prior to mobilisation and consideration given to low level trailers and full width ramps.
- When ground conditions are soft ground protection boards should be placed under the ramps and rig during loading.
- Staff and subcontractors should be briefed on this safety bulletin via toolbox talks and encouraged to raise concerns if any site plant is considered inappropriate.
