What happened?

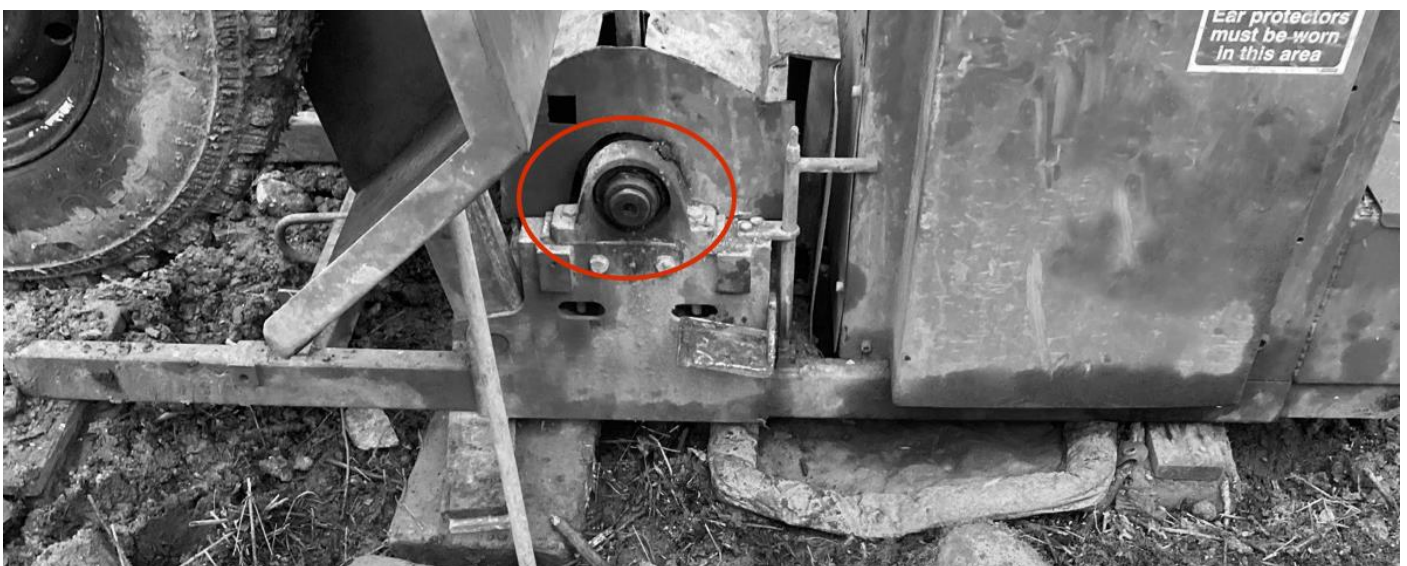
During the course of the audit, it was identified that there was no guarding of the clutch – a dangerous part of the machine that must be guarded to be compliant with the Provision and Use of Work Equipment Regulations (PUWER) 1998.

- No guard for the clutch was present on site.

- Failure of the daily/weekly inspection to sufficiently identify the missing guarding,
- Failure to report damage to plant and machinery team.

The BDA auditor immediately stopped the Lead Driller from drilling and informed both the BDA Audit Management and the driller's employer, and terminated the audit. The drilling machine was stood down until a guard could be fitted.

A toolbox talk was scheduled by the company for all operators of drilling machines to remind drillers of the importance of guarding all dangerous parts on drilling machines, in line with PUWER.

All dangerous parts on drilling machines must be guarded. On a cable percussion machine, these parts include (but are not limited to) the machine clutch, the capstan (if present), the main winch drum, the ancillary electric lifting winch
