What happened?

During February 2023, a contractor was carrying out a shallow borehole whilst using a cable percussion drilling machine. The borehole was being completed by a fully competent VQ qualified Lead Driller with significant experience in cable percussion drilling. During the progression of this borehole, the Lead Driller was undergoing an Audit from the BDA.

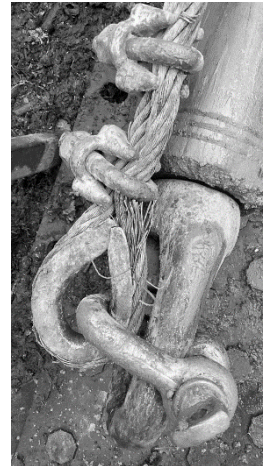
- 16mm galvanized wire rope,
- Had been thoroughly examined less than four months previously by an independent competent person,
- Had been re-terminated using U-bolts since the last thorough examination,
- Had been inspected by the Lead Driller as part of his daily inspection on the day of the audit and had been noted as 'worn'.

The rope had approximately 50% of its strands entirely broken at the pinch-point of the thimble and U-bolt, a high number broken strands at the bottom of the rope within the thimble and there were also numerous broken strands across the entire rope length.

- Frequent abrasive contact between the shackle and tooling,
- Excessive tightening of the U-bolts during re-termination, causing crushing and deformity to the wire rope.

- Failure of the daily/weekly inspection to sufficiently identify the wear,
- Failure to report damage to plant and machinery team,
- Failure to re-terminate the rope in accordance with manufacturers/industry guidance, tightening the u-bolts excessively and causing damage.
- Failure to apply knowledge learnt during wire rope inspection course,
- Failure to use protection between the thimble and tooling.

A toolbox talk was scheduled by the company for all operators of drilling machines to remind drillers of discard criteria for wire ropes, the correct re-termination procedure (including use of a calibrated torque wrench) and the importance of completing accurate daily/weekly inspection information.

All wire ropes in use on drilling machines should be inspected across their entire length on a regular basis by a competent person. Particular attention should be paid to the thimble area of re-terminated wire ropes in use with cable percussion drilling machines. This check should be documented within both official Thorough Examinations and daily/weekly inspections. All daily/weekly inspections should take note of the rope condition across the entire visible length and should be conducted by a competent operator who has received formal training on how to inspect wire ropes.
