#051

**Further to Safety Alert #048 issued on 26 October 2023 when an Operative suffered a deep cut to their left thumb requiring hospital treatment, when the engine hatch of Wacker Neuson Remote Control Vibroplate Compactor DPU80rLec670 fell, the following is an update.**

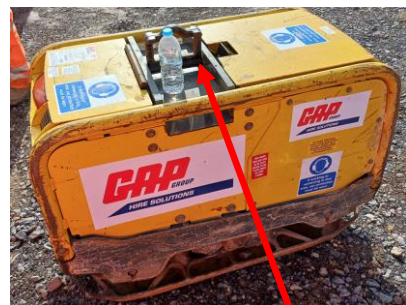
Single lifting point in raised position to enable lifting by other plant

Ensure that when compactors are lifted, they are lifted using the single lifting point on top of the compactor and not by fork tines directly underneath and in contact with the base of the compactor.
