## Flexible Pipe burst during clearance pumping

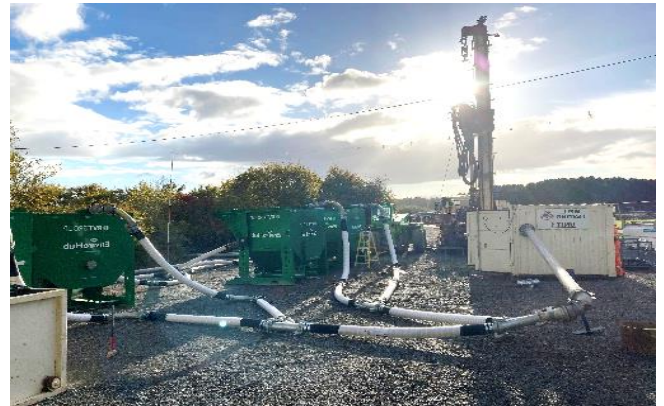
The system comprised of lamella and settlement tanks to provide filtration prior to discharging in a nearby watercourse to comply with the duty of care. Test pumping was due to continue for several days

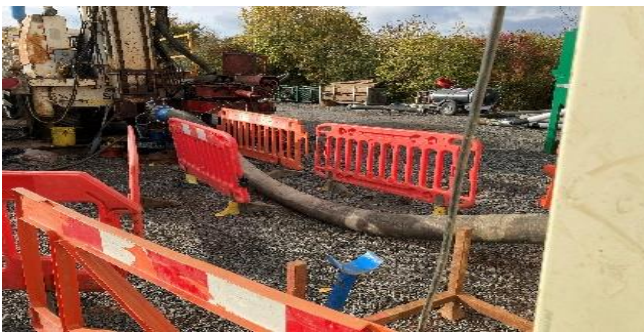
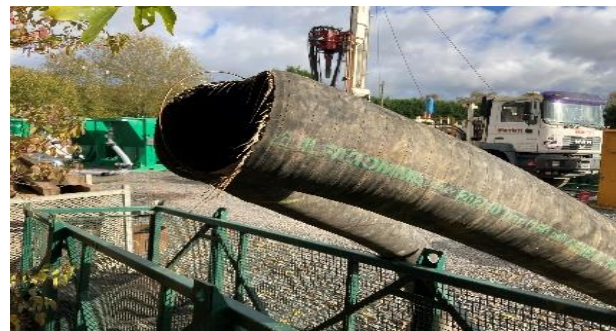
Experienced personnel were onsite, and they commenced test pumping on day two. Whilst test pumping the flow rate began to decrease from 30 l/s. The pump operatives sought to correct the drop in flow by increasing the frequency of the pump. Due to a build-up of pressure, one of the flexible pipes burst and water was released.

A pressure release valve was not fitted to the headplate.

- The investigation is ongoing, and so, key messages are still being determined. However, whilst it is recognised that pressure release valves are not always required it is good practice to install them in case of unexpected failure.
- Members of the site team were in close proximity to the burst pipe. Safe working zones must always be implemented and only where expressly required should personnel be in close proximity to pipework on site.

- Make sure you risk assess the task and always consider additional precautions such as pressure release valves, or electronic pressure transducers linked to the pump controller for immediate isolation at the preset pressure limit.
- Always check the condition of pipework and connections before use.
- Make sure the pipework onsite is of suitable size and with the appropriate pressure rating tolerance prior to carrying out test pumping.
