Lessons learned

Contractor Delivery Operator Working at Height

Date of incident	15/05/24	Incident type	Near Miss (HiPo)
Incident ref number	INC19373	Contractor	Plantforce
Location	Radstone Road	Keyword search	Working at Height

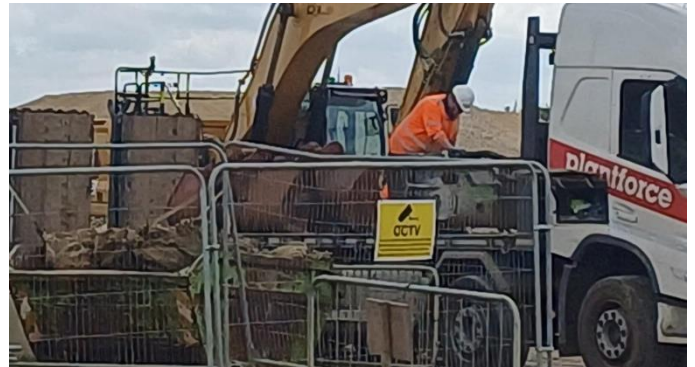
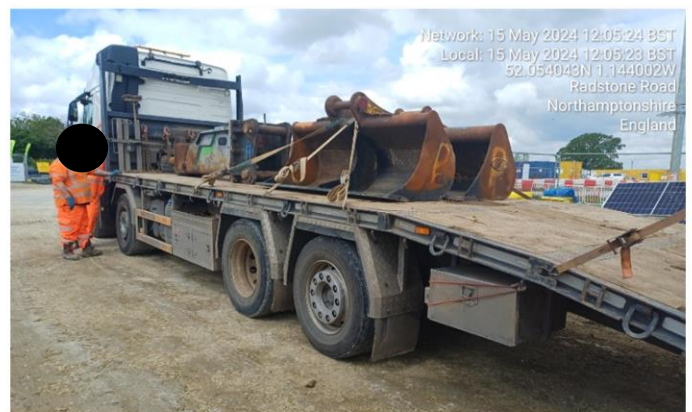
Photographs

A delivery driver was observed de-rigging a breaker attachment on a wagon flatbed which was c.1.5m high without means of fall protection. No injuries sustained.

- The delivery operator was suitably trained in securing loads and working at height
- The Safe System of Work (SSoW) detailed edge protection to be utilised prior to gaining access to the flatbed
- The SSoW did not identify other means to eliminate the requirement to work at height.
- The edge protection was ticked as being in place on the daily inspection form (although not used)
- A PoWRA form was not completed
- A supervisor was in the vicinity but did not observe the operative gain access to the flatbed.

- Always ensure a PoWRA is completed prior to beginning any new task and updated accordingly.
- Where possible the SSoW is to reflect that delivery vehicles are to be fit for purpose (consideration for the load) and are fitted with 'securing eyes', or other, to prevent the requirement to work from height.
- Where it is not possible to complete the activity from ground level, make sure that edge protection is in place before accessing the bed of the vehicle.
