What happened?

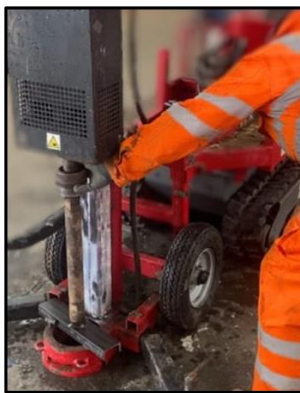
During the use of dynamic sampling rig, the assistant driller was carrying another activity close to the operation. The hammer on the mast was approximately halfway down the mast when the lead driller took the decision to tighten the rod connector (drive dolly) up himself to save seconds of time in the absence of the assistant driller. While the lead drillers hand was placed on the top of the drive dolly, the operator used the rig control causing a pinch of his little finger. The driller sustained an open fracture to the tip of his little finger.

Hand placement

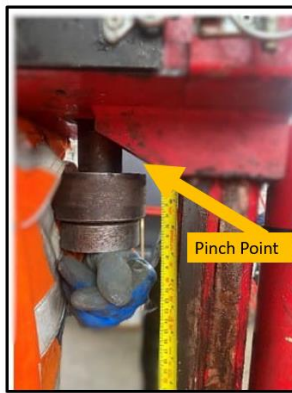
Pinch point

- Inherent pinch point on the rig from the manufacturers

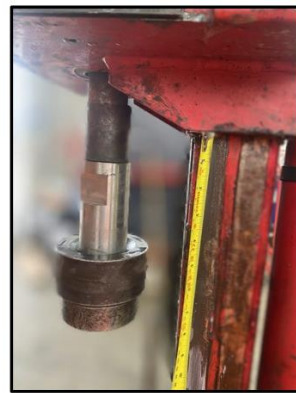
Extension piece

- Always ensure any operation is carried out by a two-team person team
- Ensure lines of communication are agreed and implemented
- Ensure rig controls are never operated while body parts are in hazardous areas
- Identify pinch points and ensure the hierarchy of controls are adopted- extension piece put in to lower the drive dolly from the hammer (as pictured)
