Pressure Systems

Summary of Incident

SA422

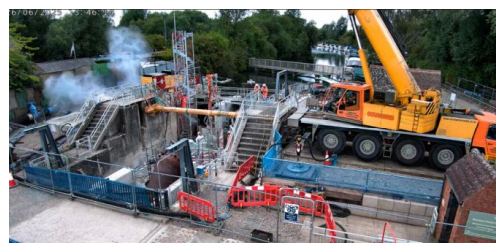
During the installation of ground anchors using a rotary drilling rig there was an excessive build-up of pressure resulting in the failure of a non-return valve. A 50mm diameter part of the valve was projected 50m across the site into a public area – no injuries. The incident was reported as a failure of a pressure system classified as a dangerous occurrence under RIDDOR

Still from the CCTV of the incident

All equipment turned off and taken out of service. Confirmation to workforce that all works were on hold until an understanding of the cause of failure was established. Use of jet wash pumps to inject water into compressed air system suspended.

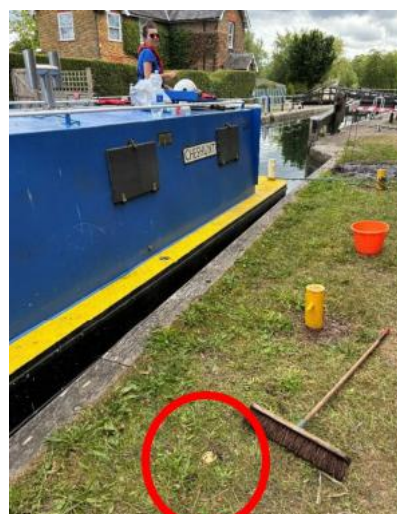
Final position of brass cap beside canal barge in public area
