NC2A section 3

#175

Grout mixer

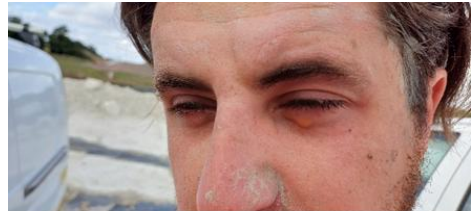
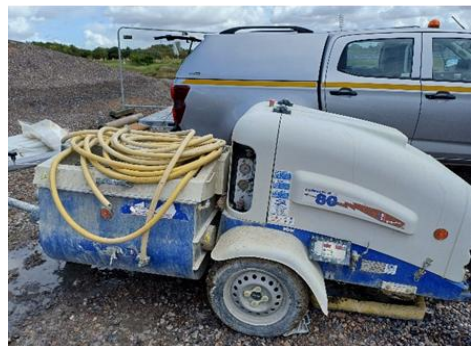
A worker was attempting to remove a blockage from a grout mixer (Euromair CP60 and CP80) and had grout sprayed into their face and eyes. The Injured Person (IP) was wearing safety glasses, but not safety goggles. First aid was administered and IP taken to A&E.

There was no Safe system of Work in place for dealing with grouting blockages.

IP took an ad hoc approach to removing blockage, not checking pressure and rodding an attached hose which was still under pressure.

- Appropriate PPE – goggles/respirator mask – provided to site with spares.
- Plant guide covering safe process for removing grout blockages produced.
- WPP and TBS revised accordingly.
- Use of google stickers on plant and copy of plant guide attached to grout mixer.
- Practical training sessions regarding dealing with grout blockages.

- Have the correct PPE for grouting operations available on site – goggles and respirator mask.
- Ensure that manuals / guides are available on site and always adhered to.
- Ensure that sterilized water is available and a further clean water supply to remove grout from the skin.
- Only trained and competent personnel are involved in the removal of grout blockages.
