## Injury – struck by object whilst using compressed air.

<b>Date of incident</b>	14-05-2025	<b>Incident type</b>	HIPO
<b>Time of incident</b>	16.00	<b>Location</b>	Kendal, Cumbria

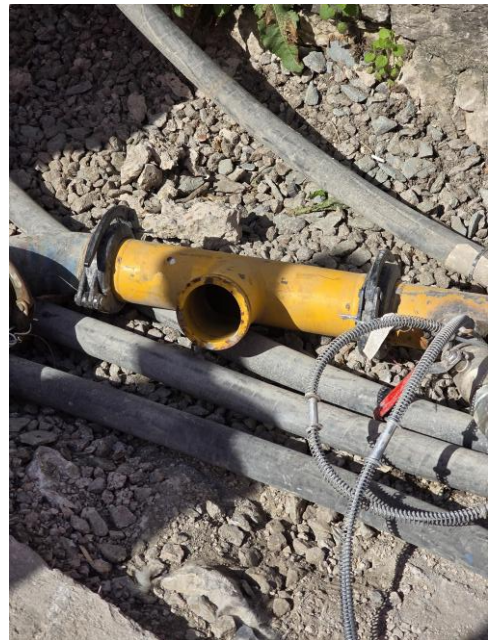
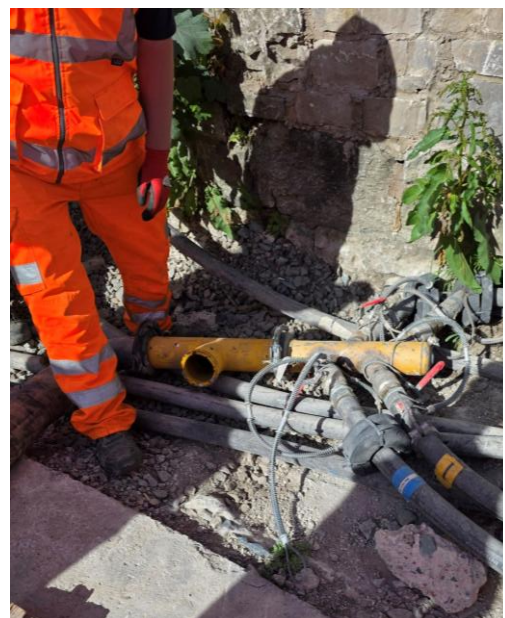
### Photographs/supporting information

This involved removing a t-piece cap to introduce a water feed into the pneumatic hose.

However, the hose had not been fully depressurised and compressed air remained in part of the system.

The removal of the cap resulted in the uncontrolled sudden release of compressed air, blowing the cap into the IP's leg with sufficient force to both dislocate their ankle and break the tibia.

Compressed air was still trapped in the system between two sets of valves (one set of which should have been opened).

This was not apparent as there was no pressure gauge provided for the affected section of the hose.

The lack of pressure gauge and the lack of familiarity of the system (this is a new technique for Keller in the UK), led to the incident occurring.

A system schematic (showing positions of exhaust valves and pressure gauges) and technique specific training will be provided for all Keller techniques, with compressed-air systems a priority.
