visual inspection

Examples of hose assembly damage/failure

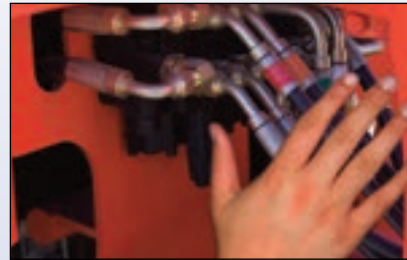
When examining hoses for damage/searching for a leak it is vital that the hands (and indeed any other part of the body) are kept away from equipment which is under pressure. The image below shows the incorrect way of doing this.

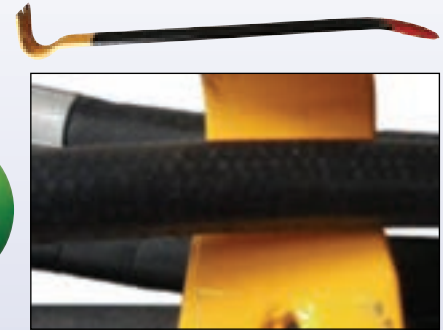
A long implement should be used when inspecting hoses for damage – this will reduce the risk of personal injury. A typical implement and how it is used is shown below.

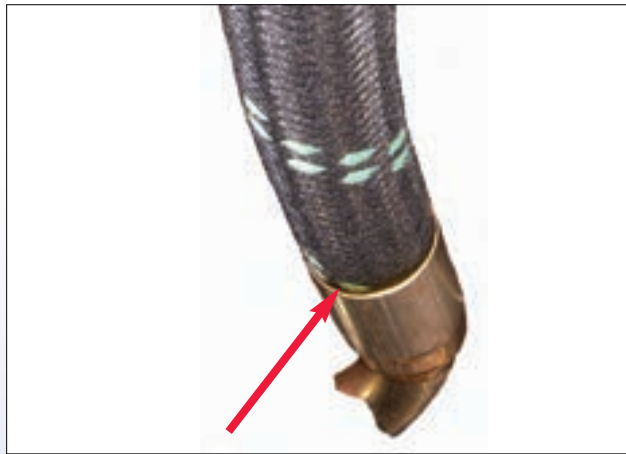
Witness of oil which shows on the hose cover

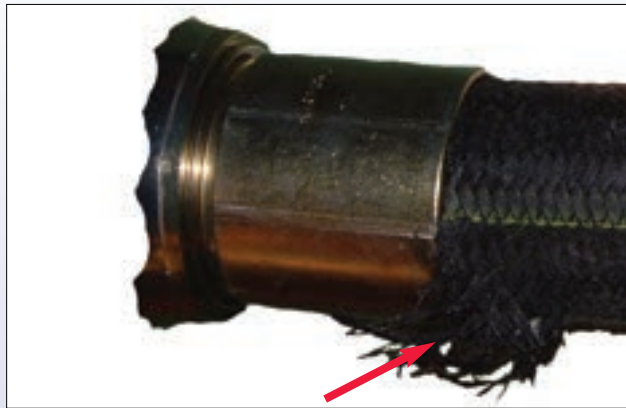
This type of damage can result in the hose bursting at the hose/coupling interface – typically some examples of this are in the following photographs.

Burst at the hose/ferrule interface

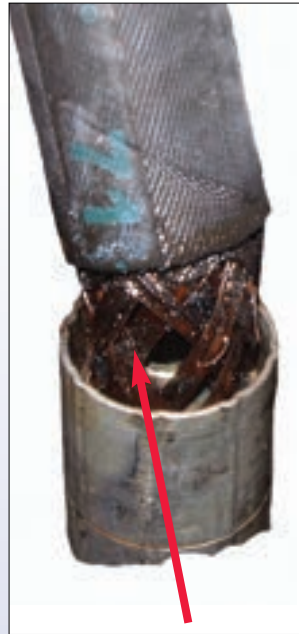
Hose pulled out of ferrule

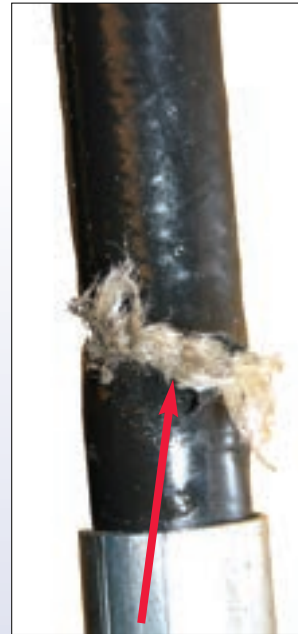
Hose burst near the ferrule

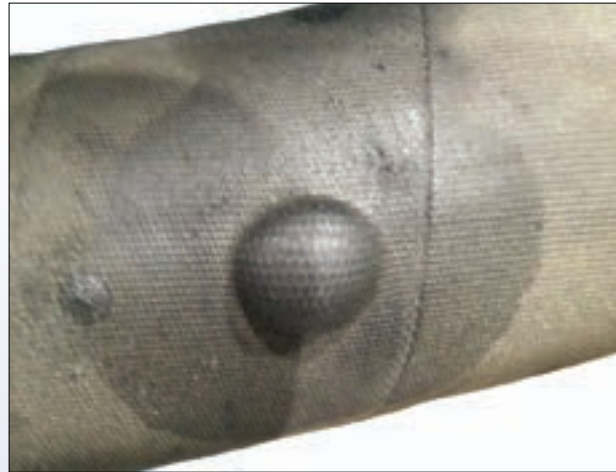
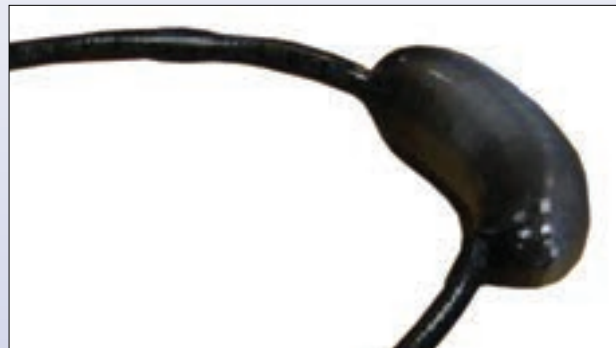
Certain failure modes can occur either near the hose/coupling interface, or in the bulk of the hose itself. The 2 photographs below give examples of the medium within the hose escaping through the hose liner and not being able to escape through the hose outer cover. This effect is not covered within the scope of this course, the root cause for this type of failure can be complicated. The period of time that a hose assembly is in service before this type of problem manifests itself can vary and depend on a number of factors. The medium in one of the applications where these photographs were taken from was nitrogen, the other was mineral oil.

Should a hose assembly have any obvious damage similar to the above it is imperative that personnel are aware that the bleb/blister will contain a medium which is under pressure – therefore, if burst, making it a potential for a fluid injection injury and also in the case of gas could release a large amount of energy with obvious consequences – including noise!

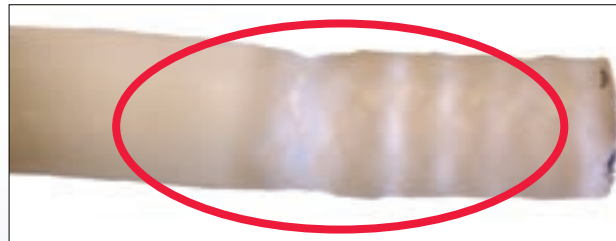
The timing for these types of problems to become evident can vary depending on a number of factors (which are beyond the scope of this course). The photographs below show examples of damage to the hose liner such that leakage occurred whilst the hose assembly was in service.

The above photograph shows a thinning of the liner such that leakage occurred

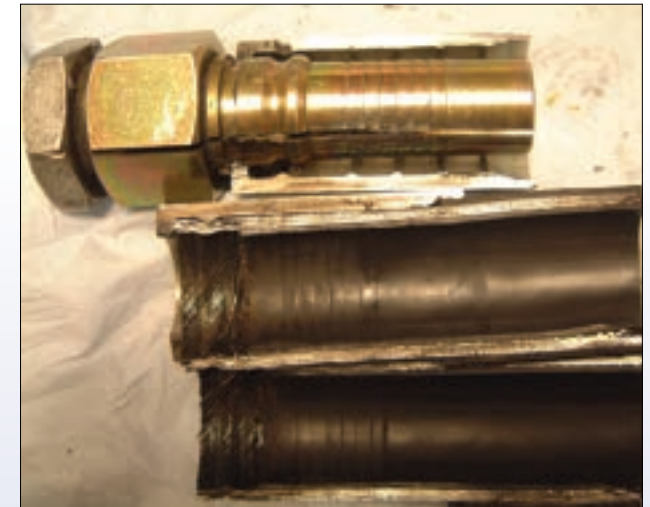
The above photograph shows radial cracks in the hose liner

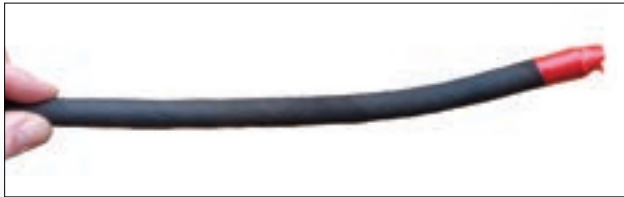
The above photograph shows a hose which was located in service near to an external heat source. Although the hose assembly was working well within its design parameters (temperature, flow and pressure) the ambient temperature caused the hose to take set in its installed form. You can see that the hose assembly is not supported but still retains its in service shape.

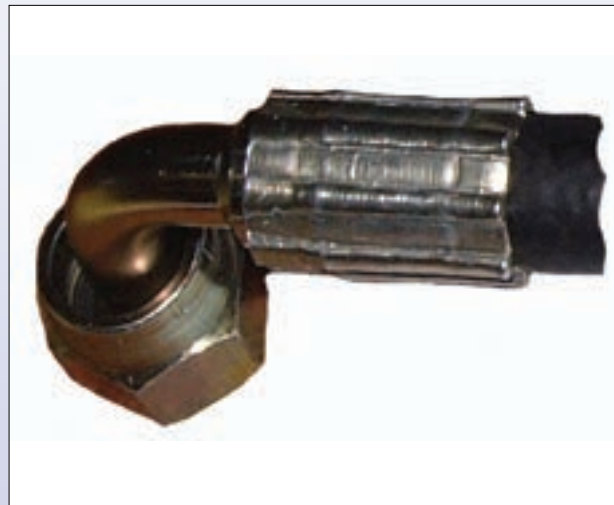
installed/being inspected pre-installation. The quality of the crimp should be visually inspected for any obvious manufacturing defects. The following show typical crimp defects, each of which would justify not allowing the hose assembly to enter service:

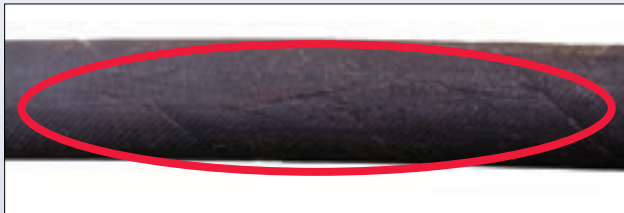
The photograph below shows a hose assembly which was inspected shortly after going into service. As can be seen there is a slight amount of abrasion damage on the outer cover – the impression left from the wrapping tape and the wrapping tape pitch is still visible. Damage such as this would not justify taking the hose out of service.

Damage such as that shown above can be minimised by providing the hose assembly with abrasion protection before the damage to the outer cover becomes excessive, such as to expose/almost expose the reinforcement.

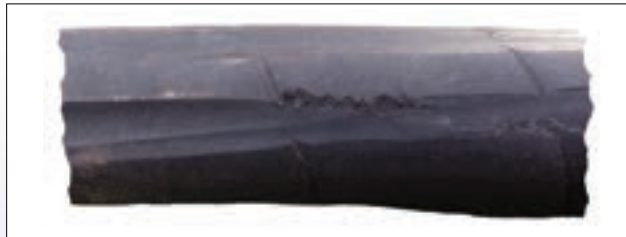
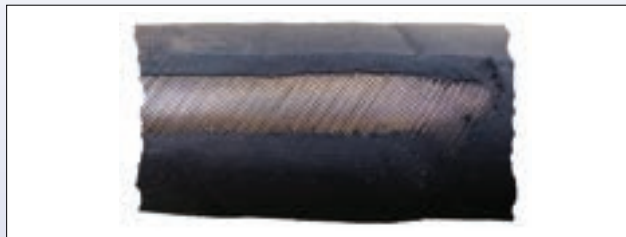
Corrosion of wire reinforcement

Once the wire reinforcement becomes exposed it will start to corrode, this will ultimately cause the hose to fail in service if not replaced in time.

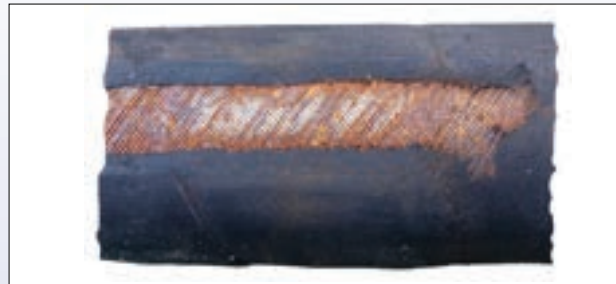
The onset of corrosion can be seen in the photograph below. This photograph was taken within 7 days of the outer cover being worn away and exposing the spiral reinforcement.

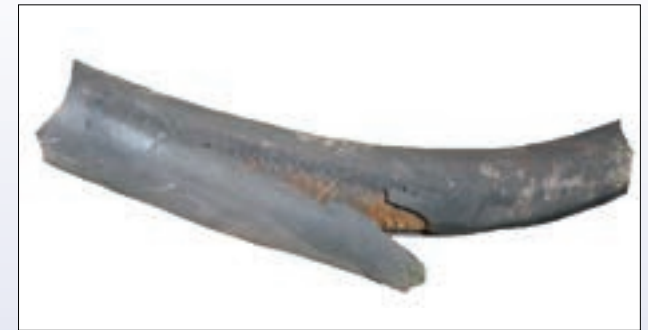
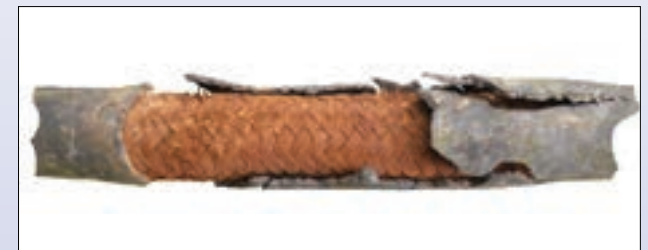
If not replaced in sufficient time the reinforcement will fail due to corrosion, such heavy corrosion is shown in the 2 photographs below.

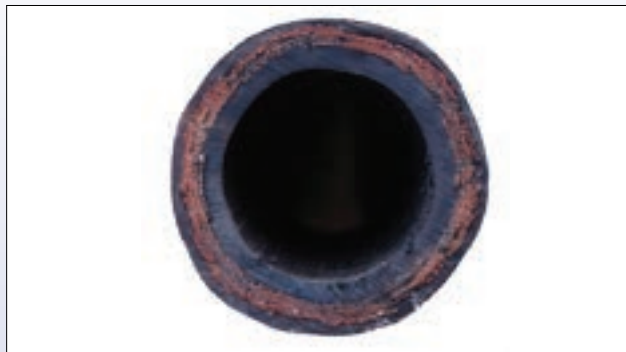
If bulk hose is stored outdoors, or in a humid/damp environment it can result in the hose corroding at the end(s) of the coil, an example of this is shown in the photograph below.

If the corrosion is severe, it can result in the hose reinforcement becoming corroded some distance down the bulk hose. This corrosion can lead to loss of adhesion between the hose inner liner, reinforcement and outer cover. If the end of the coil is corroded, the hose should be cut back to a point where there is no visual evidence of corrosion before the end connectors are assembled.

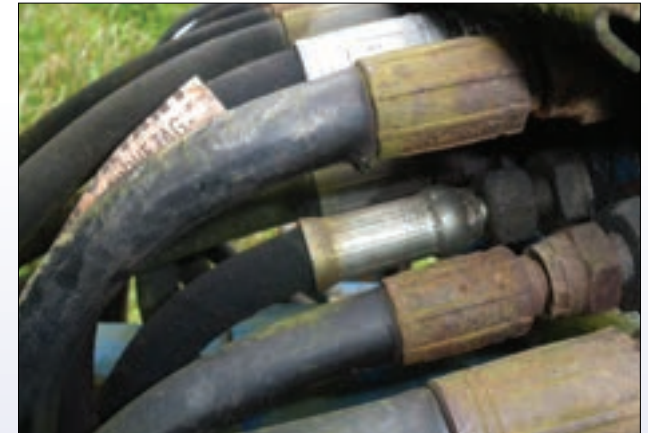
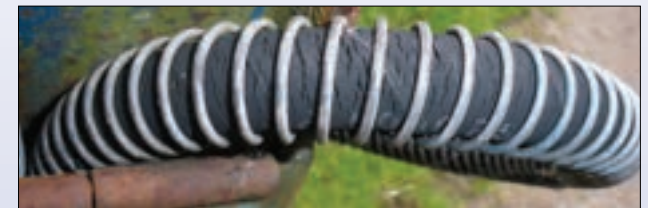
The photographs below show examples of hose assemblies and ancillary products which are used on equipment which has just come out of storage. Do any of these hose assemblies/ancillary products (for example quick release couplings) look suitable for on-going safe use?

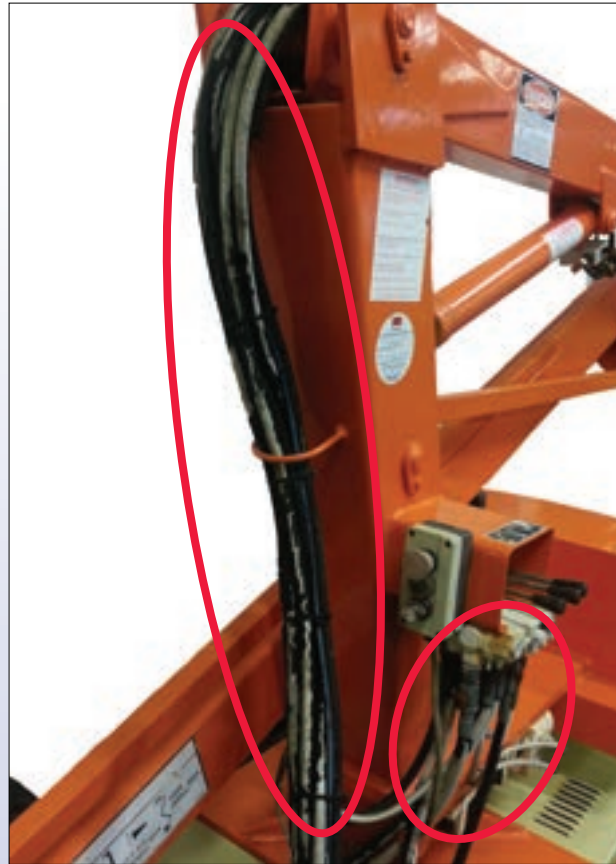
Particular attention for abrasion damage should be made when inspecting hoses which are located near to fabrications, running through bulkheads, hose supports etc. The photographs below show typical abrasion damage due to a combination of incorrect hose routing and inadequate protection. This would necessitate replacement of damaged hose assemblies.

Damage along almost the full length of each hose assembly

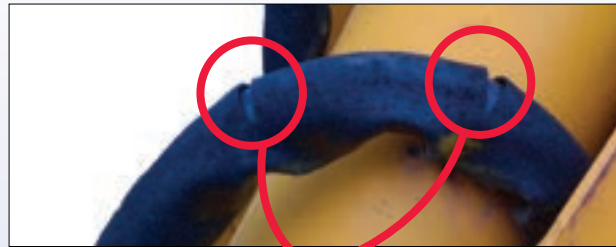
The photograph below show a hose assembly where the sleeve has split. Damage such as this would cause a hose to fail inspection.

Hose burst sleeve split

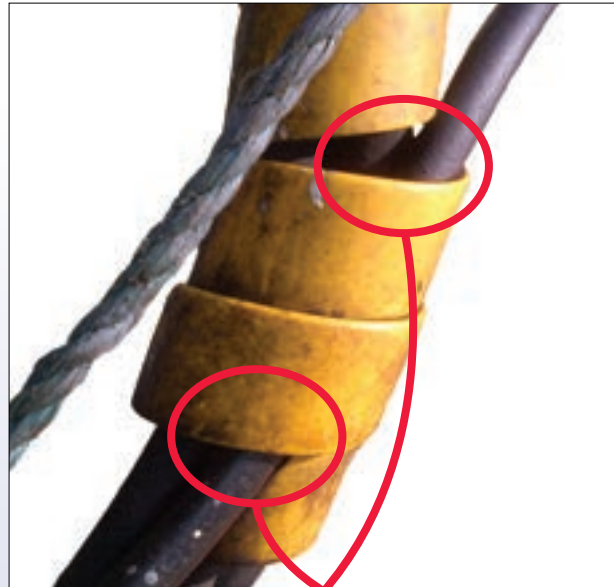
The hose is trapped within the spiral wrap

Spiral wrap should be sized and positioned to protect the hose assemblies. The spiral wrap shown on the above photograph has trapped a hose, thus causing additional damage to the hose.

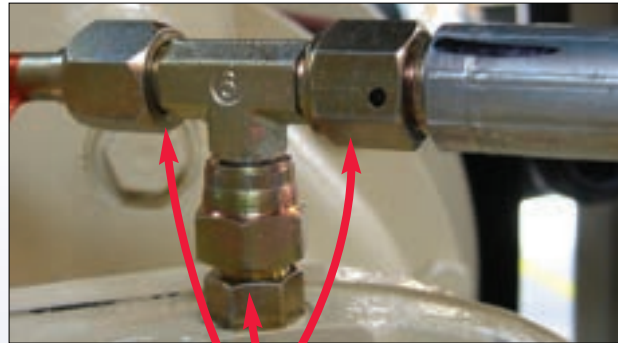
Checking that each elbow and T Piece remains firmly positioned and that there are no leaks around the port threaded interface and cone sealing areas.

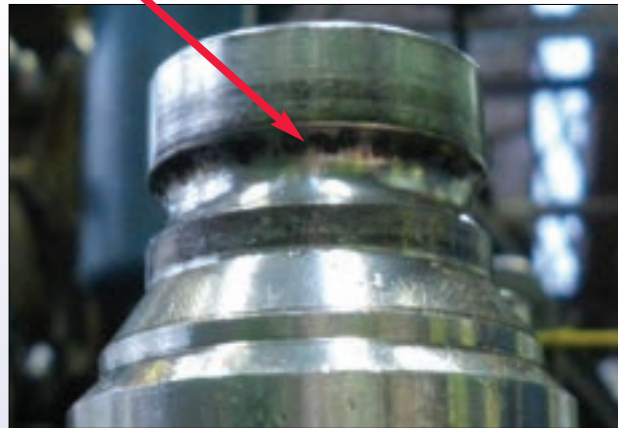
As well as being checked for correct connection and that there are no leaks in the coupled condition, Flat Face type Quick Release Couplings should be checked for damage in the uncoupled condition. The uncoupled checks should include examining the nose end of the probe for any signs of brinnelling around the locking groove. The carrier should be checked to ensure that the inner sleeve has returned fully to its correct uncoupled position.

Examine the nose of the probe for signs of damage and wear

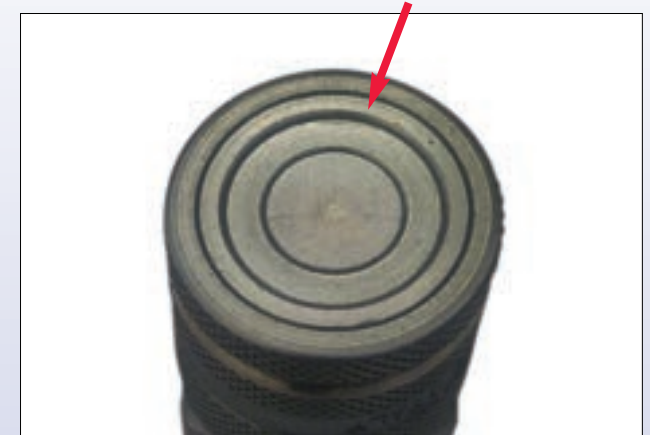
Examine the end face of the flat face carrier sleeve for signs of damage and wear ensuring that the inner sleeve has returned fully to its correct uncoupled position (almost flush to the end of the carrier body).

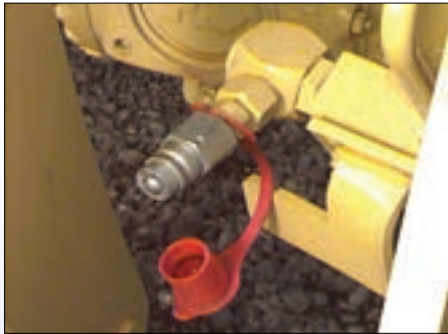
Checking that protective caps are fitted to disconnected probe and carriers where such caps are provided – and if not provided should they be fitted? i.e. is there a danger of dirt/contamination entering the system?
