SAFETY ALERT

SPT HAMMER LIFTING EYE FAILURE

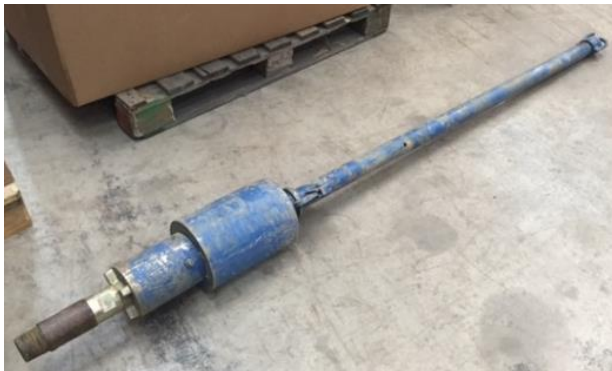
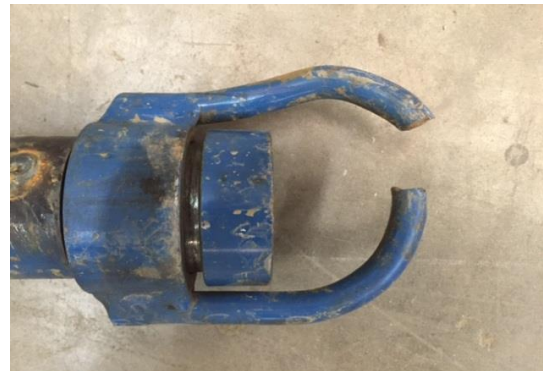
The lifting eye of an automatic trip hammer failed whilst a Standard Penetration Test was being carried out. The hammer was in date and had a current lifting certificate in line with LOLER 98.

The trip hammer had been winched up the drill mast of a multi-purpose rig, connected to the top of the drill string and a penetration test carried out. As the test was near completion the trip hammers lifting eye failed causing the hook of the winch cable to come free of the hammer. This caused the weight of the hammer to fall back down the shaft back onto the anvil.

The hammer was immediately taken out of operation. All other hammers purchased from this manufacturer have also been taken out of operation.

- Management to ensure all new equipment is suitable for the purpose for which it is intended, especially when there is a change in supplier or manufacturer.
- Lead Drillers to inspect the hammer before use. Look for excessive wear, deformations or cracks and check the condition of bolt, pins and latches.
- The hammer should only be used for the purpose it is intended. DO NOT use the hammer to pull the drill string from the bottom of the borehole on completion of a test.
