# Initial Incident Notification

**Incident:** Broken Leg after falling down hole

nationalgrid

# Incident Notification - Closure Report

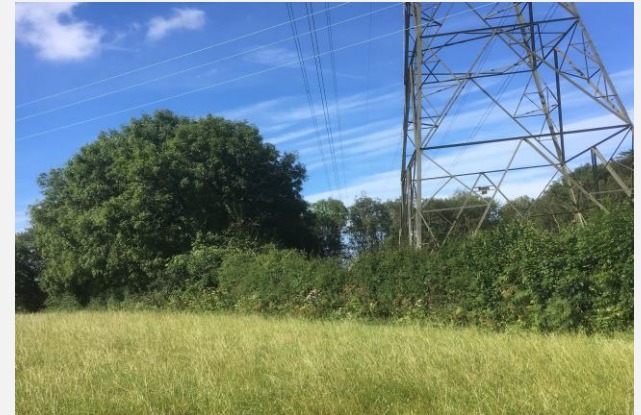
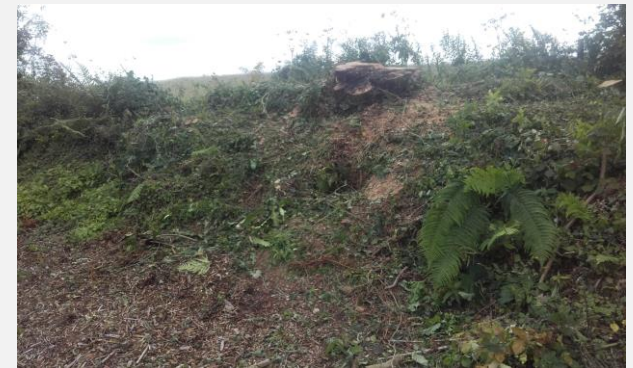
- The IP was working as part of a two man sub contract team undertaking the planned task of vegetation clearance works at scaffold location 4YF89 – 4YF90.
- At the time of the event the IP was working on uneven ground manually clearing the brushwood from the work area when he stepped into a hole that had been uncovered
- The IP was taken to the nearest A&E department for further assessment / treatment.
- As a result of this event the IP sustained a fractured Tibia just above the left ankle and a fracture to the Fibula just below the left knee.
- The IP spent five consecutive nights from the date of the event in Hospital where he underwent surgery to insert a plate pins into his left Tibia. The Fibula bone was realigned and correct alignment of the bone achieved.

- Review and update all site specific method statements, Demarcate additional hazards and ensure all operatives are briefed
- Site team to undertake Risk Assessment training & brief all project staff on the importance of fully assessing the task in advance and continuously throughout the completion of it
- Improve the frequency of onsite monitoring focusing on working practices, condition of PPE being worn; quality of the documentation completed is to the required standard.
