Safety Alert

Subject:	Uncontrolled release of a land geotechnical drill rig winch wire whilst under tension.	Issue Number:	GHSSET/EU/28/08/18
IMPACT No.	11976	Date Published:	11th September 2018

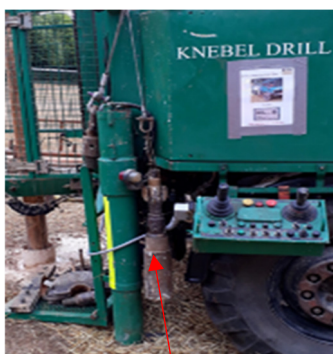
The driller failed to notice that the winch wire had become snagged and continued to raise the mast, thus continuing to increase the tension in the wire until the steel thimble bent, causing the wire and attached hoist plug to release in an uncontrolled manner within close proximity of the driller.

Hoist plug

- Retract the winch wire to a safe position when not in use, where this is not possible, lower the winch wire to a safe location away from all structures and other potential snagging hazards. Contain within a trip tray or bucket to prevent a tripping hazard.

- All potential snagging hazards must be checked before operation of the winch or the lowering / raising of the drill mast.

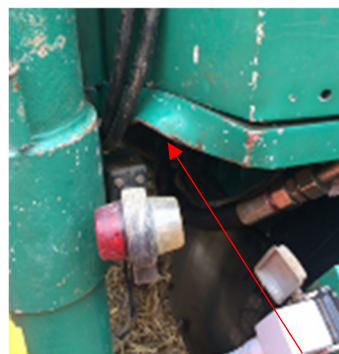
To facilitate the HPD test the driller needed to raise the drill mast resulting in the winch wire being pulled upwards. As the winch wire was pulled up, the thimble within the hard eye of the winch wire momentarily caught (snagged) on the edge of the drill rig chassis.

Damage sustained to chassis and steel winch wire thimble

- Review the task risk assessments to ensure that the potential for lifting equipment (winch wires) becoming snagged is appropriately considered and mitigated. All control measures shall be included in the operating procedure / work instruction.

- Review the way that lifting equipment and accessories (winches & wire ropes etc) interacts with drilling rigs and associated operations.
- Investigate engineering solutions that will mitigate against snagging risks between lifting equipment (winch wires) and the structure of the drilling rig.
