NWE Bulletin 86 – Hydraulic Hose Failure

Significant Near Miss

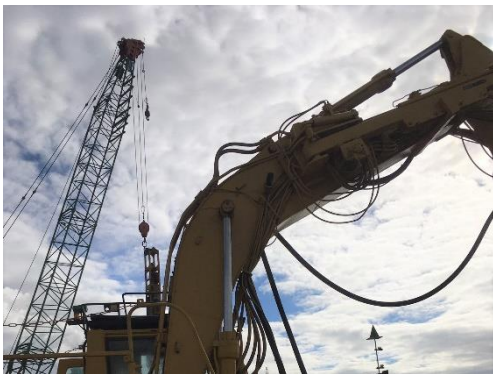
The incident happened on an excavator chassis mounted mast machine.

Whilst lifting the mast from the anchor position to allow the rig to reposition a hydraulic hose failed on the dipper ram.

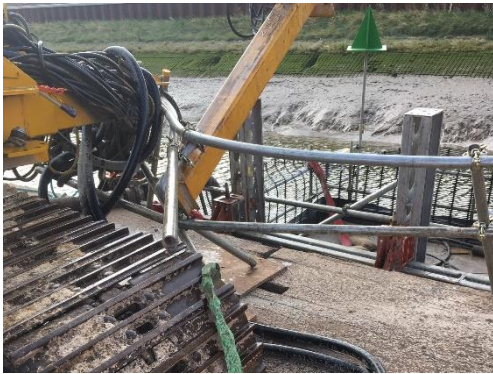
This allowed the mast and dipper arm to swing inwards. The mast came to rest on the scaffold edge protection.

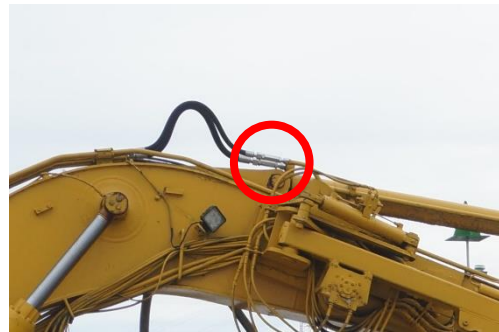
Burst protection repair to dipper ram

- Operation of both rigs was immediately stopped
- All flexible hydraulic hoses were replaced
- Burst protection was retrofitted to dipper and bucket ram hoses
