NWE Bulletin 92 – Hammer Injury

RIDDOR Reportable Event

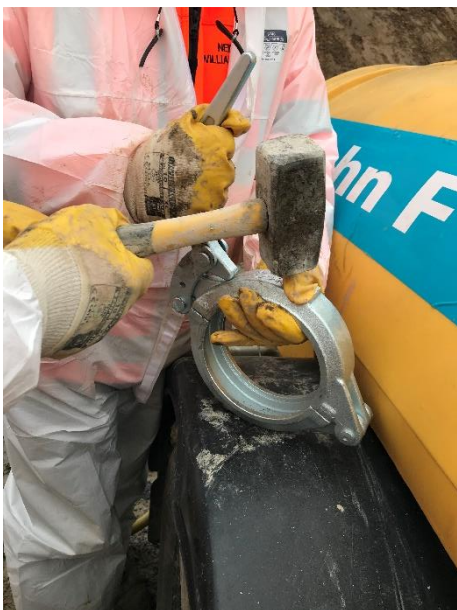
While putting concrete hoses together with a colleague the IP was struck by a hammer being used by his colleague to secure the clamp. The IP accidentally put his thumb in the area where the hammer was striking the clamp.

Mock up of event without hose in place

- The use of hammers to assist in the closing of clamps is discouraged. The clamps are not designed to be secured using hammers, subsequently there is a risk of catastrophic failure. The use of hammers for this purpose is not permitted in Keller globally.
- Ensure that clamps are clear of concrete and that the hinge and lock mechanism are working freely, damaged or distorted clamps are not to be used. – Apply the 5S Shine principle when removing and storing clamps.
- Ensure that rubber seals are clean and correctly seated before closing clamps.

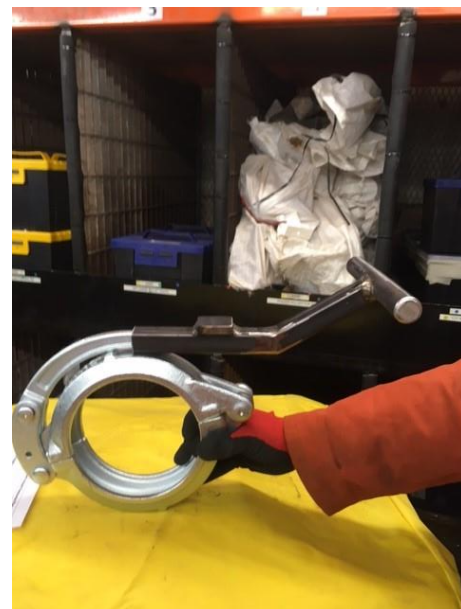
A working group has been set up to identify alternative means to close clamp fittings. The initial prototype is illustrated below.
