G2S

#112

Working at Height (WAH) - Vehicle unloading

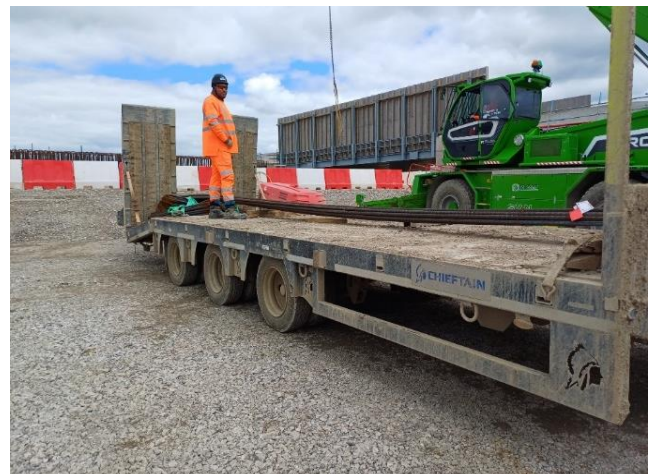
A Contractors Crane Supervisor was observed engaging in a lifting operation from a delivery vehicle trailer bed (<1m height) without edge protection being in place.

- Although available, the trailer's integral edge protection was not installed around the trailer bed.
- The task was routine.
- Use of edge protection was detailed within the WPP, but not the Task Briefing Sheet.

- Activity stopped
- Documentation reviewed
- Review of task planning, management and supervision
- Edge protection installed.

- All WAH activities must be planned - ensure safe systems of work are in place.
- Review your Task Briefing Sheet, is edge protection required and in place?
- If edge protection is not available, stop work until suitable protective measures are put in place
- Even familiar and routine tasks come with risks - stop, think, make the right choice
